Project Name: 15 Caroline S

Project Description: Existing house to be raised additional 26", within the existing footprint. No new areas developed. Access will be through already developed and paved roads. There is no suitable habitat for red knot within the project area.

RE: Hazardous Building Materials Survey for Proposed Renovations
Location: 15 Caroline Street, Milford, Connecticut
Freeman Companies Project #: 2014-1201

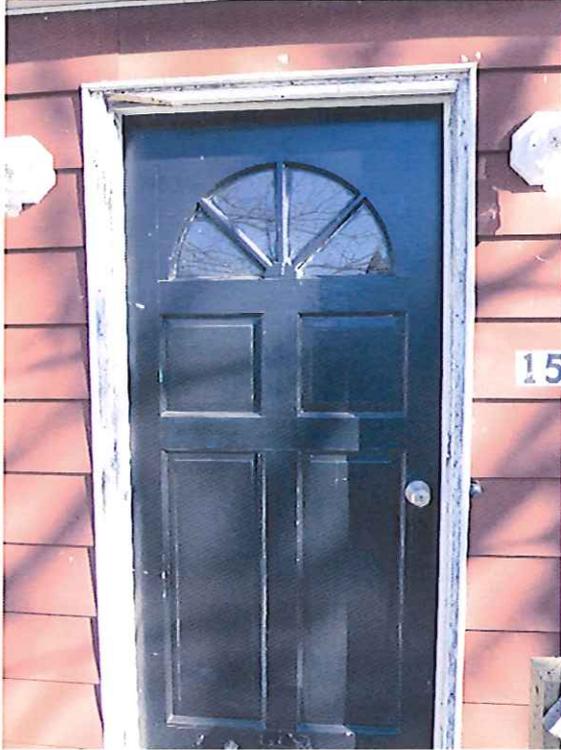
Front Door

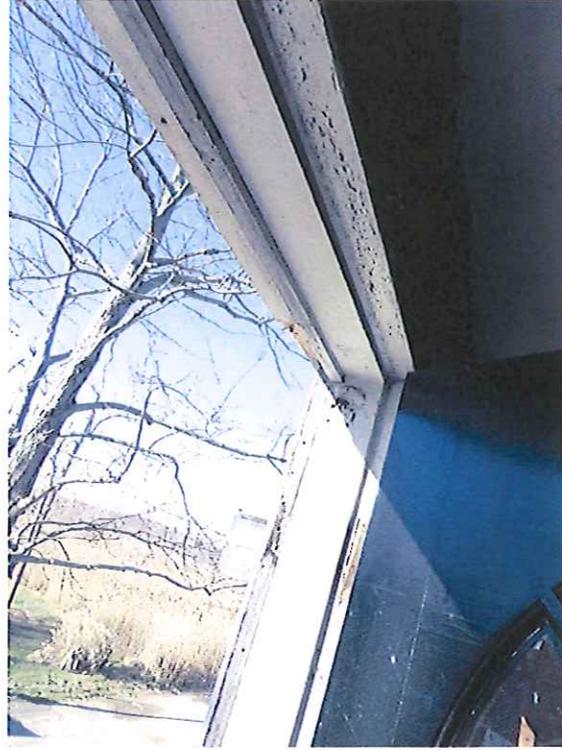
Front Door Frame

The below mentioned Front Door Frame is defined as a friction surface and will require a full replacement rather than abatement of the finish paint.

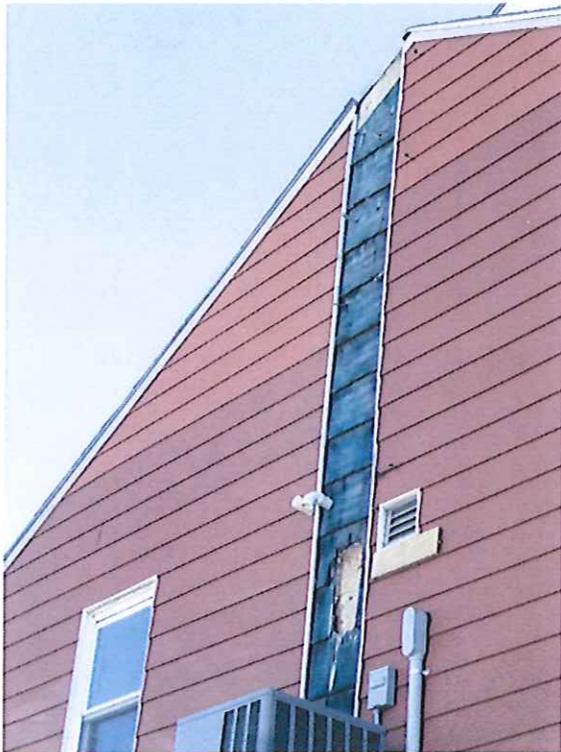
Exposed Original Siding

During any renovation or demolition process, safe work procedures must be implemented by properly (lead-paint) trained workers employed by contractors to address worker protection, lead exposure controls, waste stream management, and ambient air quality monitoring. Specifically, contractors will be required to comply with all applicable OSHA regulations including 29 CFR 1926.62, "Lead Exposure in Construction: Interim Final Rule" and 29 CFR 1926.59, "Hazard Communication for the Construction Industry". In addition, pre-disposal lead-waste testing requirements must be complied with.

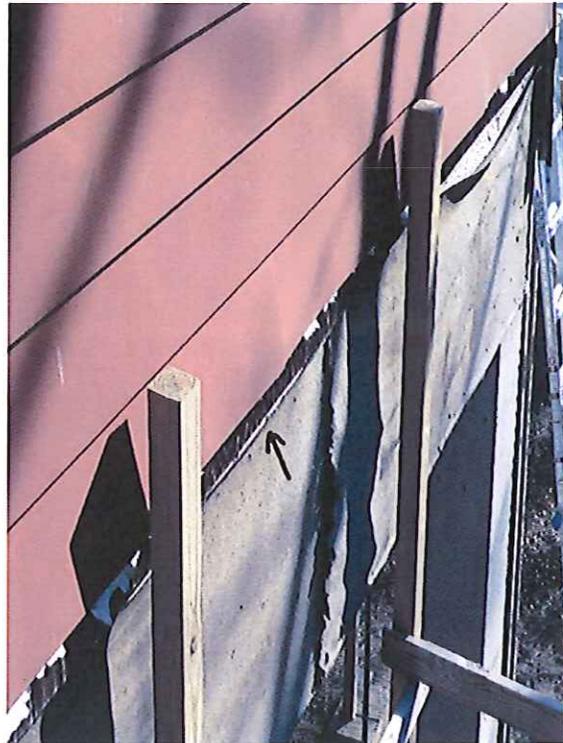
Exposed Original Siding
