RE: Project 2107 – 8 Pearl Street Milford, CT

This letter is to provide a summary description of the Statutory Checklist for CDBG-DR OORR Project 2107 – 8 Pearl Street.

Figure E-10 Statutory Checklist

Attachment 9 – Checklist Item 13C, 13D, 13E, 13F Documentation – Hazardous Material Inspection
Report

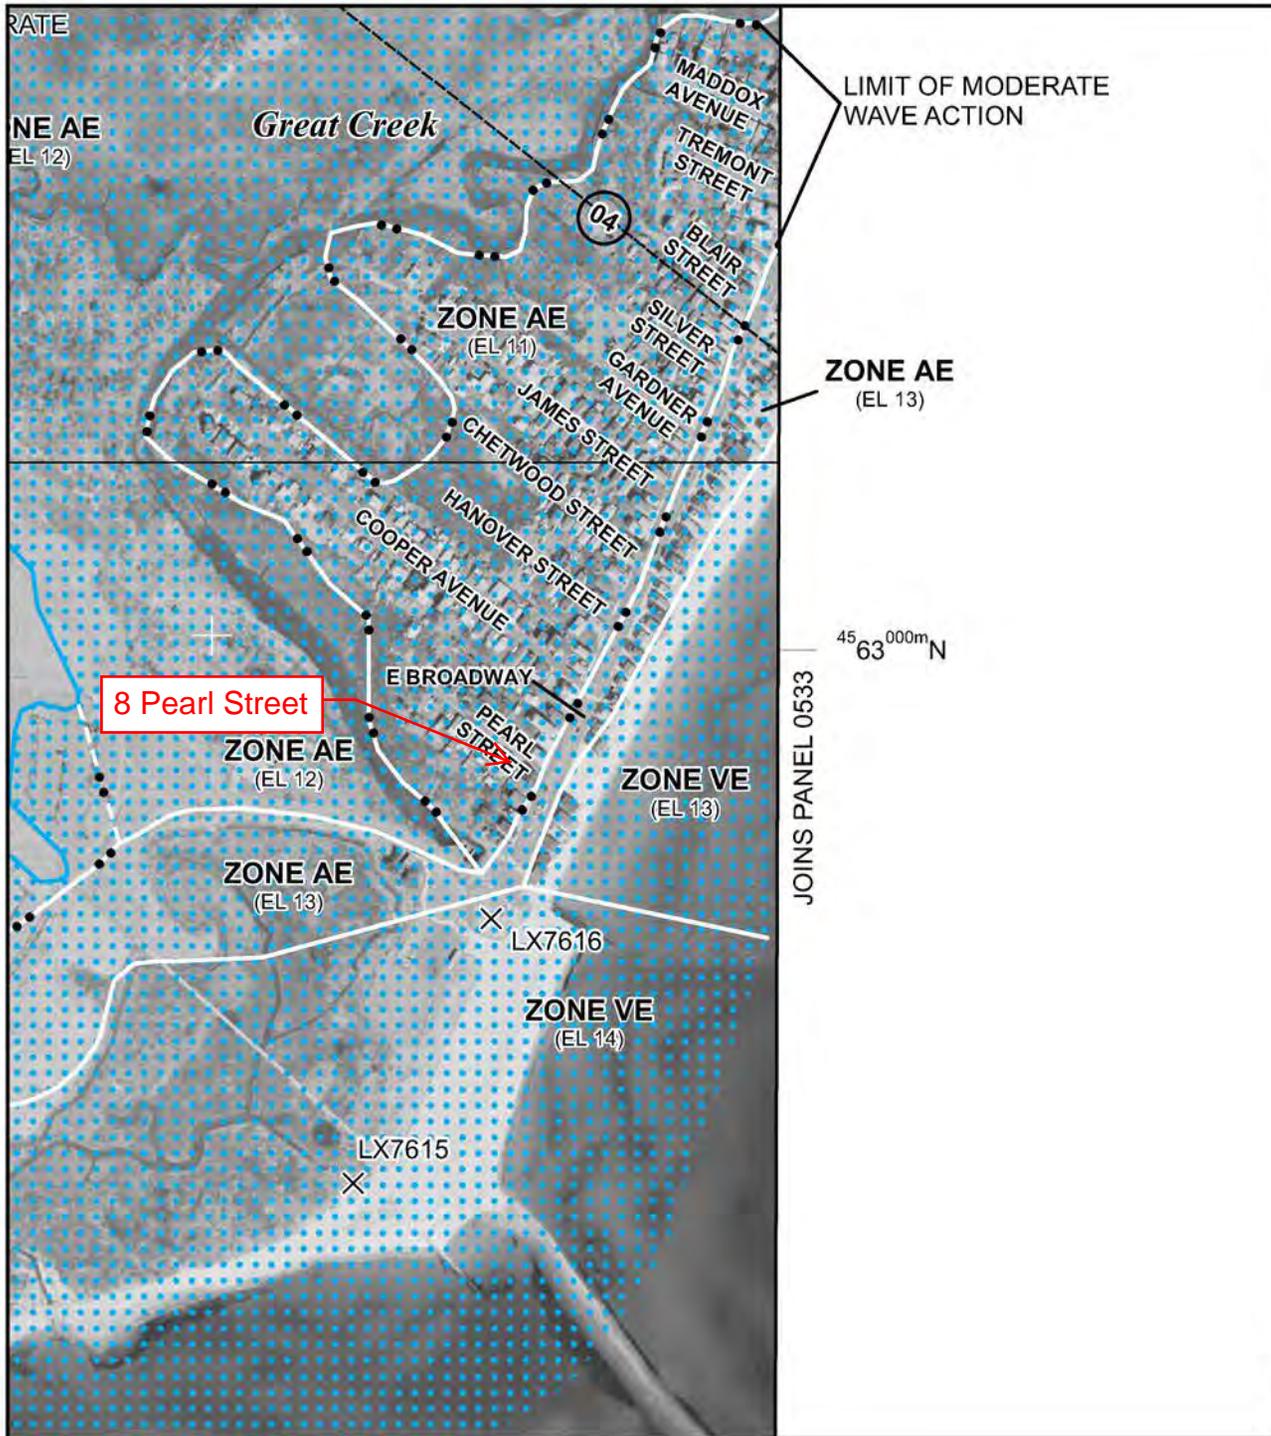
Attachment 2 – Checklist Item #2, #12A and #14A Documentation – FEMA FIRM Flood Mapping

2. Floodplain Management [58.5(b)] [Ex Or 11988] [24 CFR 55]	<input type="checkbox"/>	<input type="checkbox"/>	<input checked="" type="checkbox"/>	<input type="checkbox"/>	<input checked="" type="checkbox"/>	<input type="checkbox"/>	National Flood Insurance Program (NFIP), Flood Insurance Rate Map (FIRM) Number 09009C0529J, Revised July 8, 2013 indicates the project site at 8 Pearl Street Milford, CT is located inside Zone AE with a base flood elevation of 11 feet defined for the 1% Annual Chance Flood. Refer to Attachment 2 included as documentation. Project work does not propose a substantial improvement to the structure.

PANEL 0529J

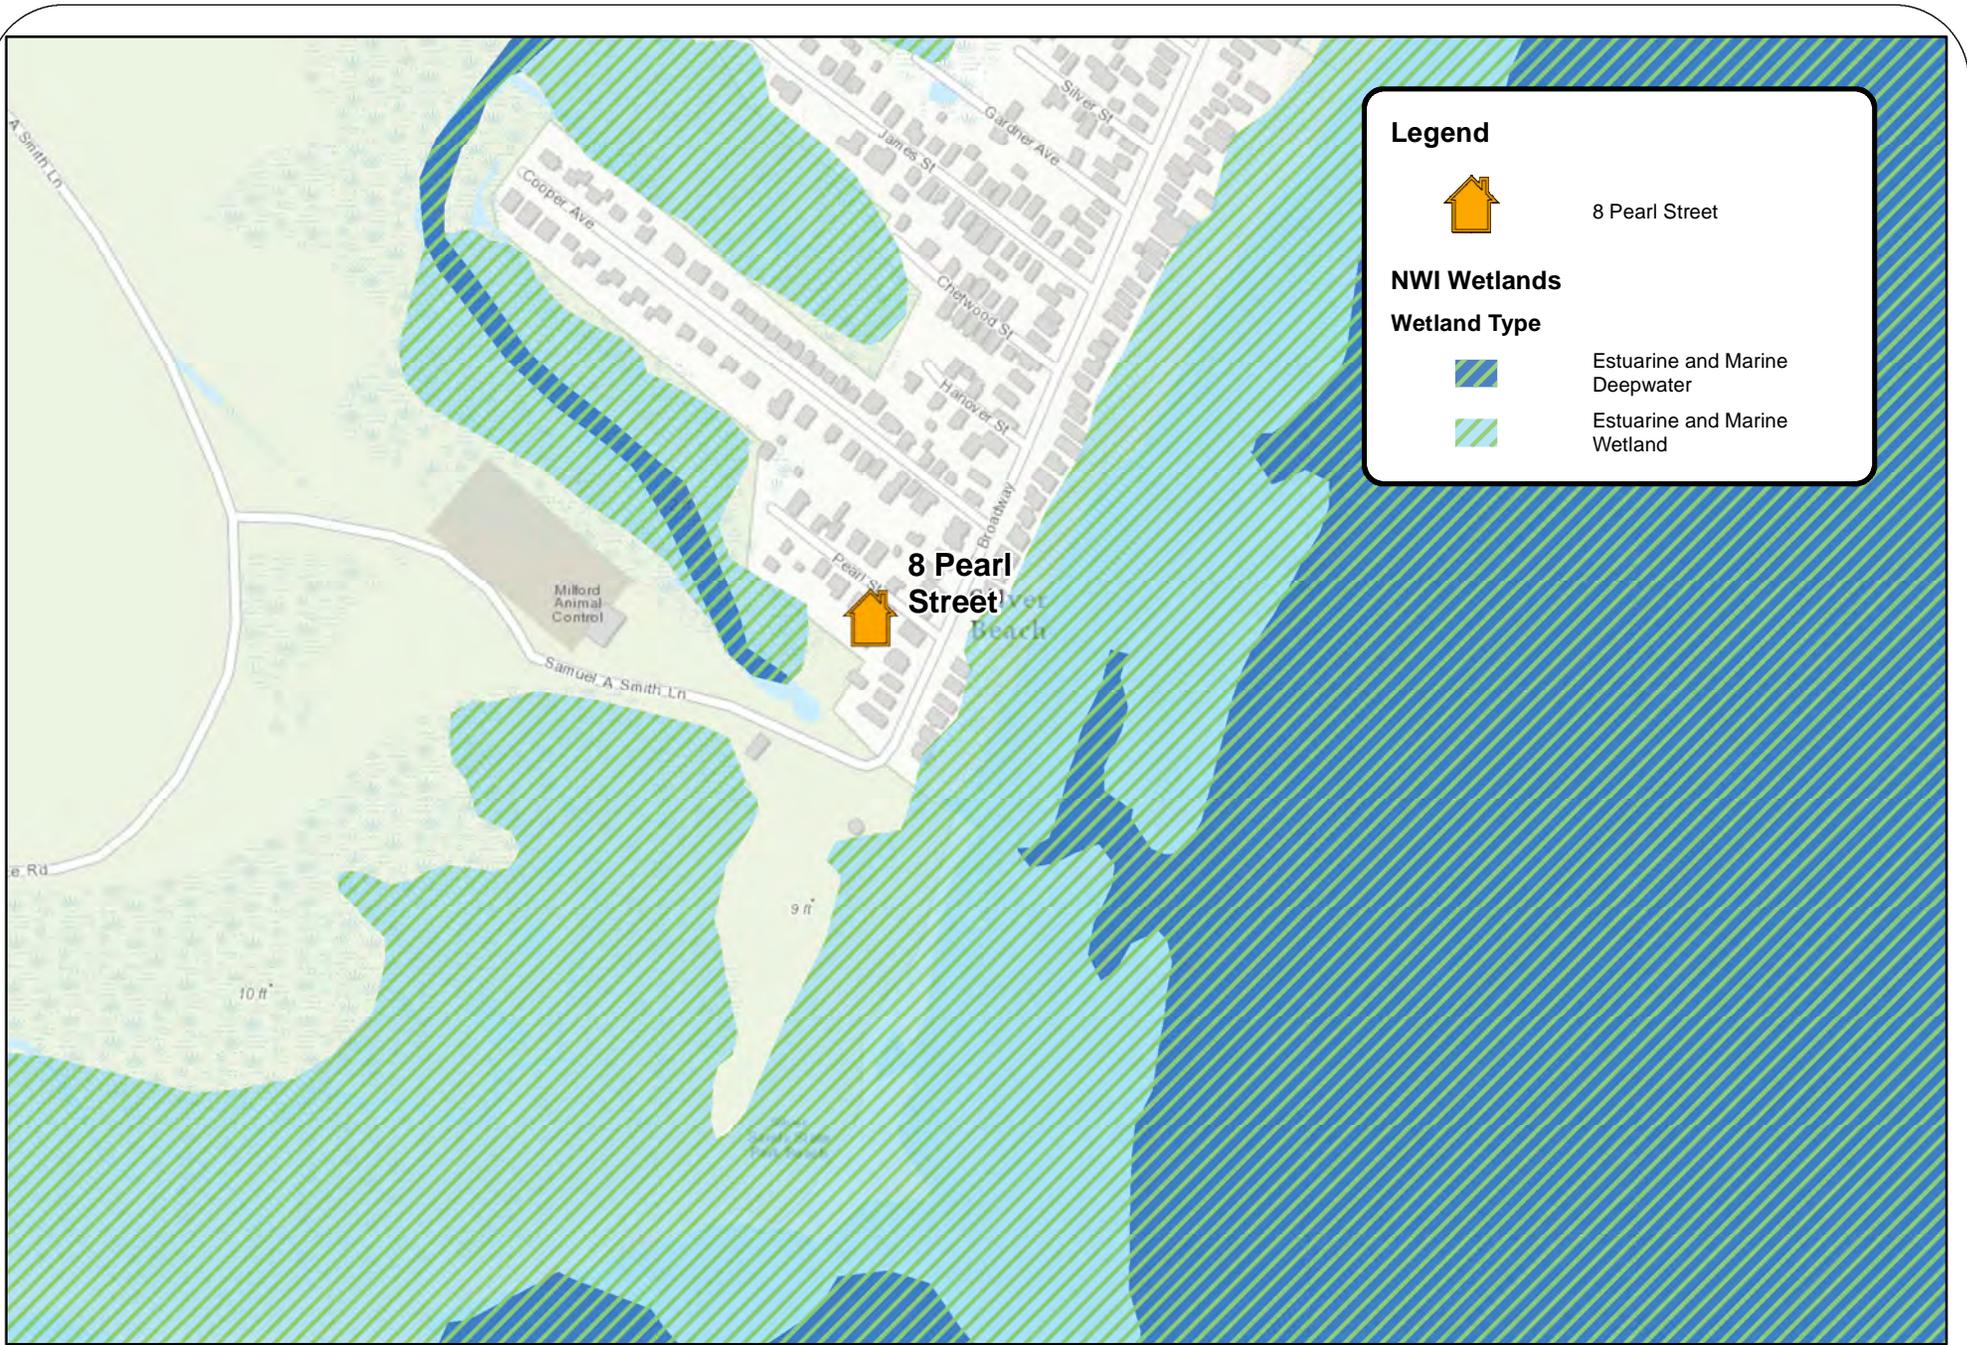
Attachment 3 – Checklist Item 3 Documentation – Wetlands Protection

3. Wetland Protection [58.5 (b)]	<input type="checkbox"/>	<input type="checkbox"/>	<input checked="" type="checkbox"/>	<input type="checkbox"/>	<input checked="" type="checkbox"/>	<input type="checkbox"/>	United States Fish and Wildlife Services (USFWS), National Wetlands Inventory (NWI) mapping identifies the project site outside a wetland zone. See attachment 3 for map documentation. Mapping is Geographic Information System (G.I.S.) map created using data accessed from USFWS NWI website at http://www.fws.gov/wetlands/Data/State-Downloads.html

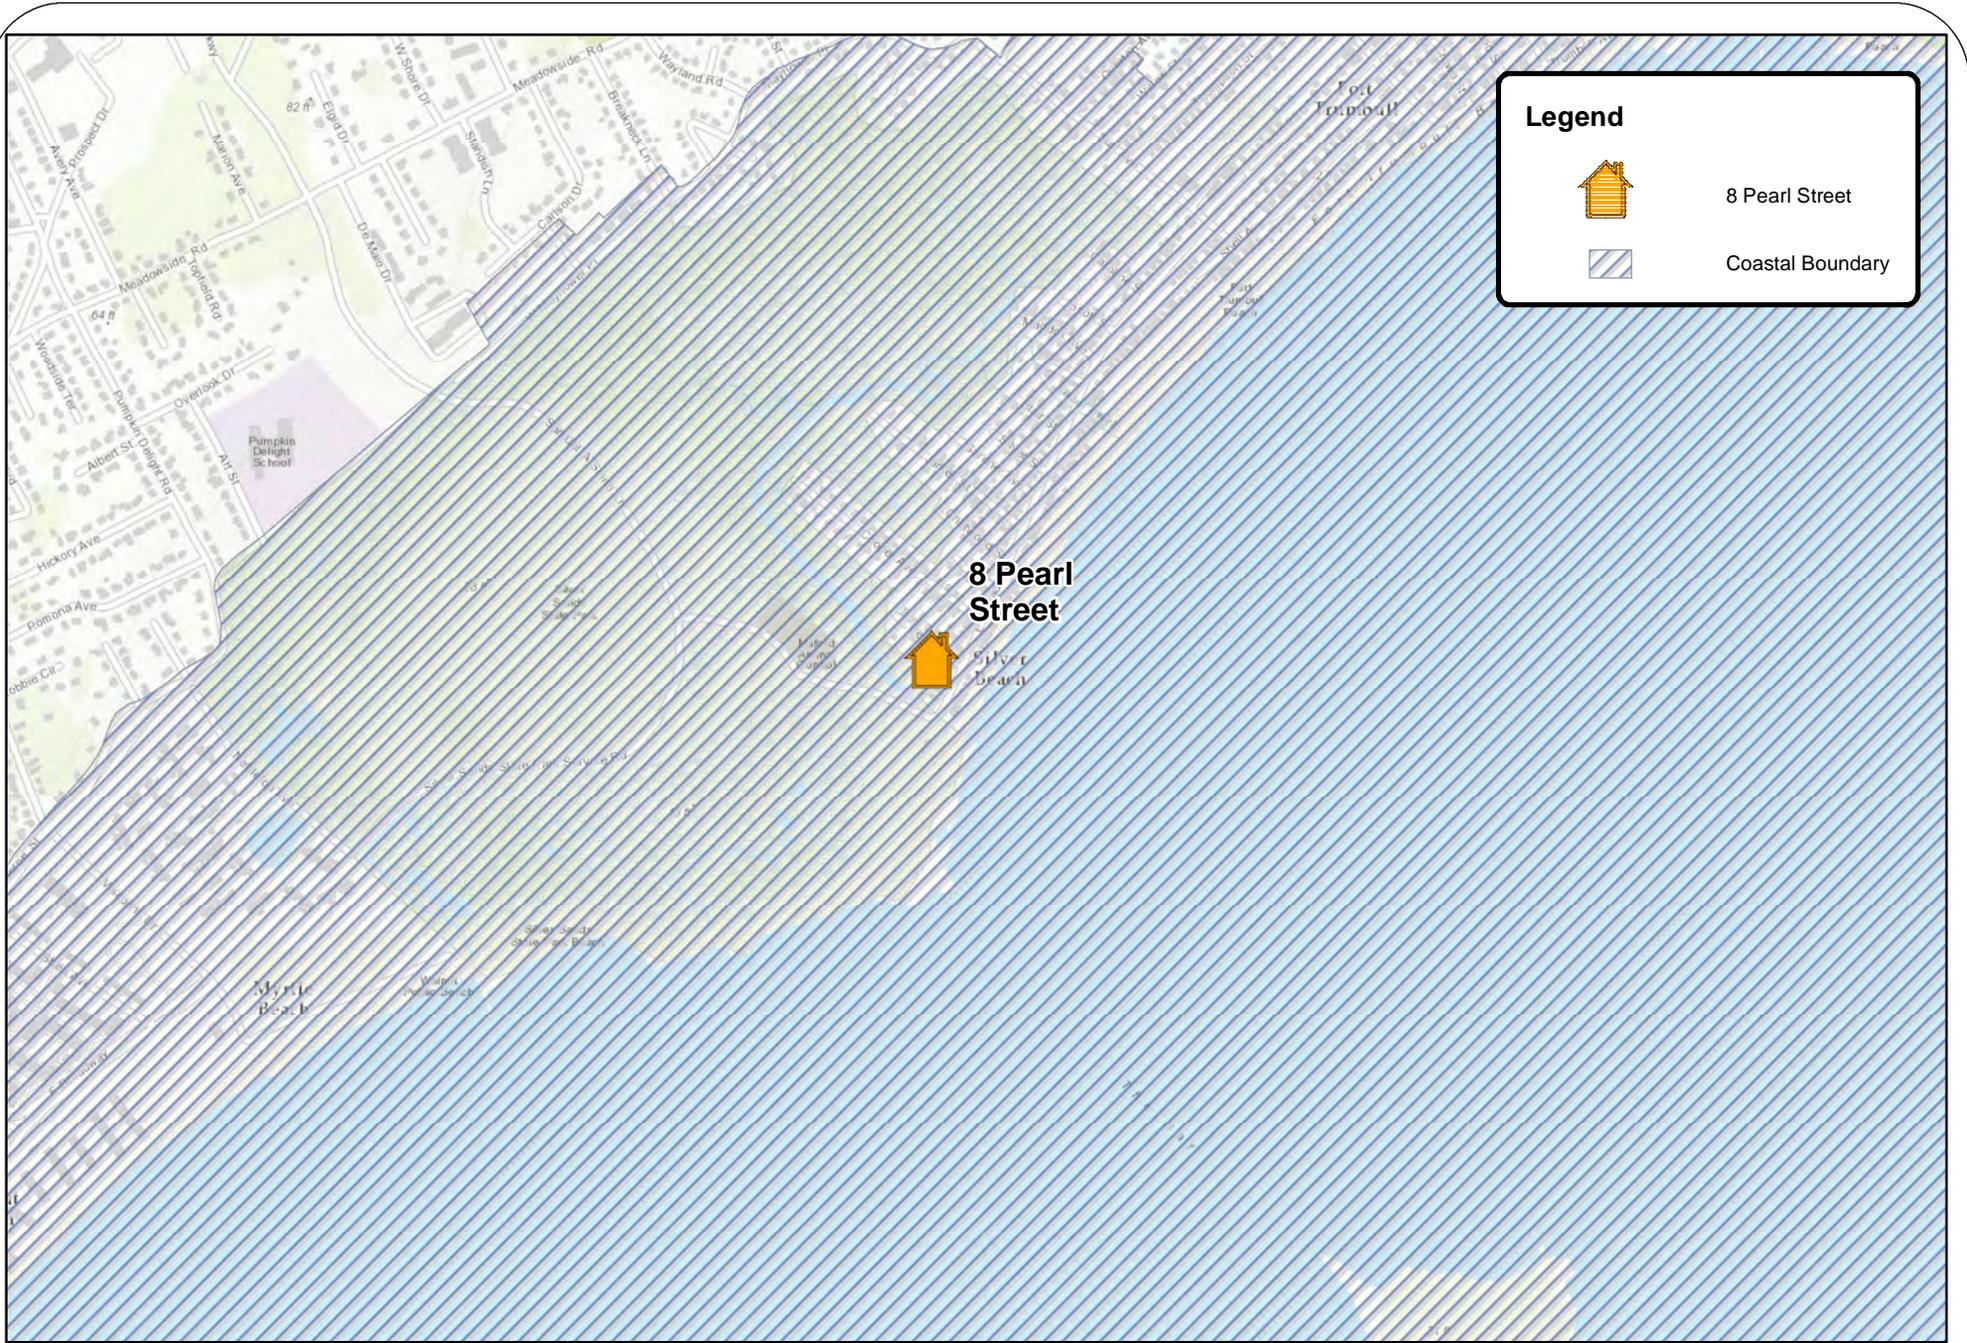
Attachment 4 – Checklist Item 4 Documentation – Coastal Management Zone

4. Coastal Zone Management [58.5(c)]	<input type="checkbox"/>	<input type="checkbox"/>	<input checked="" type="checkbox"/>	<input type="checkbox"/>	<input checked="" type="checkbox"/>	<input type="checkbox"/>	Project site at 8 Pearl Street Milford, CT is located inside a Coastal Boundary Zone. Project activities are consistent with the Coastal Management Act. See attachment 4 for map documentation. Mapping is Geographic Information System (G.I.S.) map created using data accessed from CT Environmental Conditions Online (CT ECO) of the Coastal Boundary Zone from http://www.cteco.uconn.edu/

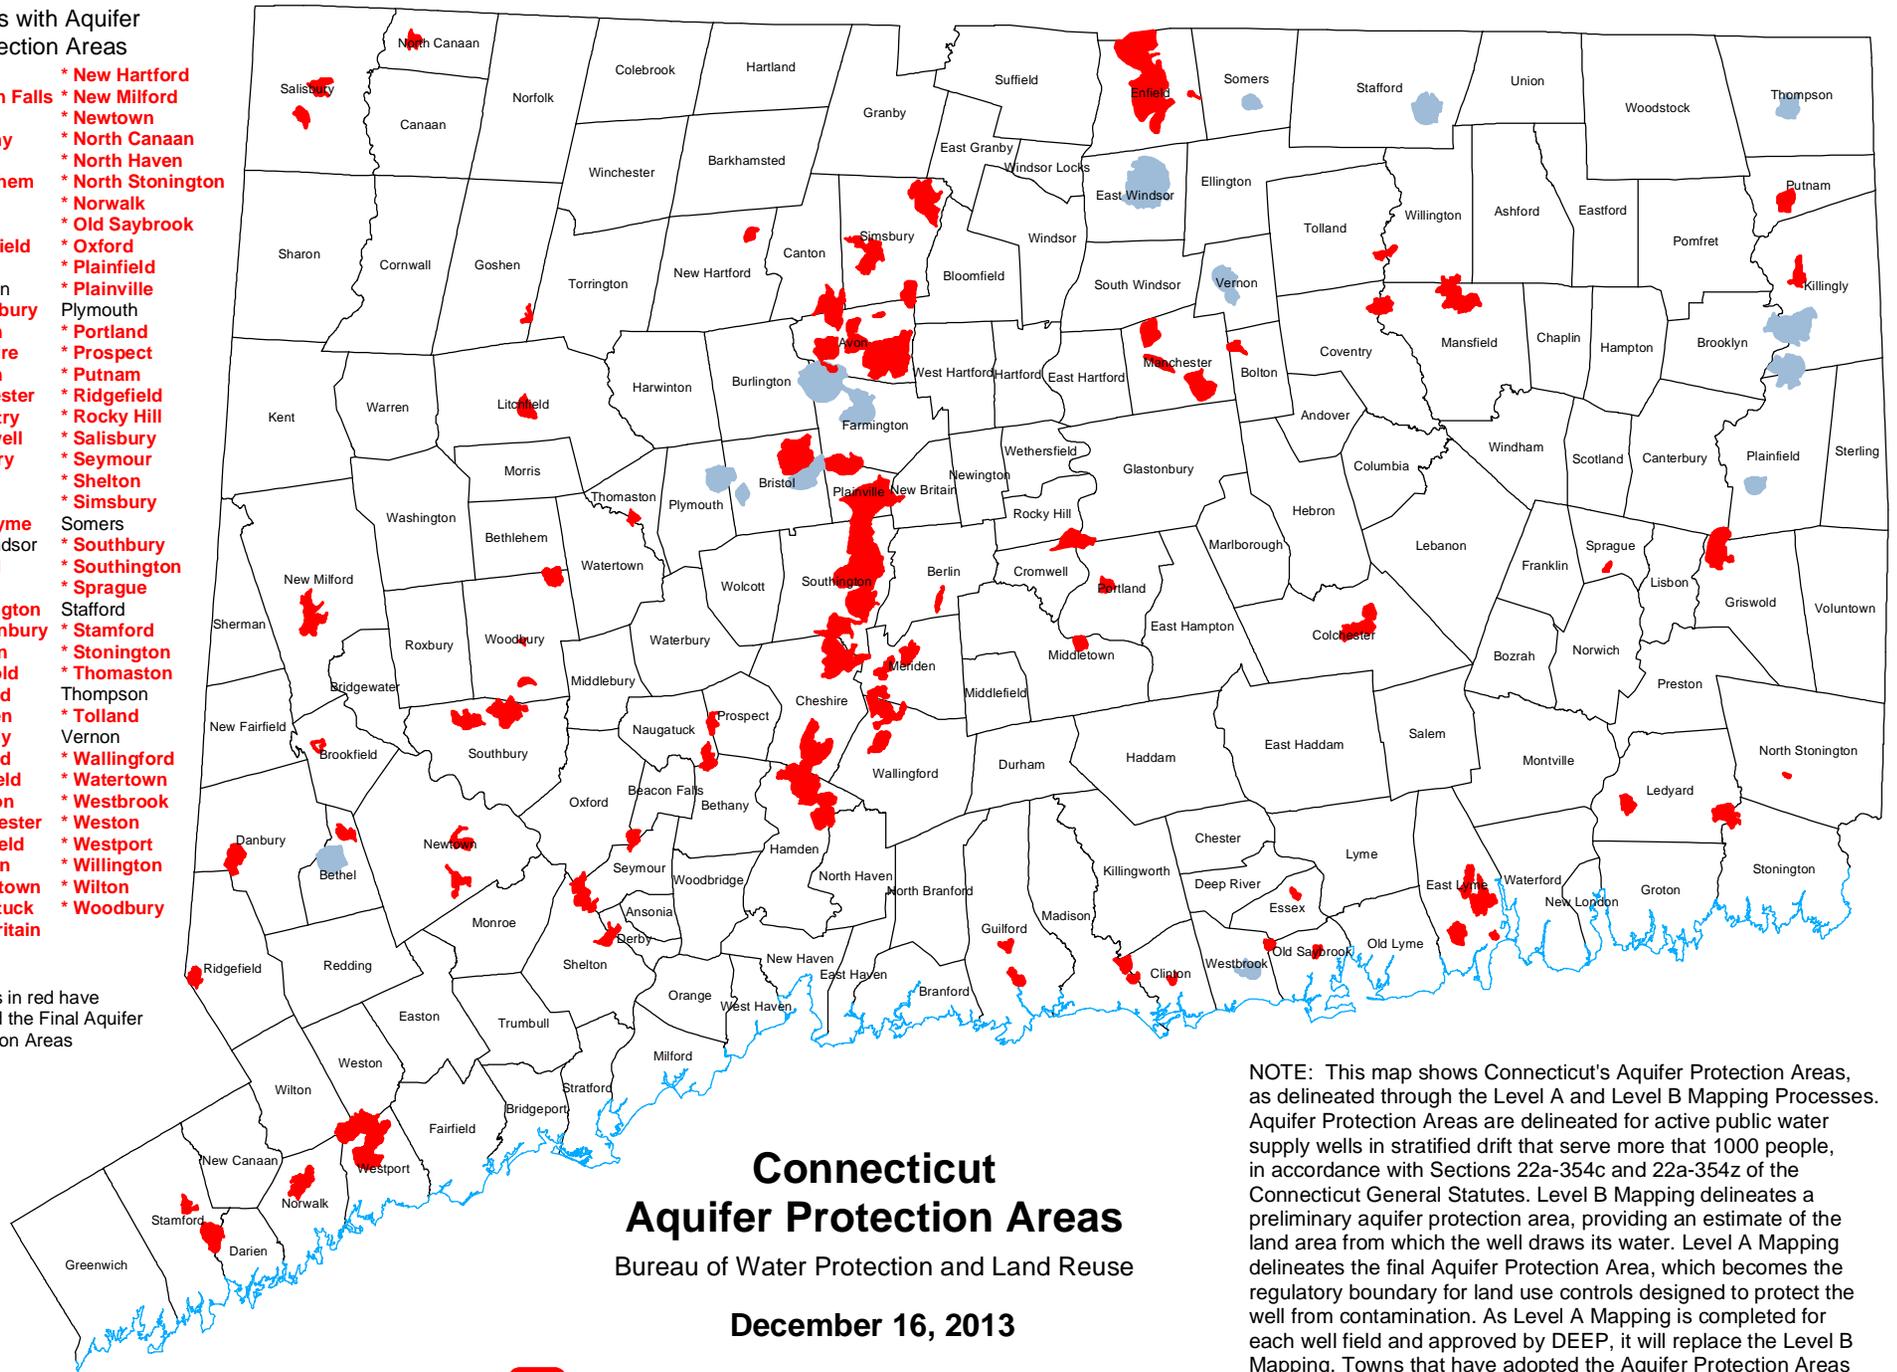
Connecticut Aquifer Protection Areas

5. Water Quality – Aquifers [58.5(d)] [40 CFR 149]	<input checked="" type="checkbox"/>	<input type="checkbox"/>	<input type="checkbox"/>	<input type="checkbox"/>	<input type="checkbox"/>	<input type="checkbox"/>	On site water and sewer facilities are not included in rehabilitation work for 8 Pearl Street Milford, CT. Connecticut DEEP Bureau of Water Protection and Land Reuse map titled

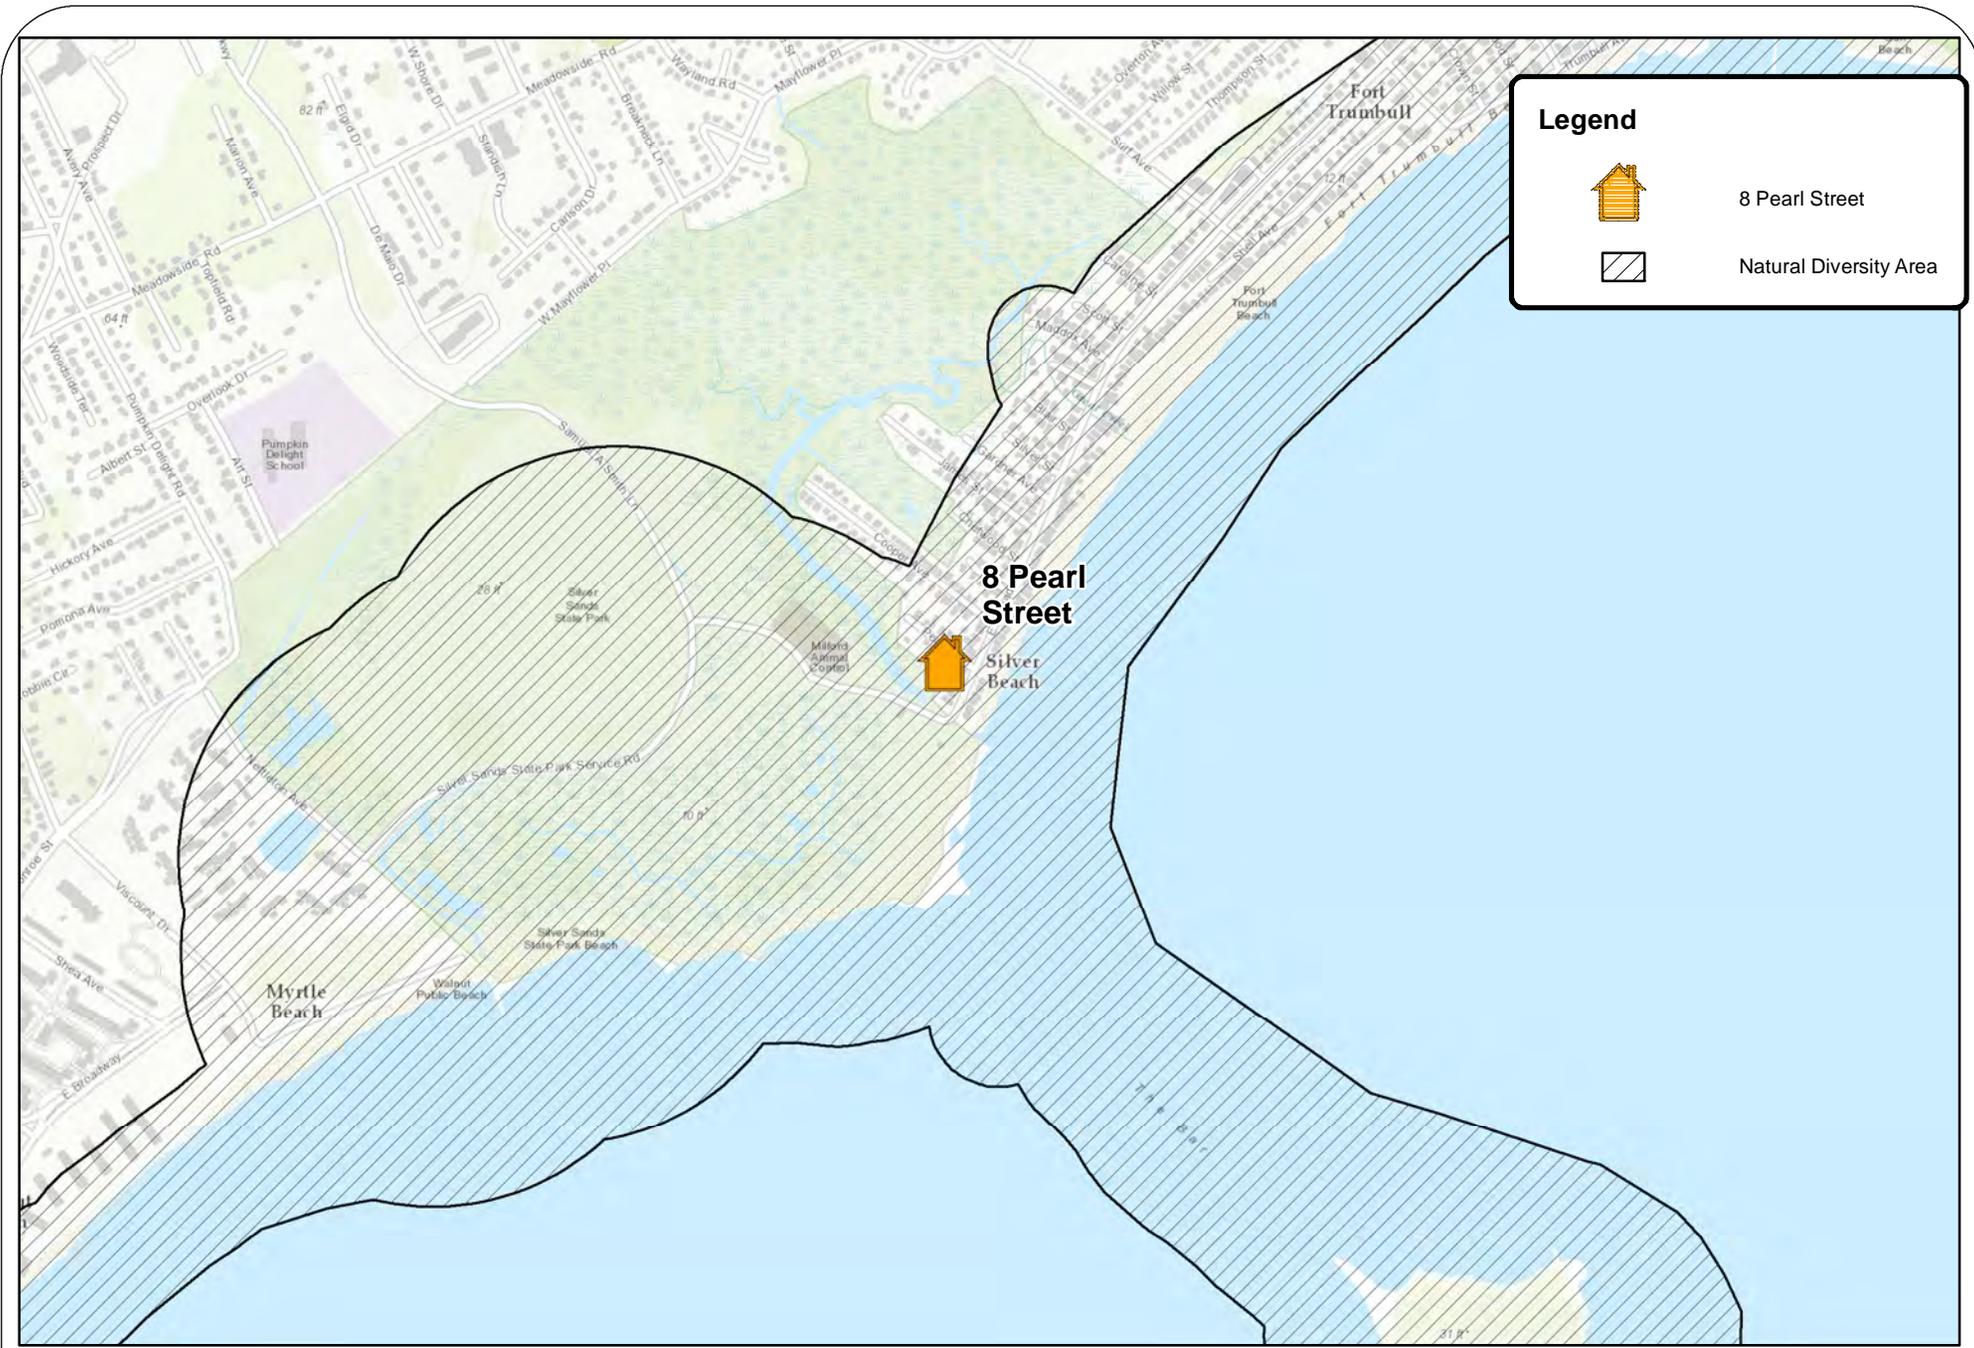
Attachment 6A – Checklist Item 6 Documentation – Natural Diversity Data Base and Endangered Species

6. Endangered Species [58.5(e)] [16 U.S.C. 1531 et seq.]	<input type="checkbox"/>	<input type="checkbox"/>	<input checked="" type="checkbox"/>	<input type="checkbox"/>	<input checked="" type="checkbox"/>	<input type="checkbox"/>	Project is located outside mapped Natural Diversity Data Base (NDDB) areas from CT DEEP. Project site does not contain sandy beaches. See attachment 6A for Geographic Information System (G.I.S.) map of NDDB areas created using data accessed from Connecticut Environmental Conditions Online (CT ECO) at http://www.cteco.uconn.edu/ . U.S. Fish & Wildlife Service Information, Planning, and Conservation (IPaC) List, included as attachment 6B, does not identify any Critical Habitats, or Wildlife Refugees in the project site. The two (2) threatened species, one (1) endangered species, and the seventeen (17) migratory birds potentially present in the project area are not anticipated to be affected by project activities.

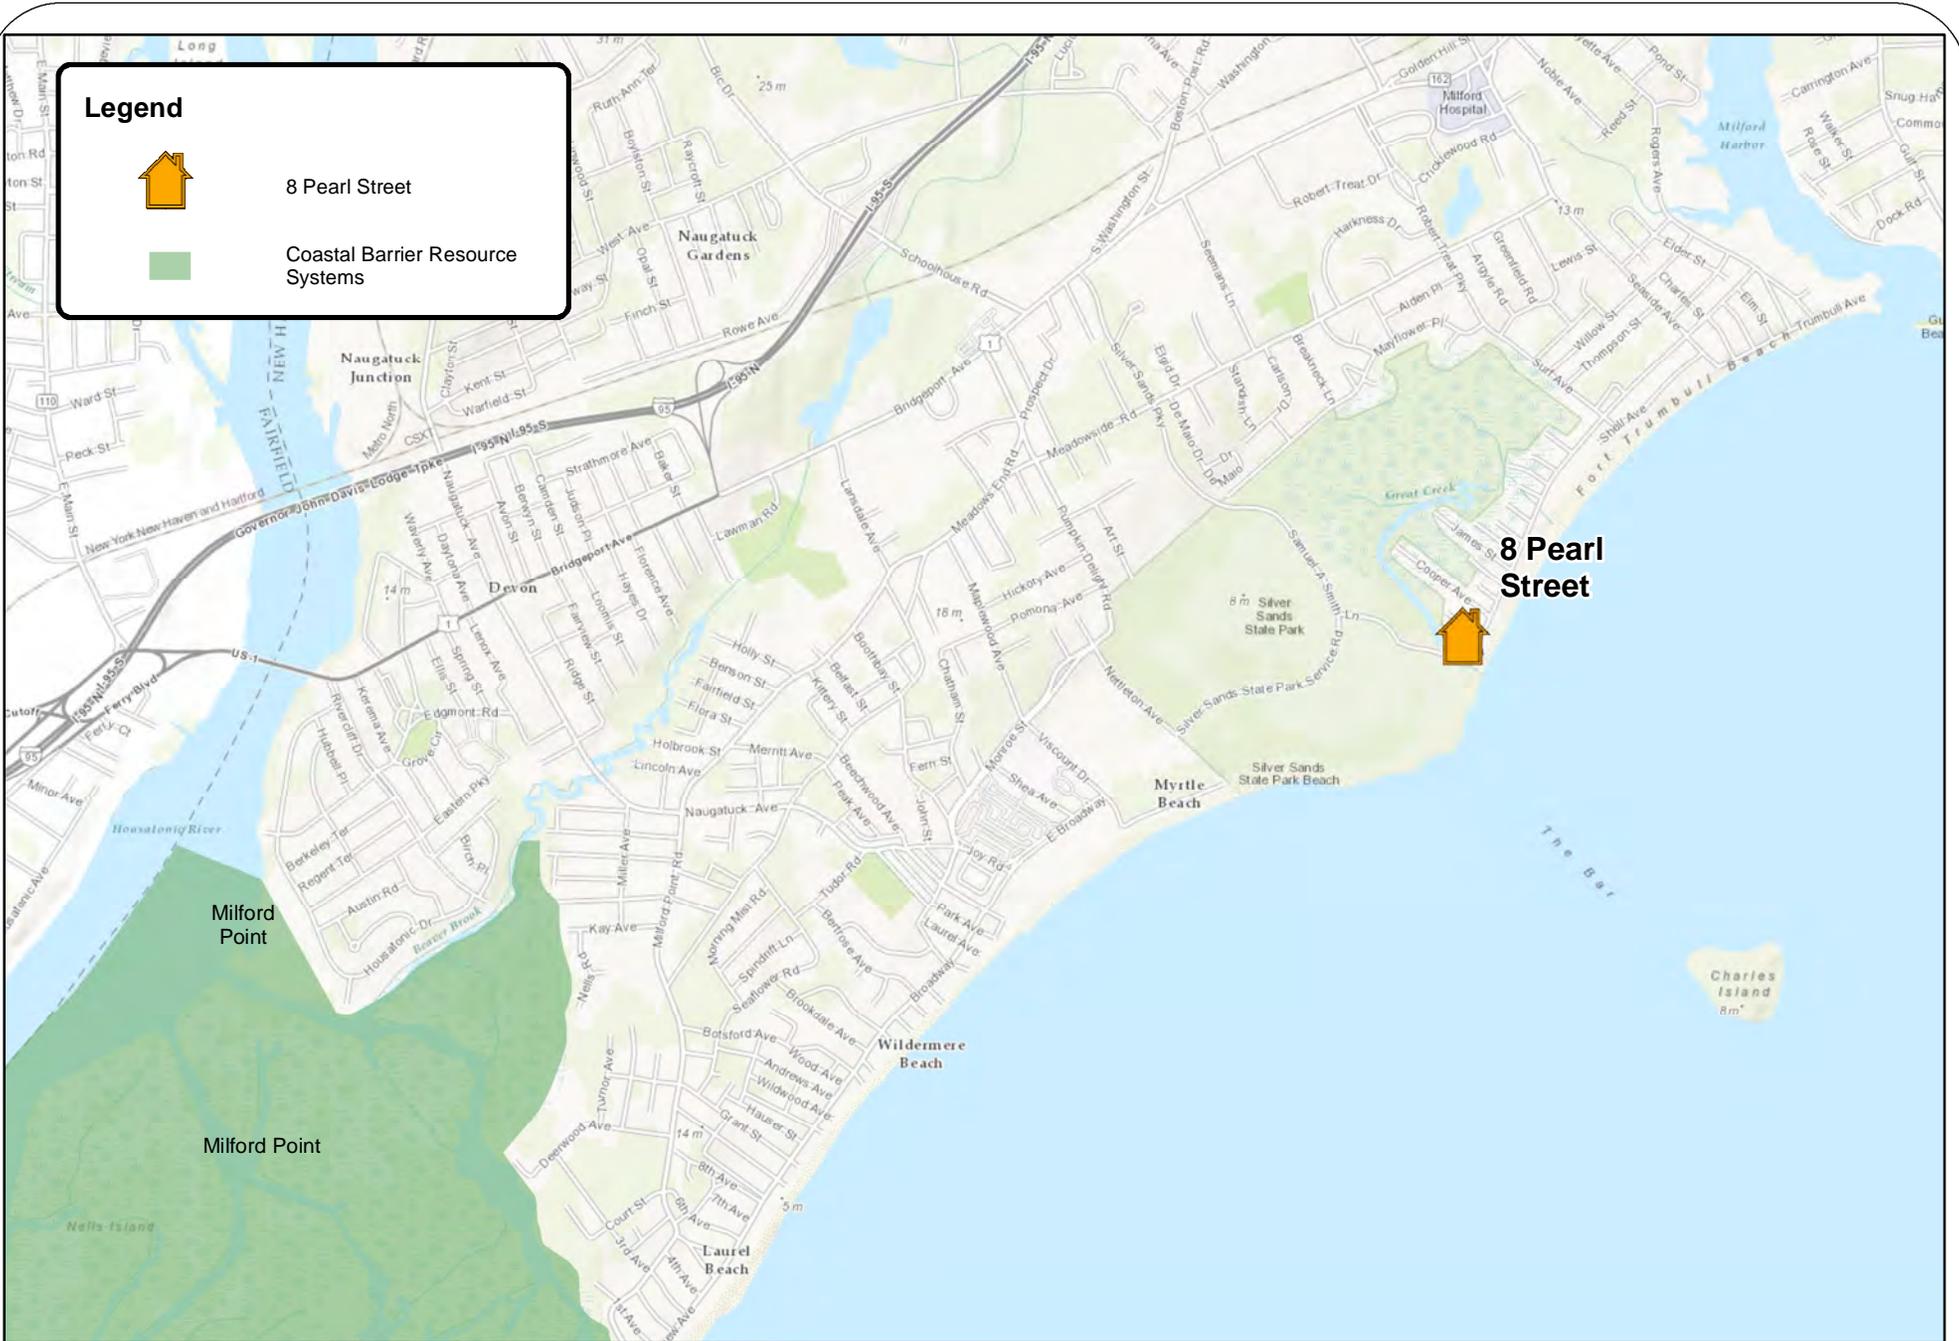
Coastal Barrier Resource Systems

12 B. Coastal Barriers [58.6(c)]	<input type="checkbox"/>	<input type="checkbox"/>	<input checked="" type="checkbox"/>	<input type="checkbox"/>	<input checked="" type="checkbox"/>	<input type="checkbox"/>	Project at 8 Pearl Street Milford, CT is not located within a Coastal Barrier Resource System unit. See attachment 8 for documentation. Mapping is Geographic Information System (G.I.S.) map created using data digitized from official John H. Chafee Coastal Barrier Resource System maps enacted by law and endorsed by the U.S. Fish and Wildlife Service. Digital data was accessed from CT Environmental Conditions Online (CT ECO) at http://www.cteco.uconn.edu/
12 C. Airport Clear Zone Notification [58.6(d)]	<input checked="" type="checkbox"/>	<input type="checkbox"/>	<input type="checkbox"/>	<input type="checkbox"/>	<input type="checkbox"/>	<input type="checkbox"/>	Project does not involve the purchase or sale of a property as such 24 CFR 58.6(d) is not applicable.

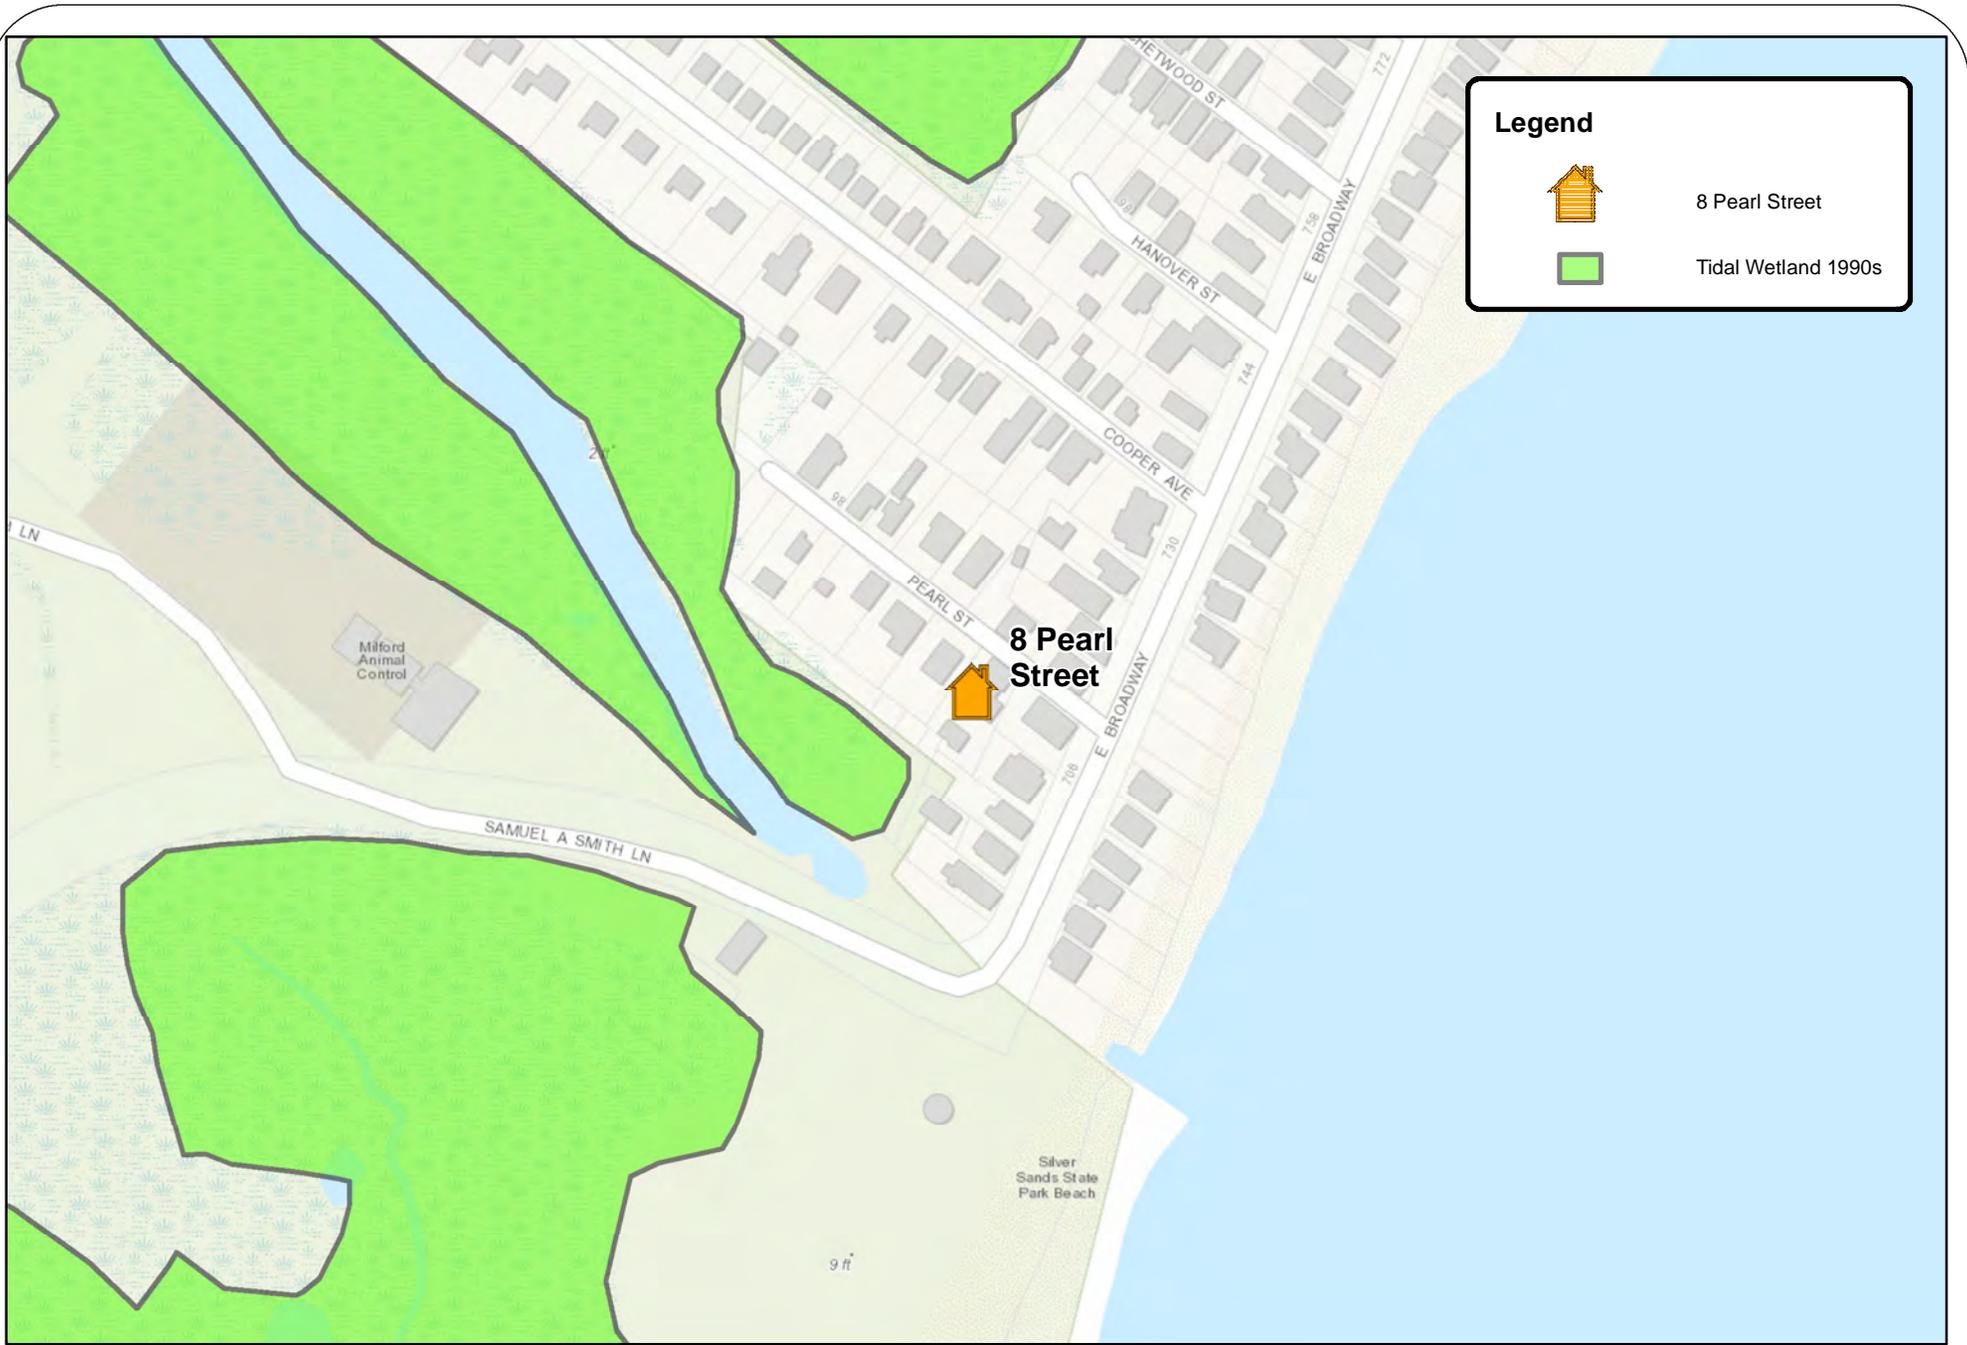
Attachment 11 – Checklist Item 14C Documentation – Tidal Wetlands

14 C. Tidal Wetlands Act [CGS 22a-28 to 22a-35]	<input checked="" type="checkbox"/>	<input type="checkbox"/>	<input type="checkbox"/>	<input type="checkbox"/>	<input type="checkbox"/>	<input type="checkbox"/>	Connecticut Department of Energy and Environmental Protection Tidal Wetlands Mapping as defined in C.G.S. Section 22a-29 and Section 22a-93(7)(e) identifies the project as outside a Tidal Wetland Zone. See attachment 11 for documentation. Mapping is Geographic Information System (G.I.S.) map created using data accessed from CT Environmental Conditions Online (CT ECO) of Tidal Wetlands Mapping accessed from http://www.cteco.uconn.edu/
14 D. Local inland wetlands/watercourses [CGS 22a-42]	<input type="checkbox"/>	<input type="checkbox"/>	<input checked="" type="checkbox"/>	<input type="checkbox"/>	<input checked="" type="checkbox"/>	<input type="checkbox"/>	Project rehabilitation work is limited to rennovtions to exsiting structure and are not expected to impact wetlands/watercourses. See attachment 11 for Connecticut
