Environmental Review Record  
and  
Statutory Checklist

Residence of Gail and Jack Trez  
20 Cooper Avenue  
Milford, CT

NEPA Compliance Document  
Prepared Pursuant to 24 CFR Part 58

**Initial Property Inspection Report**

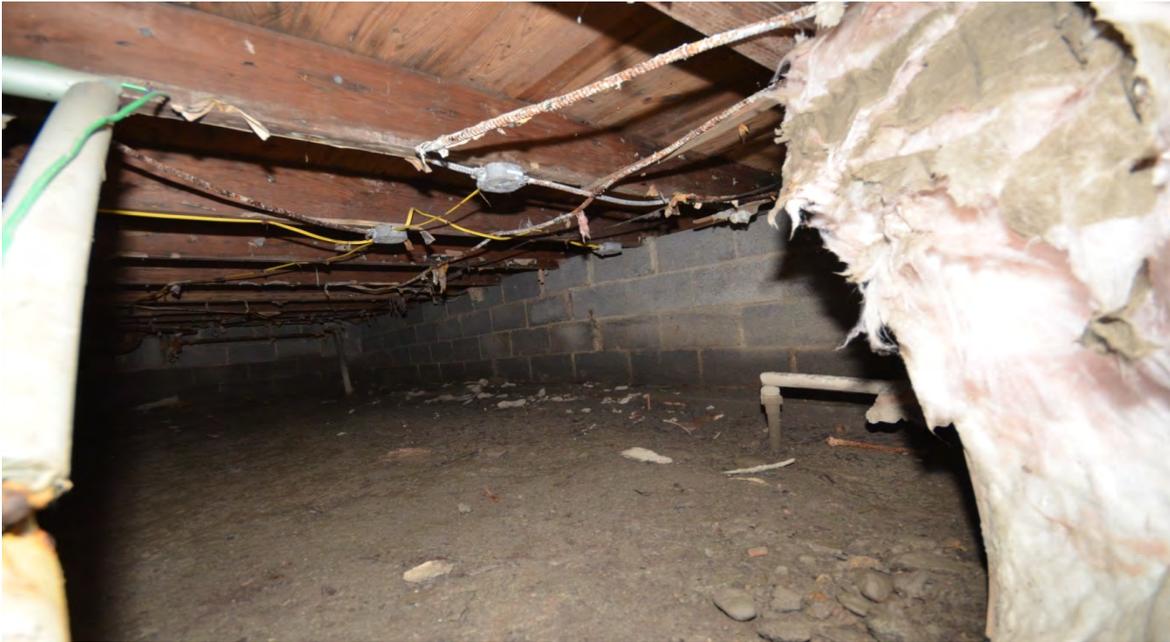
Figure 2

Damage compliant by owner	Inspection observation <i>Recommendation</i>	Rehabilitation Cost projection	Mitigation cost projection
<b>The property is in an AE Flood Zone 11' above datum zero:</b> If the dwelling is mitigated and raised above the flood zone a new foundation structure with new footings will be designed and constructed to raise the building. The existing foundation walls and footings shall be removed with this new construction included in the cost of this item estimate. Modification of existing and/or construction of new exterior stairs to accommodate the new elevation are included in this item cost projection.			\$90,000
Crawl space - insulation: The owner stated the storm surge flooded the crawl space damaging the floor insulation.	The some of the insulation is still in the crawl space and is dislodged from its installed position, hanging on pipes and other objects below. The insulation is matted and destroyed. Other portions missing entirely <b>See Figure 2</b>	\$1,500	\$1,500

<i>Recommendation: Remove the damaged insulation and replace with new batt insulation.</i>		
Crawl space - masonry: The owner stated the storm surge flooded the crawl space damaging the masonry walls.	<p>Some of the masonry walls may have been displaced by moving water, especially at the rear portion of the dwelling. Some of the mortar joints are cracked. Some of this damage may have been pre-existing but would have been exasperated by the storm. A small portion of masonry block adjacent to a crawl space access hatch fell off when the owner replaced the hatch after inspection of the crawl space interior. That portion of wall was placed back into position but not set in mortar. <b>See Figure 3</b></p> <p><i>Recommendation: If done as rehabilitation, check for loose or shifting blocks. Remove any loose or shifting block found and repair other defective areas. Repair with new block and reinforcing.</i></p>	\$4,500	NA

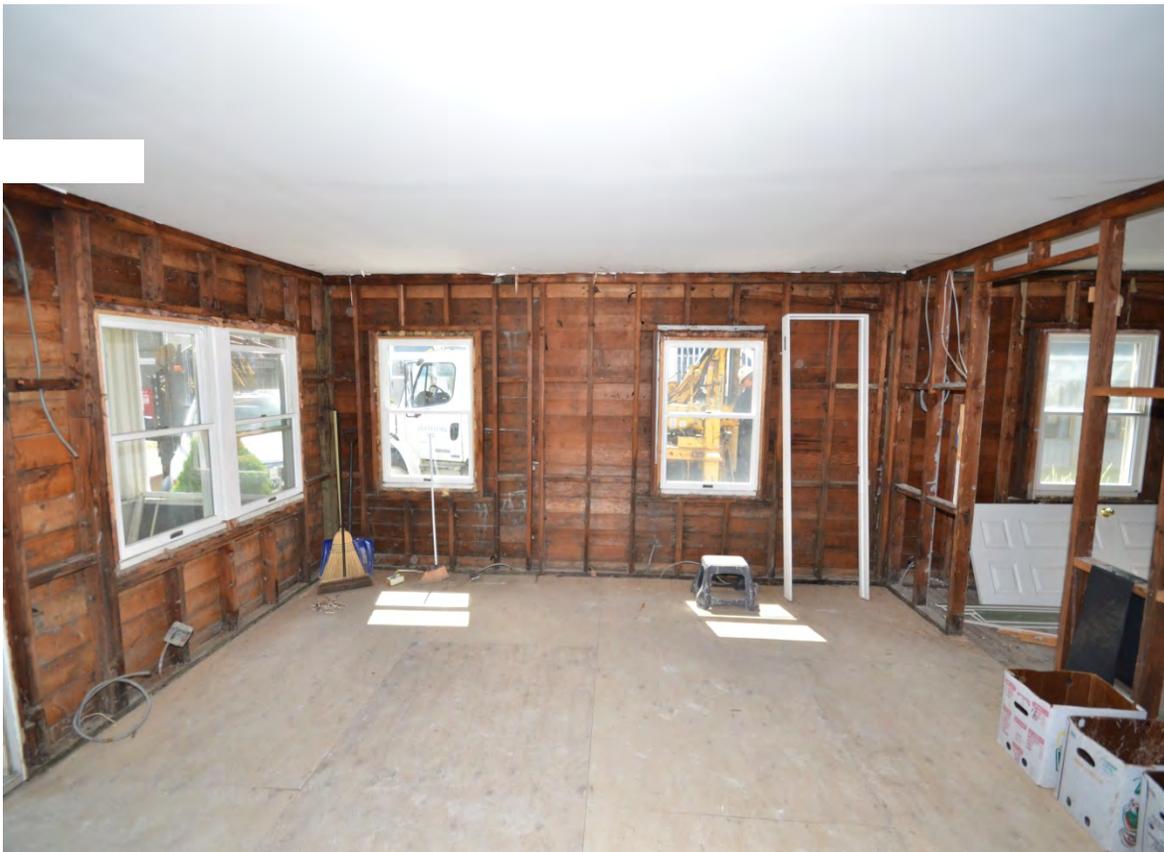
Figure 5

Headers: The owner pointed out doors and windows do not have structural headers.	The existing framing is substandard and has no headers at door and window openings. <b>See Figure 5</b>  <i>Recommendation: Install new headers at all existing load bearing wall openings.</i>	NA	\$1,500

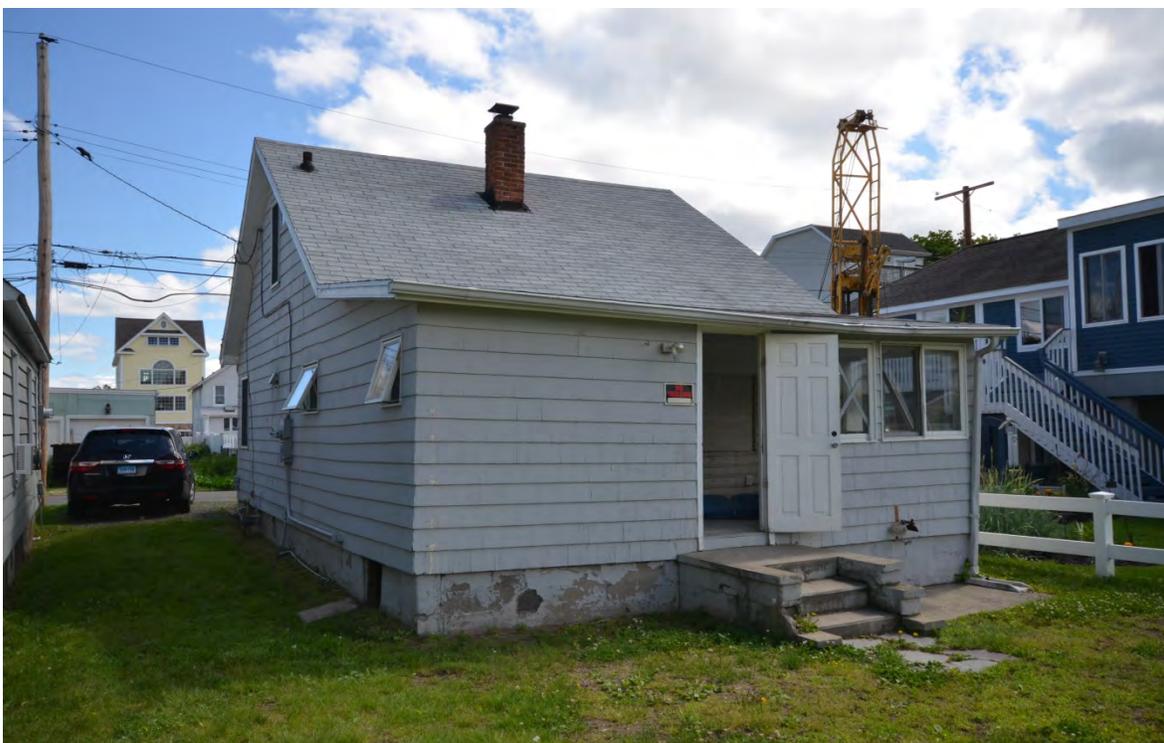
Figure 6

Gutters: The owner stated branch and limbs from a falling tree hit the gutters damaging and displacing the rear gutters.	The gutter on the rear of the house are bent and damaged. The gutters on the front are also damaged. <b>See Figure 6</b>  <i>Recommendation: Remove the old gutters and replace with new gutters.</i>	\$750	\$750
Concrete/masonry stoops: The owner pointed out the gaps at the stoop interface to the building.	The stairs, front porch slab and stoops are cracked and separated from the main building. This could have been damaged by moving water. <b>See Figure 7</b>  <i>Recommendation: If done as rehabilitation, remove and replace the damaged items. If done as mitigation the items will be removed and replaced with raised stairs and decks with the mitigation.</i>	\$2,000	NA
Kitchen: The owner removed the kitchen cabinets during storm clean up.	There is no kitchen installed in the dwelling. A few cabinets are on the site but not installed.  <i>Recommendation: Provide a new kitchen cabinets and countertop.</i>	\$5,500	\$5,500

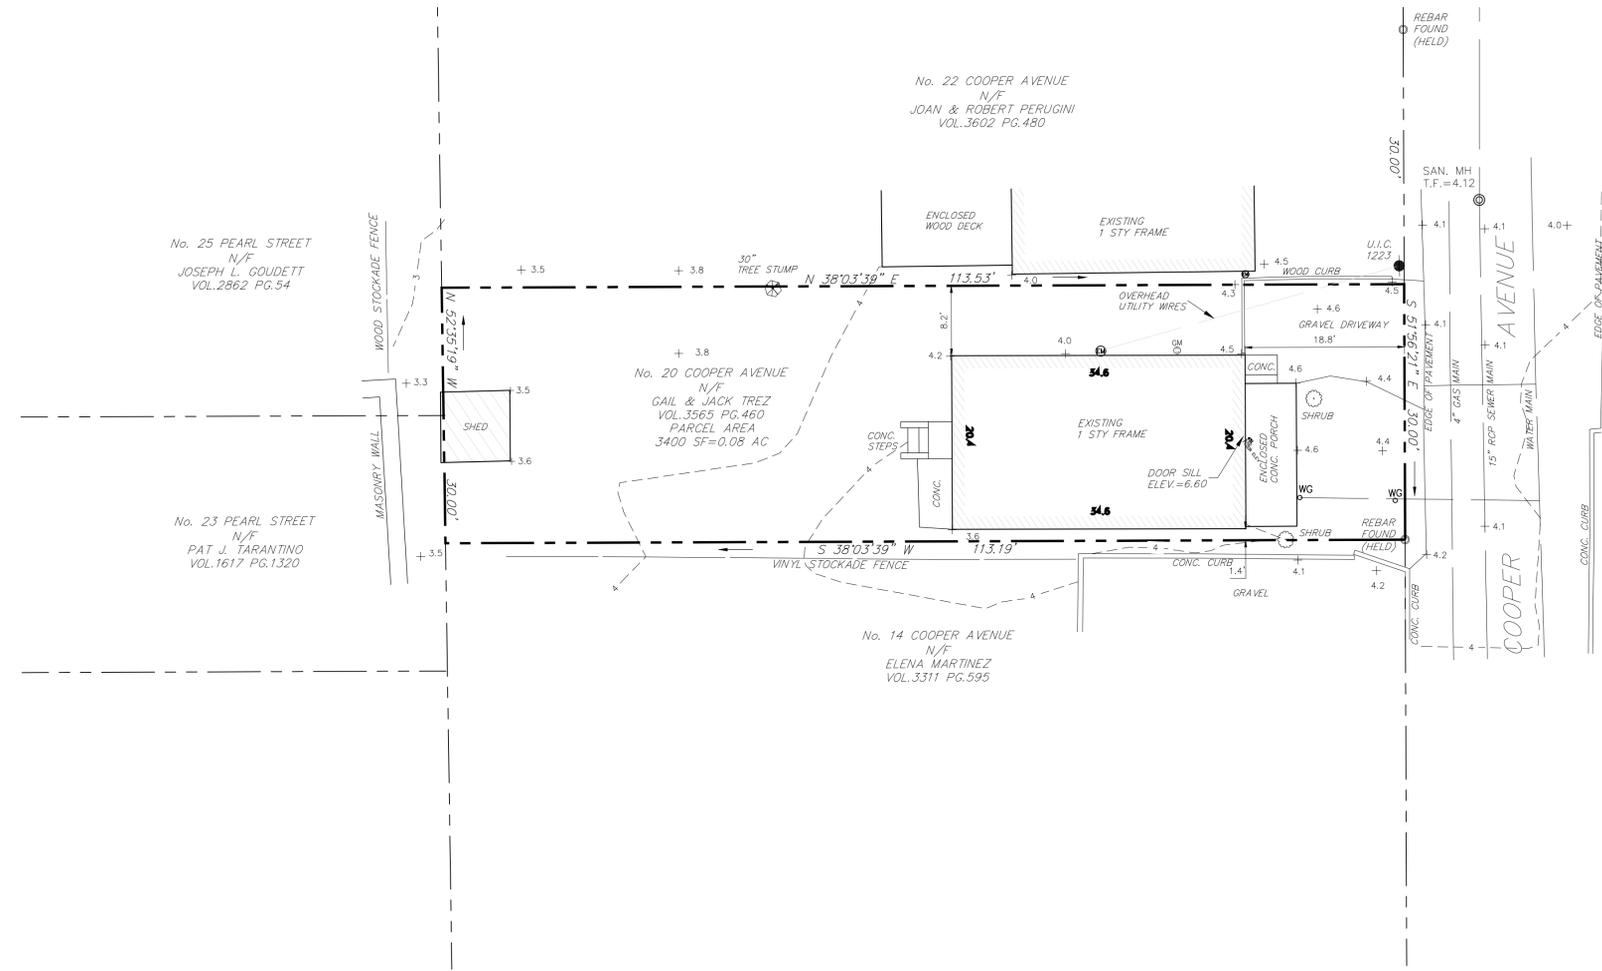
THE PROPERTY DEPICTED HEREON IS LOCATED IN FLOOD ZONE AE [BASE FLOOD ELEVATIONS DETERMINED] (ELEVATION 11') AND FLOOD ZONE VE [COASTAL FLOOD ZONE WITH VELOCITY HAZARD (WAVE ACTION); BASE FLOOD ELEVATIONS DETERMINED] (ELEVATION 13') BASED ON A VISUAL INSPECTION OF "FIRM FLOOD INSURANCE RATE MAP NEW HAVEN COUNTY, CONNECTICUT PANEL 529 OF 635 MAP NUMBER 0900900529J MAP REVISED JULY 8, 2013 BY: FEDERAL EMERGENCY MANAGEMENT AGENCY."
