SUMMARY OF THE NCHRP REPORT 350
CRASH TEST RESULTS FOR THE
NARROW CONNECTICUT IMPACT ATTENUATION SYSTEM

Report No.
2216-2-02-5

Research Project
SPR-2216

Connecticut Department of Transportation
Bureau of Engineering and Highway Operations
Office of Research and Materials

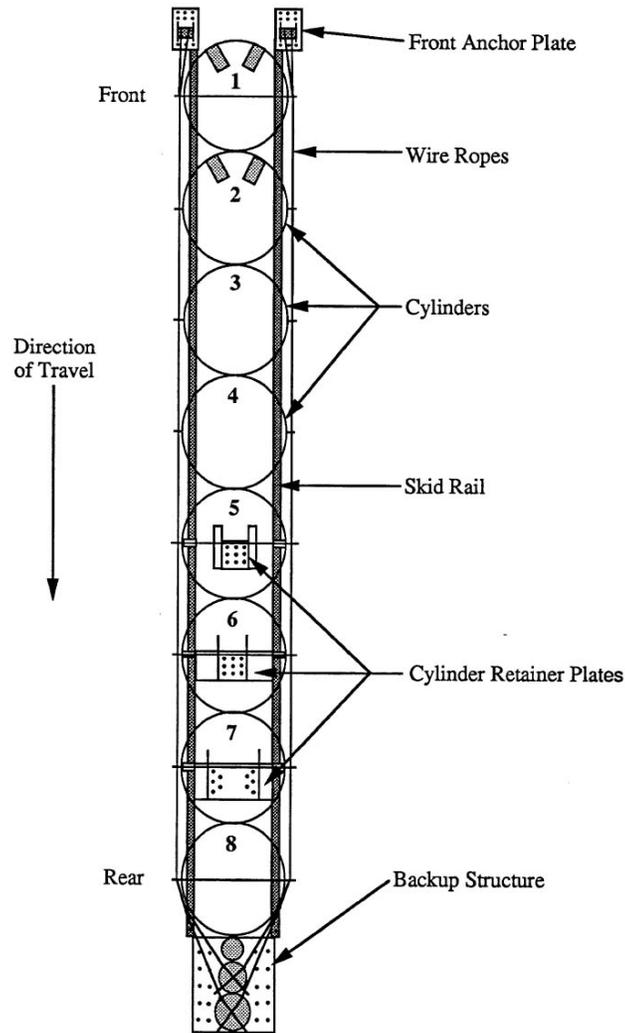
Figure 1. NCIAS Plan View Schematic

Figure 1 shows (in schematic form) the design configuration of the NCIAS. Figure 2 shows a picture of the system at the gore area of Exit 7 on Route 2 Eastbound in Glastonbury, CT.

The system is securely anchored to a sound concrete pad which is 30-ft (9 m) long, 10-ft (3 m) wide, and designed to resist heavy uplifting and overturning loads, which may be incurred during severe side impacts of the NCIAS. The anchored components are semi-permanently bolted to the base pad with 7/8-in (22 mm) chemically anchored studs and are intended to remain undamaged during a system impact. The components consist of the free-standing back-up structure, two (2) skid rails, three (3) cylinder retainer plates, and two (2) front anchor plates.

The eight (8) steel cylinders are employed as the energy-absorbing material and are all 3-ft (0.9 m) in diameter, 4-ft (1.2 m) high and have wall thicknesses ranging from 1/8-in (3.2 mm) to 3/8-in (9.5 mm). The wire ropes are used to control lateral deflection of the

NCIAS and provide a smooth redirecting response under side-impact conditions. They consist of two (2) 1-in (25.4 mm) diameter wire ropes placed along each side of the NCIAS. The last basic component is the vinyl-coated polyester cover, which is attached to the top of the cylinders to prevent the build-up of snow, ice, and debris inside the cylinders.

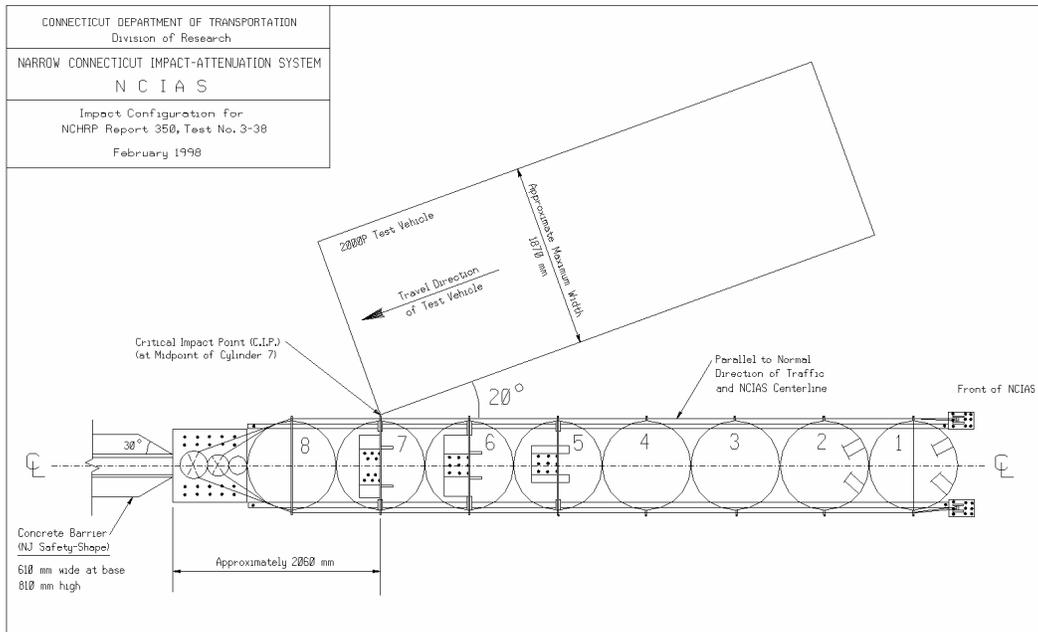
Figure 3. Impact Configuration for Test No. 3-38

This test also uses a 4409 lb (2000 kg) pick-up truck at a speed of 62 mph (100 km/h) and an impact angle of 20 degrees; however, the vehicle impacts the NCIAS at the critical impact point. This impact point, as agreed upon by the FHWA and the Connecticut Department of Transportation, is at the center of cylinder 7 (see Figure 3).

significant amount of occupant compartment deformation. The maximum reduction in space in the firewall to instrument panel area was 71 percent, which could cause serious injury. This test on the NCIAS was, therefore, not acceptable.

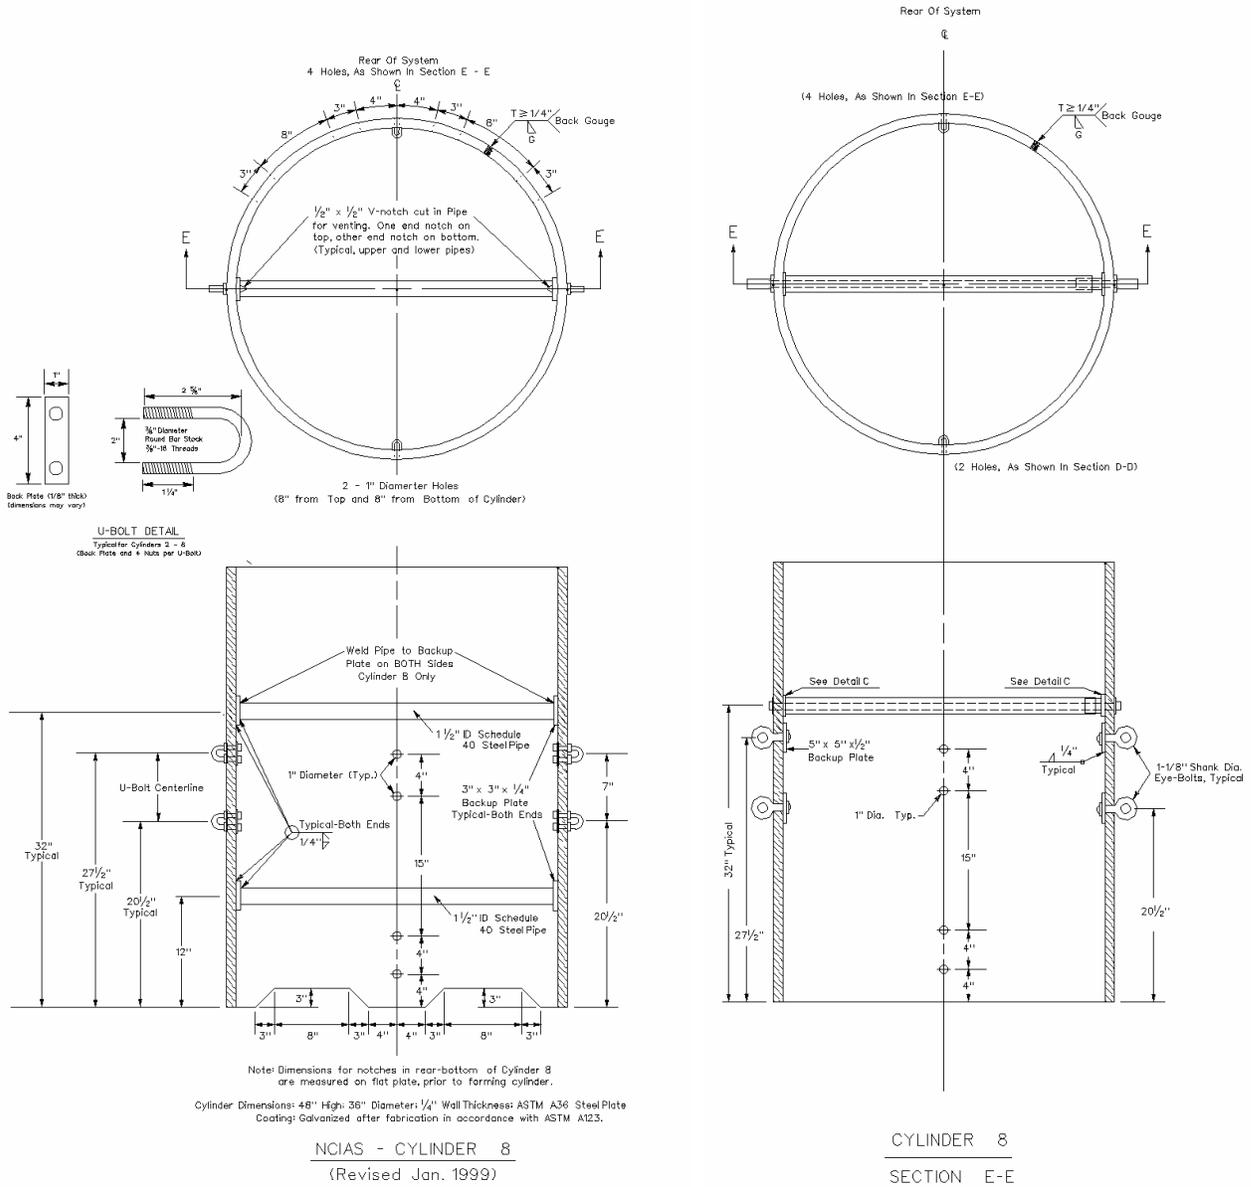
Figure 4. Cylinder 8 - Revised and Original

The significant amount of occupant compartment deformation was caused when cylinder 8 deformed, allowing the front wheel to contact the backup structure and concrete median barrier. Cylinder 8 was then strengthened, as noted below, and as shown in Figure 4.

1. A second transverse compression pipe was added below the first pipe.

2. Two notches were cut in the bottom-rear of cylinder 8 to allow the cylinder wall to pass over the anchor bolts that anchor the backup structure.
3. The four 29 mm shank eye bolts for the wire ropes were replaced by four standard 13 mm U-bolts.

With this laterally strengthened cylinder 8, the test was repeated. The NCIAS then performed acceptably for all criteria specified for Crash Test 3-38. The modifications to cylinder 8 would not affect the outcome of the previous tests so those were not repeated [6].

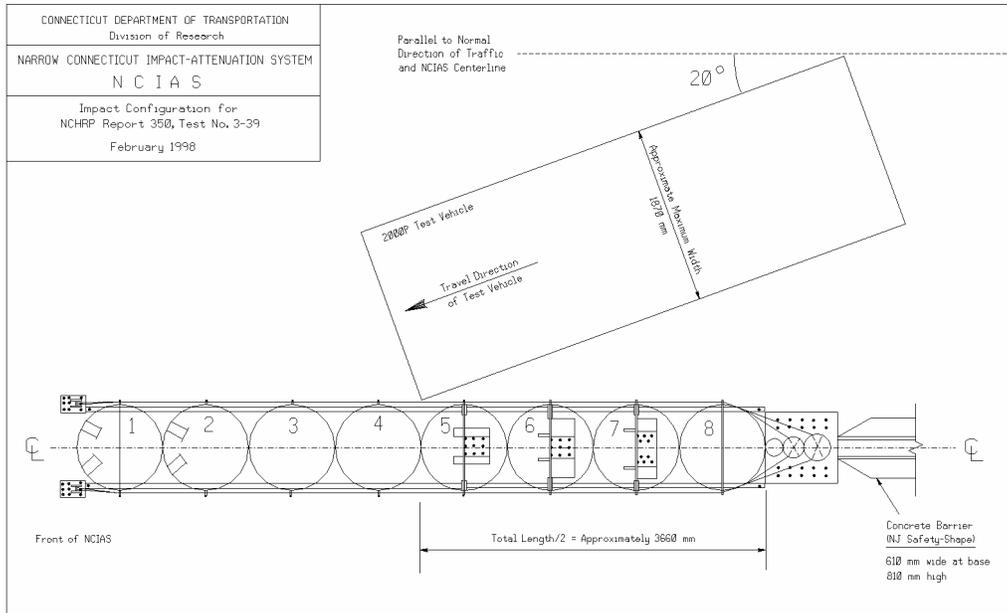
Figure 5. Impact Configuration for Test No. 3-39

In Crash Test 3-39, a 4409 lb (2000 kg) pick-up truck impacts the midpoint of the NCIAS in the reverse direction at a nominal speed of 62 mph (100 km/h) at an angle of 20 degrees. The impact point was determined to be at the interface of cylinders 4 and 5, or 11 inches (270 mm) downstream of the centerline of cylinder 4 (see Figure 5). The occupant impact velocity for both the longitudinal and lateral directions was less than the maximum allowable amount (see Table 2). The occupant ridedown acceleration for both the longitudinal and lateral directions, however, was greater than the maximum allowable amount (see Table 2). Therefore, due to this high occupant ridedown acceleration and due to significant deformation of the occupant compartment, the NCIAS did not meet the requirements of NCHRP Report 350 test designation 3-39.

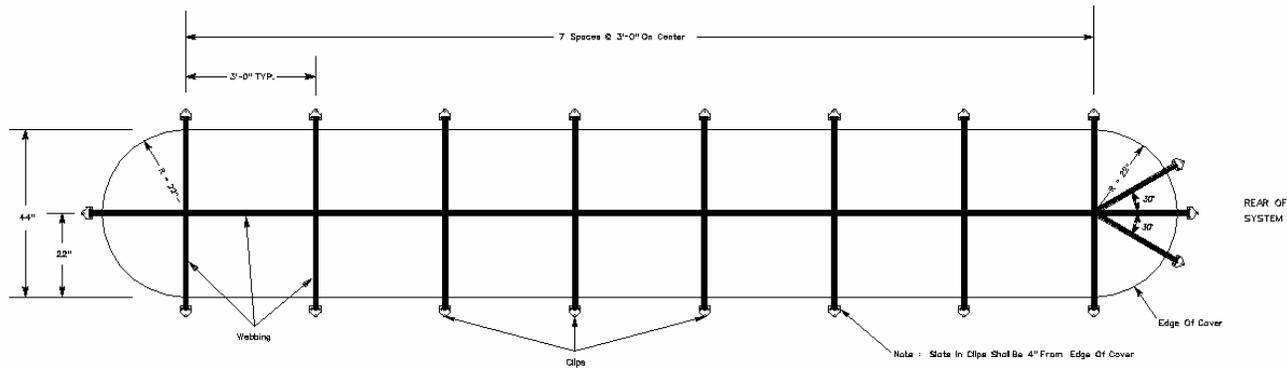
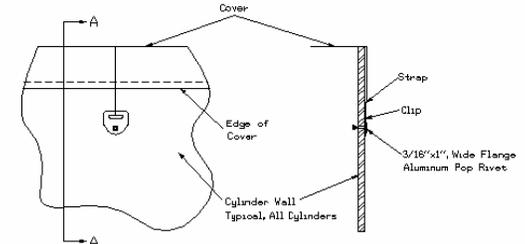
Figure A-5 Cover Details

NCIAS COVER FABRICATION SPECIFICATIONS

Stitching - Stitching shall be full length of all Straps and in conformance with the configuration shown below. Vertical stitching shall be used throughout the NCIAS Cover with a size of 6 per inch. All loose thread ends shall be securely tied to prevent raveling.

Clips - Over-plated steel clips conforming to the configuration shown below shall be fastened to the free end of each Strap. Each Clip shall have a 2" slot and 5/16" hole as shown.

Note: Rivet Holes shall be placed such that the Cover is taut throughout the NCIAS.

NOTE: THE THREE REAR-MOST COVER CLIPS SHALL BE BOLTED (NOT RIVETED) TO CYLINDER 8 USING 5/16" X 1/4" ALUMINUM BOLTS, NUTS, AND WASHERS. ALL OTHER CLIPS SHALL BE RIVETED TO THE CYLINDER WALLS AS SHOWN.

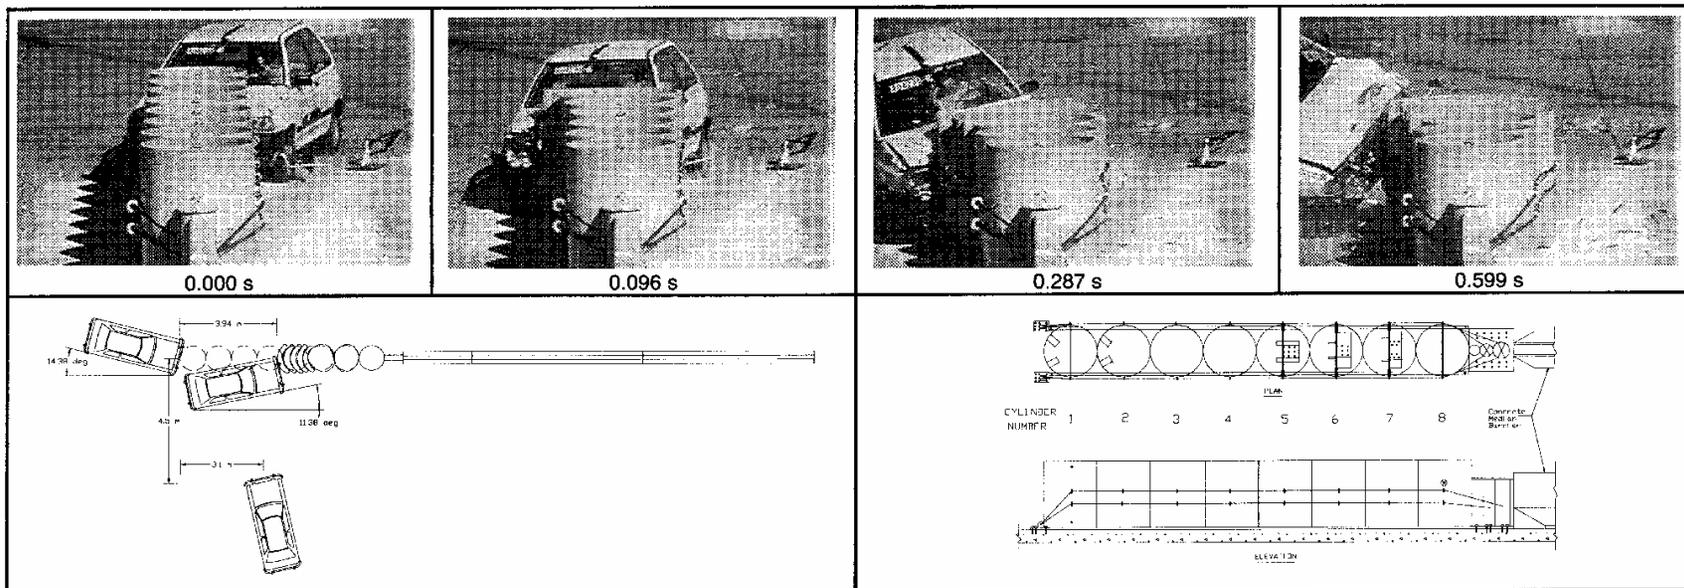
Figure B1-1 Summary of Results for Test 3-32

General Information		Impact Conditions		Test Article Deflections (m)	
Test Agency	Texas Transportation Institute	Speed (km/h)	98.9	Dynamic	3.94
Test No.	404231-2	Angle (deg)	14.4	Permanent	3.44
Date	12/15/97				
Test Article		Exit Conditions		Vehicle Damage	
Type	Crash Cushion	Speed (km/h)	12.6	Exterior	
Name or Manufacturer	Narrow Conn. Imp. Attn. System	Angle (deg)	11.4	VDS	11LFQ4
Installation Length (m)	7.3			CDC	11LFEW3
Size and/or dimension and material of key elements	8 each 914 O.D. x 1219 mm tall steel pipe cylinders of various wall thickness	Occupant Risk Values		Maximum Exterior	
Soil Type and Condition	Concrete pavement, dry	Impact Velocity (m/s)		Vehicle Crush (mm)	310
Test Vehicle		x-direction	10.0	Interior	
Type	Production	y-direction	2.8	OCDI	LF0000000
Designation	820C	Ridedown Accelerations (g's)		Max. Occ. Compart.	
Model	1990 Ford Festiva	x-direction	-12.4	Deformation (mm)	8
Mass (kg)		y-direction	-3.2

Curb	810	Max. 0.050-s Average (g's)		Post-Impact Behavior	
Test Inertial	820	x-direction	-12.7	(during 1.0 s after impact)	
Dummy	75	y-direction	-2.1	Max. Yaw Angle (deg)	-109
Gross Static	895	z-direction	-2.1	Max. Pitch Angle (deg)	-8
				Max. Roll Angle (deg)	29

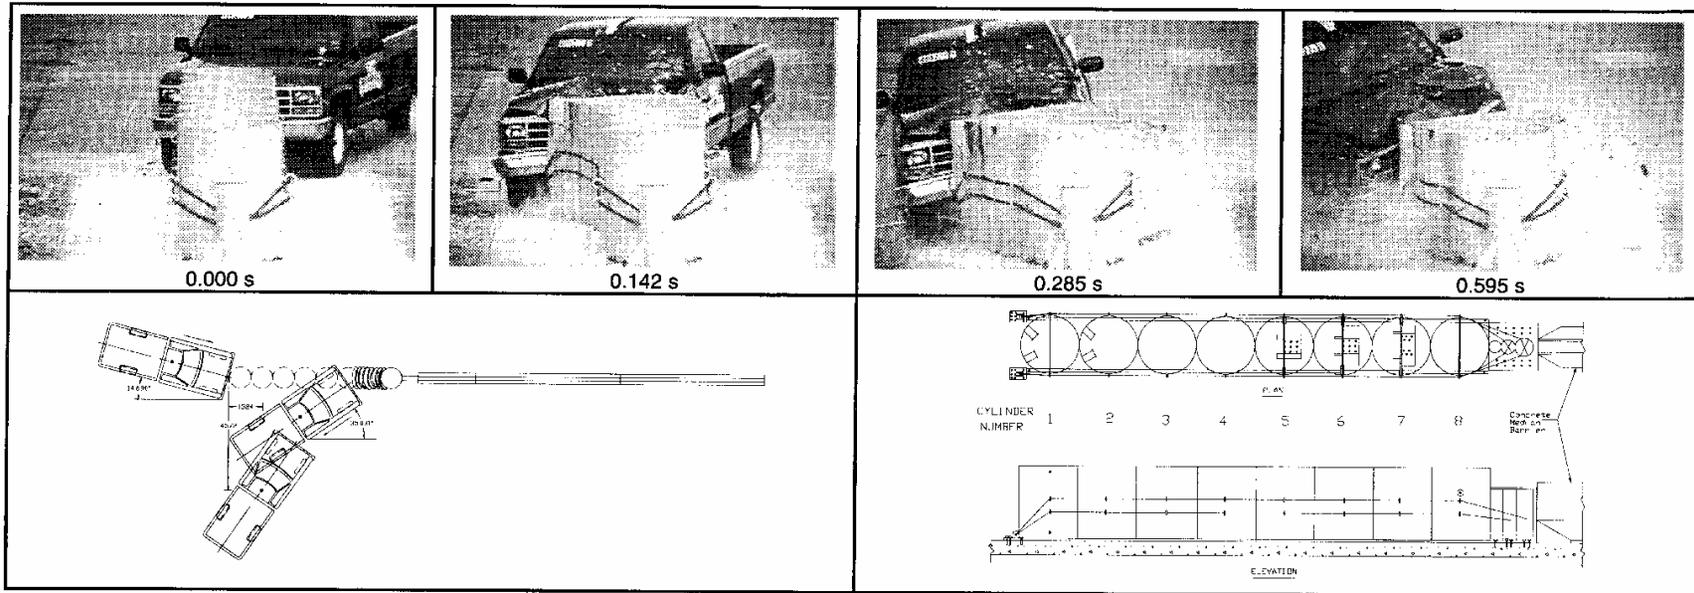
Figure B2-1 Summary of Results for Test 3-33

General Information		Impact Conditions		Test Article Deflections (m)	
Test Agency	Texas Transportation Institute	Speed (km/h)	99.3	Dynamic	2.27
Test No.	404231-1	Angle (deg)	14.7	Permanent	2.12
Date	10/28/97				
Test Article		Exit Conditions		Vehicle Damage	
Type	Crash Cushion	Speed (km/h)	10.9	Exterior	
Name	Narrow Conn. Imp. Atten. System	Angle (deg)	35 behind	VDS	12FD4
Installation Length (m)	7.35			CDC	12FDEW3
Size and/or dimension and material of key elements	8 each 914 O.D. x 1219 mm tall steel pipe cylinders of various wall thickness Concrete pavement, dry	Occupant Risk Values		Maximum Exterior	
Soil Type and Condition		Impact Velocity (m/s)		Vehicle Crush (mm)	260
Test Vehicle	Production	x-direction	8.5	Interior	
Type	2000P	y-direction	3.0	OCDI	FS0000000
Designation	1992 Chevrolet 2500 pickup	Ridedown Accelerations (g's)		Max. Occ. Compart.	
Model	2033	x-direction	-12.3	Deformation (mm)	0
Mass (kg) Curb	2000	y-direction	-5.9

Test Inertial	76	Max. 0.050-s Average (g's)		Post-Impact Behavior	
Dummy	2076	x-direction	-10.4	(during 1.0 s after impact)	
Gross Static		y-direction	-2.7	Max. Yaw Angle (deg)	-72
		z-direction	2.4	Max. Pitch Angle (deg)	-7
				Max. Roll Angle (deg)	19

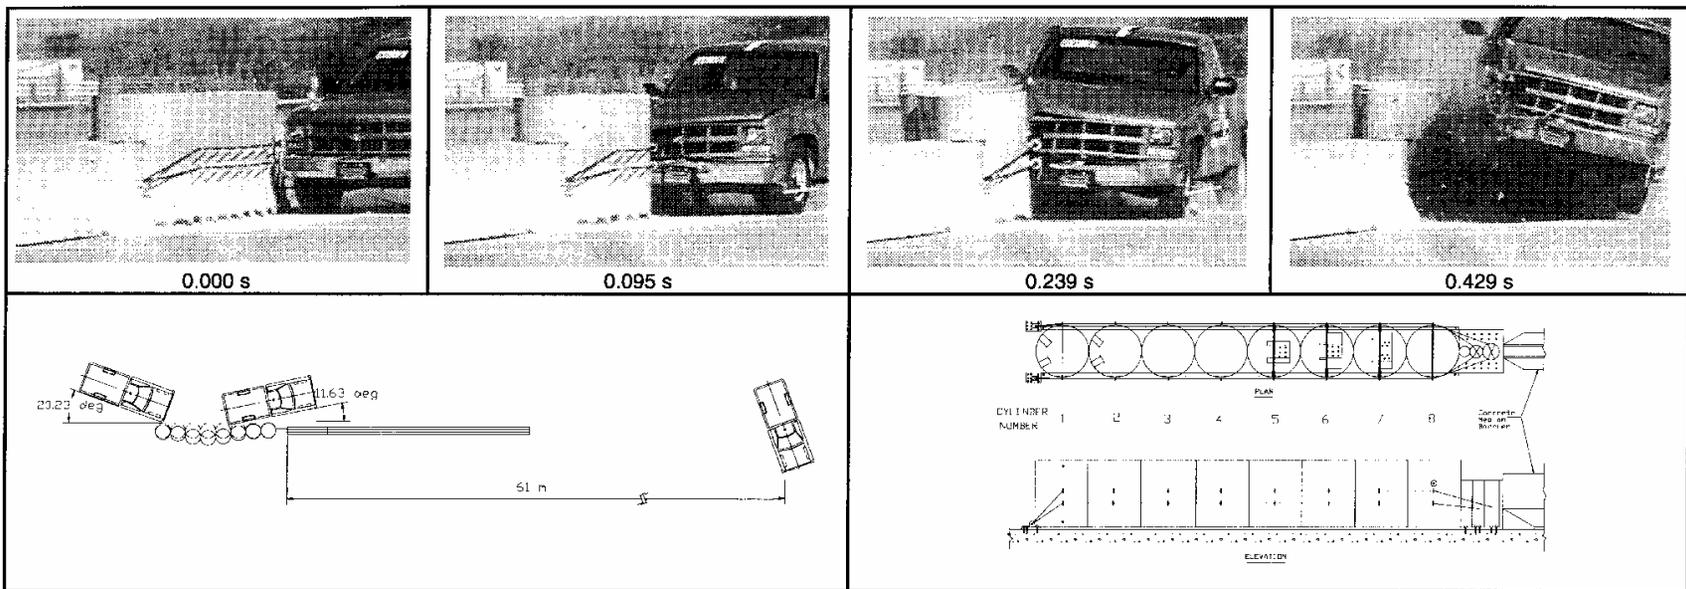
Figure B3-1 Summary of Results for Test 3-37

Exterior
 VDS 01RFQ5
 CDC 01FREK3
 & 01RYEW3
 Maximum Exterior
 Vehicle Crush (mm) 550
 Interior
 OCDCI FS0103000
 Max. Occ. Compart.
 Deformation (mm) 39
 Post-Impact Behavior
 (during 1.0 s after impact)
 Max. Yaw Angle (deg) -25
 Max. Pitch Angle (deg) 7
 Max. Roll Angle (deg) -11

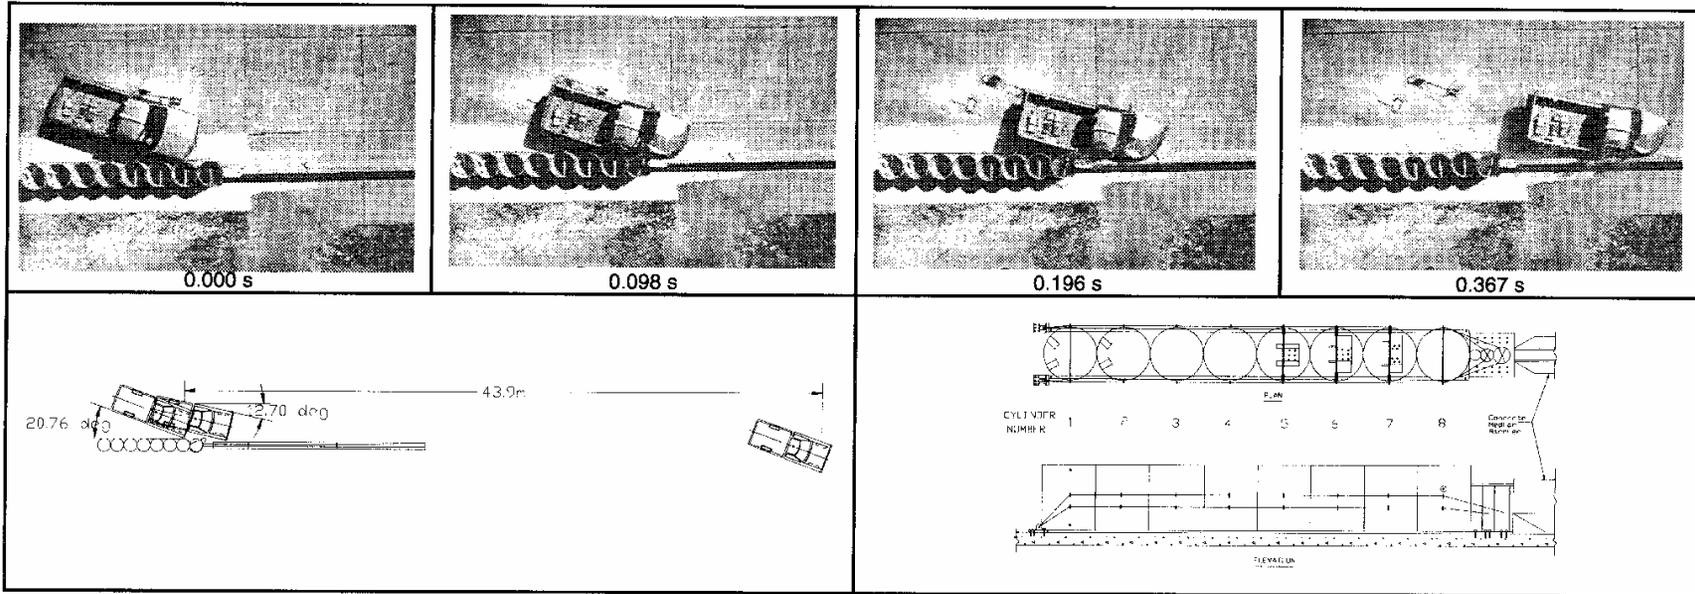
Figure B4-1 Summary of Results for Test 3-38(1)

General Information		Impact Conditions		Test Article Deflections (m)	
Test Agency	Texas Transportation Institute	Speed (km/h)	95.9	Dynamic	N/A
Test No.	404231-4	Angle (deg)	20.8	Permanent	0.35
Date	03/02/98			Vehicle Damage	
Test Article		Exit Conditions		Exterior	
Type	Crash Cushion	Speed (km/h)	67.7	VDS	01RFQ7
Name	Narrow Conn. Imp. Atten. System	Angle (deg)	12.7	CDC	01FZEK4 & 01RYEW4
Installation Length (m)	7.31	Occupant Risk Values		Maximum Exterior	
Material or Key Elements	8 each 914 O.D. x 1219 mm Tall Steel Pipe Cylinders of Various Wall Thickness	Impact Velocity (m/s)		Vehicle Crush (mm)	320
Soil Type and Condition	Concrete Pavement, Dry	x-direction	8.9	Interior	
Test Vehicle		y-direction	4.7	OCDI	FS1038010
Type	Production	Ridedown Accelerations (g's)		Max. Occ. Compart.	
Designation	2000P	x-direction	-13.1	Deformation (mm)	0
Model	1994 Chevrolet 2500 Pickup Truck	y-direction	-11.7	Post-Impact Behavior

Mass (kg) Curb	1864	Max. 0.050-s Average (g's)		(during 1.0 s after impact)	
Test Inertial	2000	x-direction	-8.8	Max. Yaw Angle (deg)	11
Dummy	75	y-direction	-9.0	Max. Pitch Angle (deg)	-11
Gross Static	2075	z-direction	4.7	Max. Roll Angle (deg)	-19

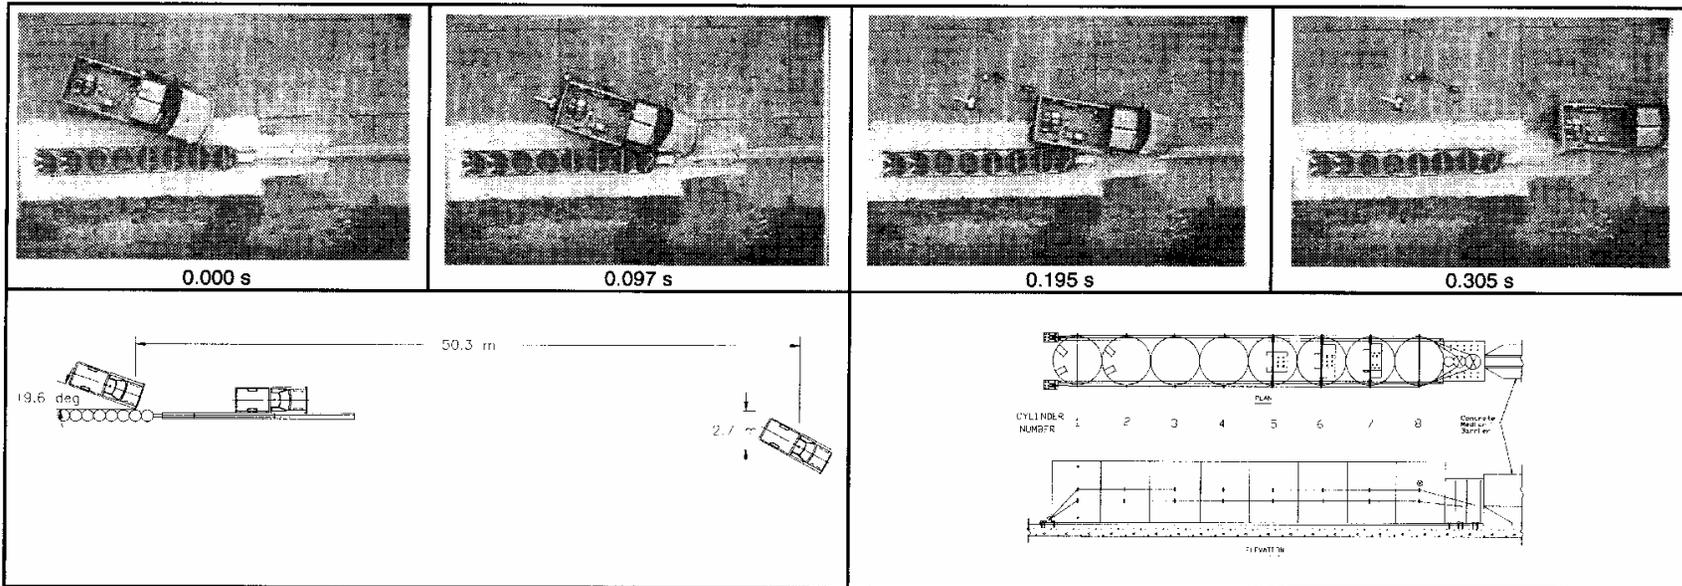
Figure B5-1 Summary of Results for Test 3-38(2)

Type Crash Cushion
 Name or Manufacturer Mod. Narrow Conn. Imp. Atten. Sys
 Installation Length (m) 7.31
 Material or Key Elements ... 8 @ 914O.D.x1219mm Tall Steel Pipe
 Cylinders of Various Wall Thickness
 Soil Type and Condition Concrete Pavement, Dry

(during 1.0 s after impact)
 Max. Yaw Angle (deg) -18
 Max. Pitch Angle (deg) -9
 Max. Roll Angle (deg) -9

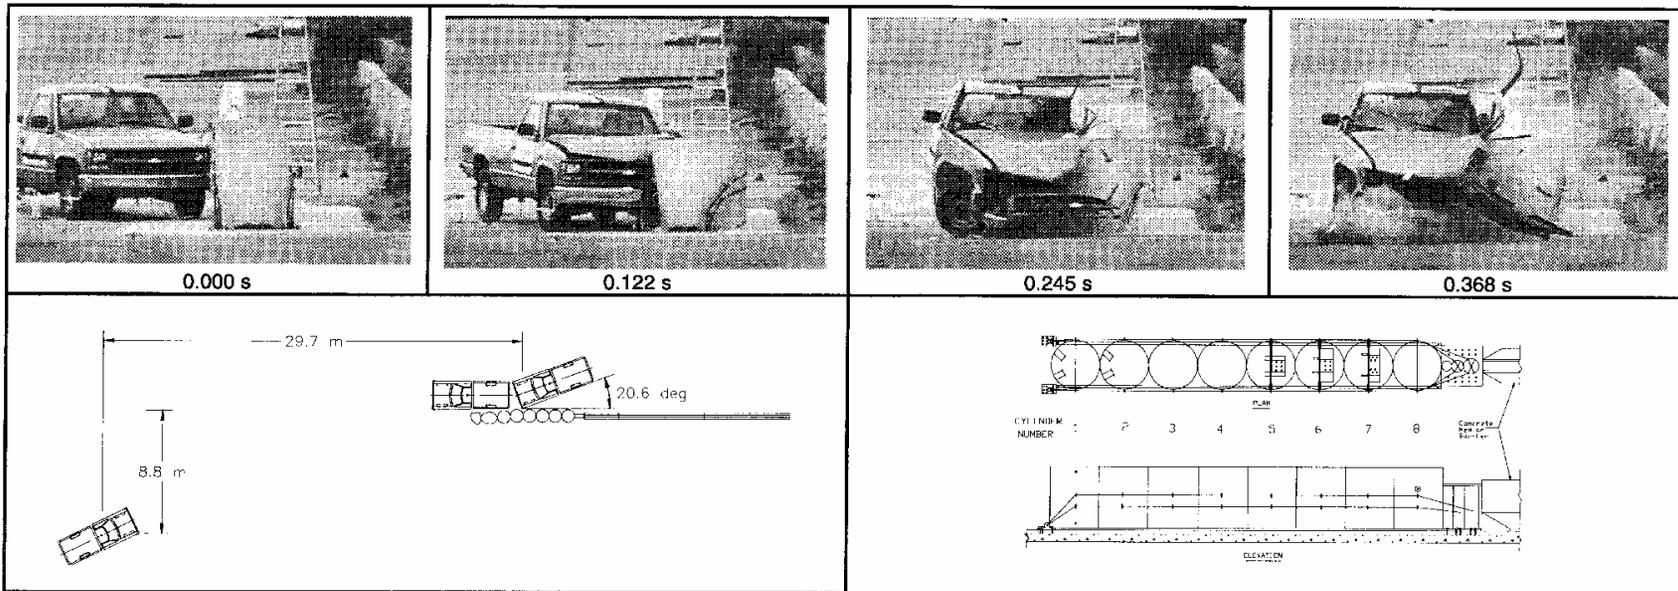
Figure B6-1 Summary of Results for Test 3-39

Type Crash Cushion
 Name Mod Narrow Conn. Imp. Atten. System
 Installation Length (m) 7.31
 Material or Key Elements ... 8 @ 914O.D.x1219mm Tall Steel Pipe
 Cylinders of Various Wall Thickness
 Soil Type and Condition Concrete Pavement, Dry

(during 1.0 s after impact)
 Max. Yaw Angle (deg) 28
 Max. Pitch Angle (deg) -4
 Max. Roll Angle (deg) -5
