**Evaluation of a Cold In-Place Recycled  
Rehabilitation Treatment**

**Final Report**

Research Project: SPR-2259

Report No. CT-2259-F-09-2

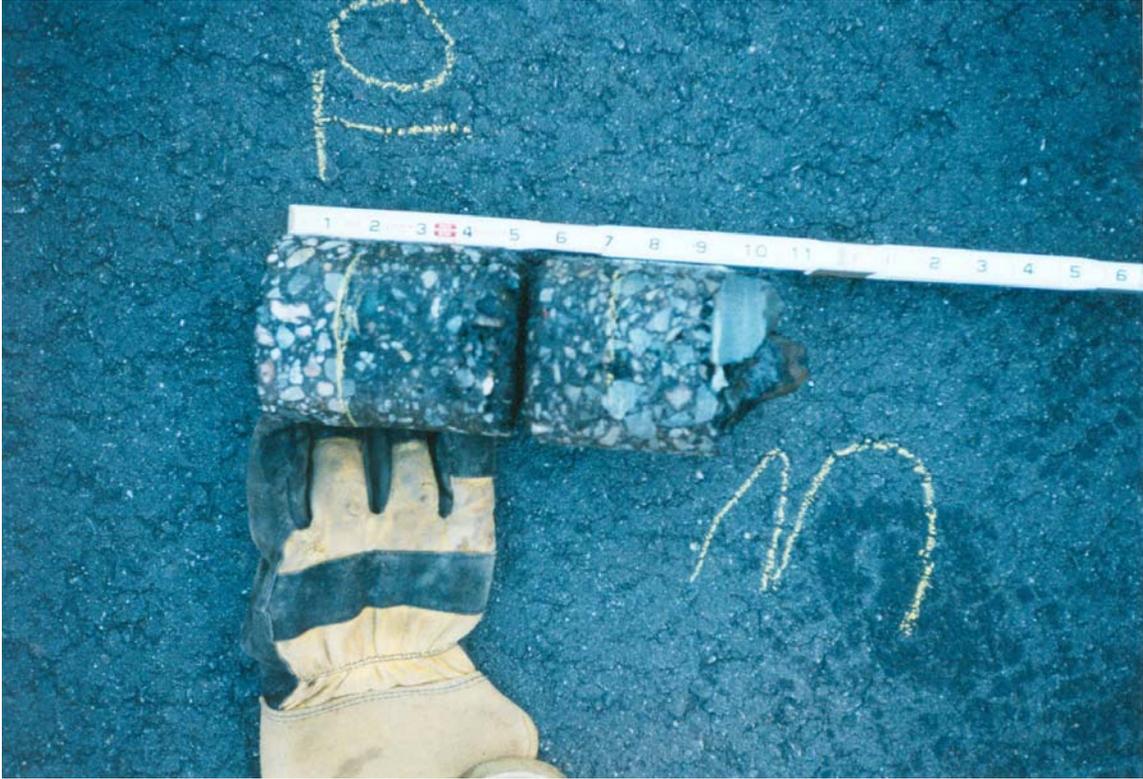
The existing pavement was composed of 1.5-inches of Class 1 HMA overlay (1987) on 1-inch Class 138 HMA surface treatment (1967) on the original 1958 flexible pavement structure, which includes a macadam layer on the bottom. A full-depth core taken prior to construction is presented in Figure 2.

**FIGURE 2** Full-depth core 10-inches deep drilled prior to cold in-place recycling construction.

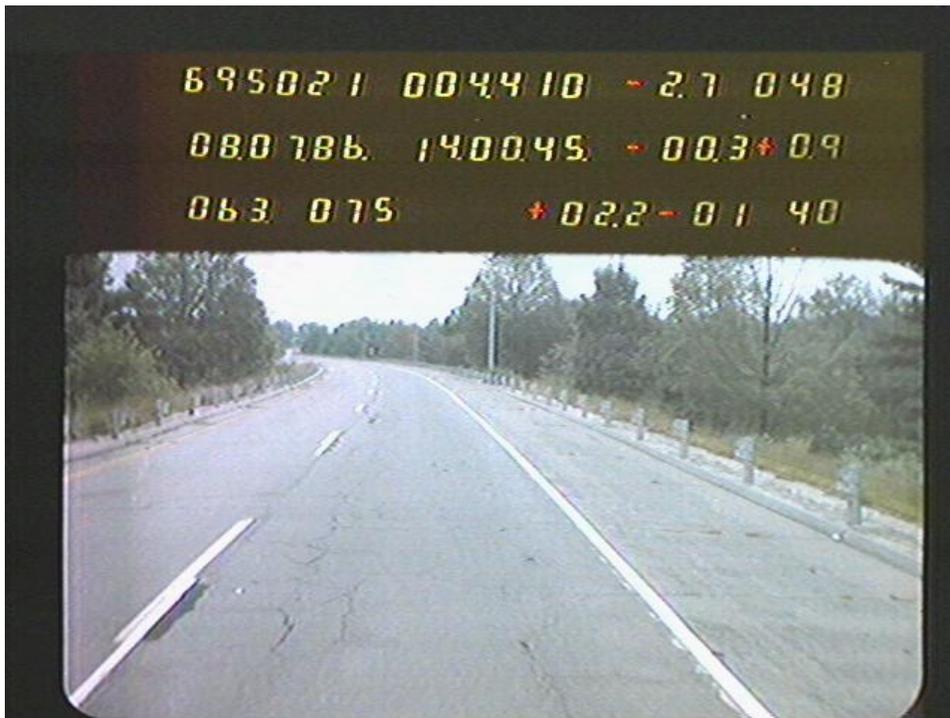
The PM section reviewed 1986 Photolog images and observed severe block/alligator cracking (see Figure 3). The pavement below the 1987 overlay was very brittle. It appeared in these historical Photolog images that the initial cracking reflected through the 1987 overlay before 1990. Sometime between 1990 and 1991, State Maintenance forces sealed all of the cracks to preserve the pavement structure (see Figure 4 of 1991 photo taken at same location as Figure 3 photo).

**FIGURE 3** 1986 Photolog image of S.R. 695 EB at 4.41 miles showing block cracking.

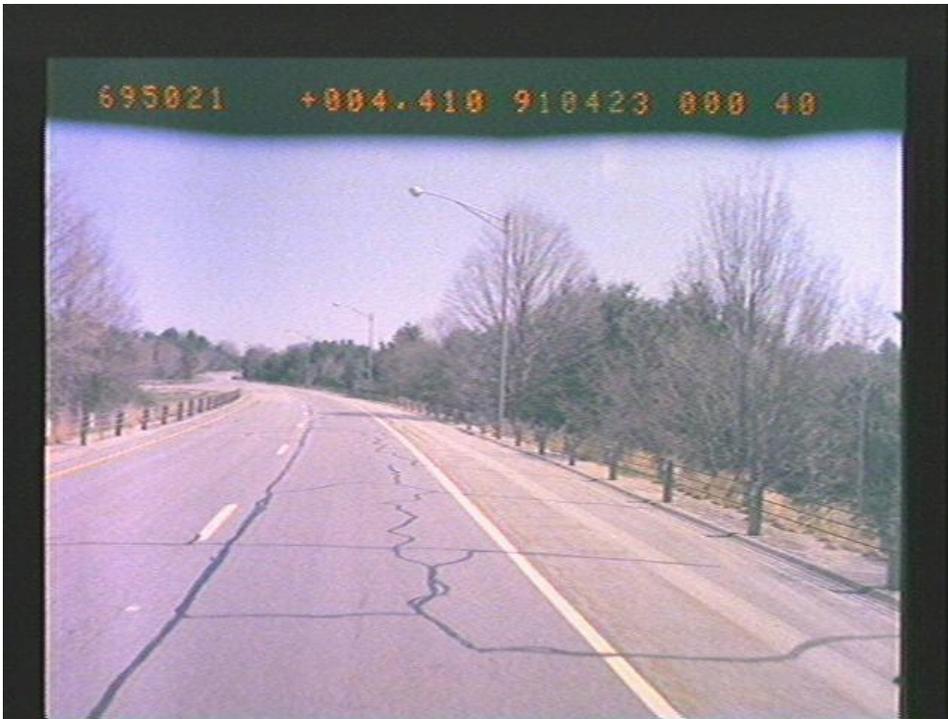
**FIGURE 4** (a) 1991 Photolog image of S.R. 695 EB at 4.41 miles showing reflective cracking in only 4 years following construction in 1987.

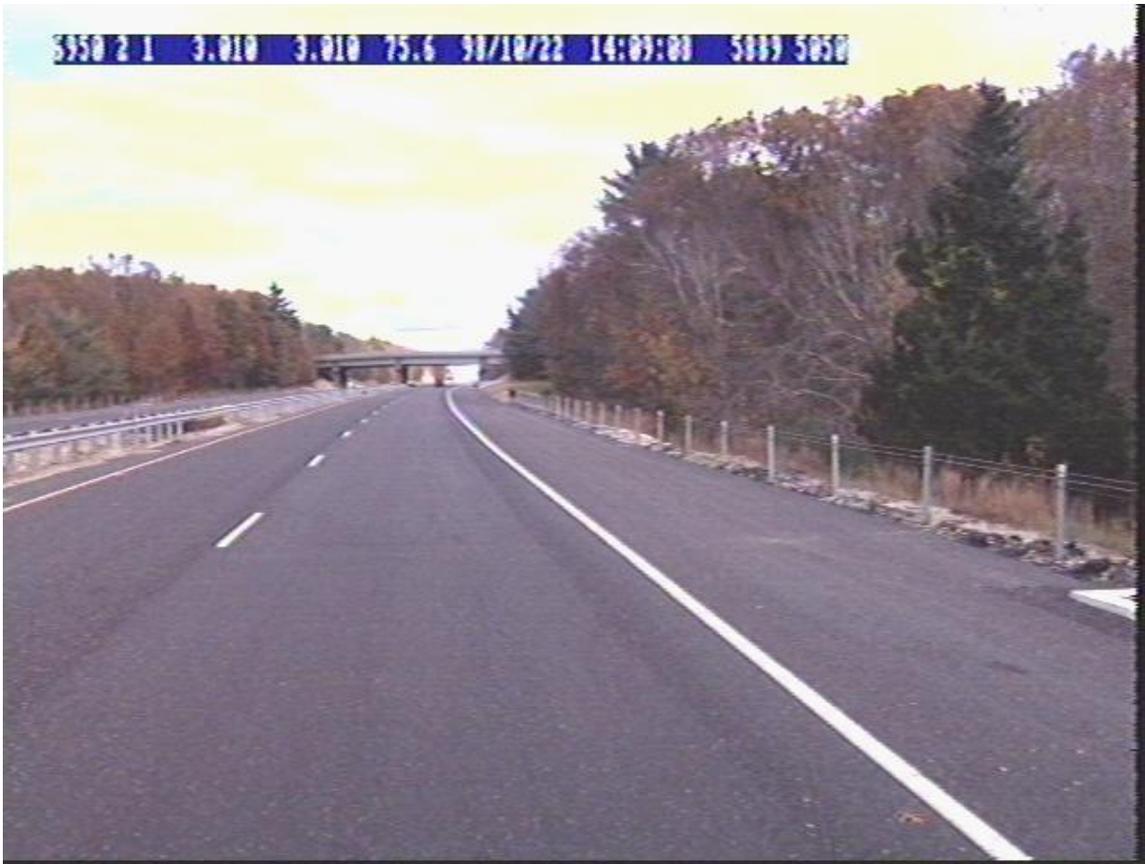
**FIGURE 5** 1998 Photolog image of S.R. 695 during construction. Note: this is the CIR base pavement prior to being overlaid with hot-mix asphalt.

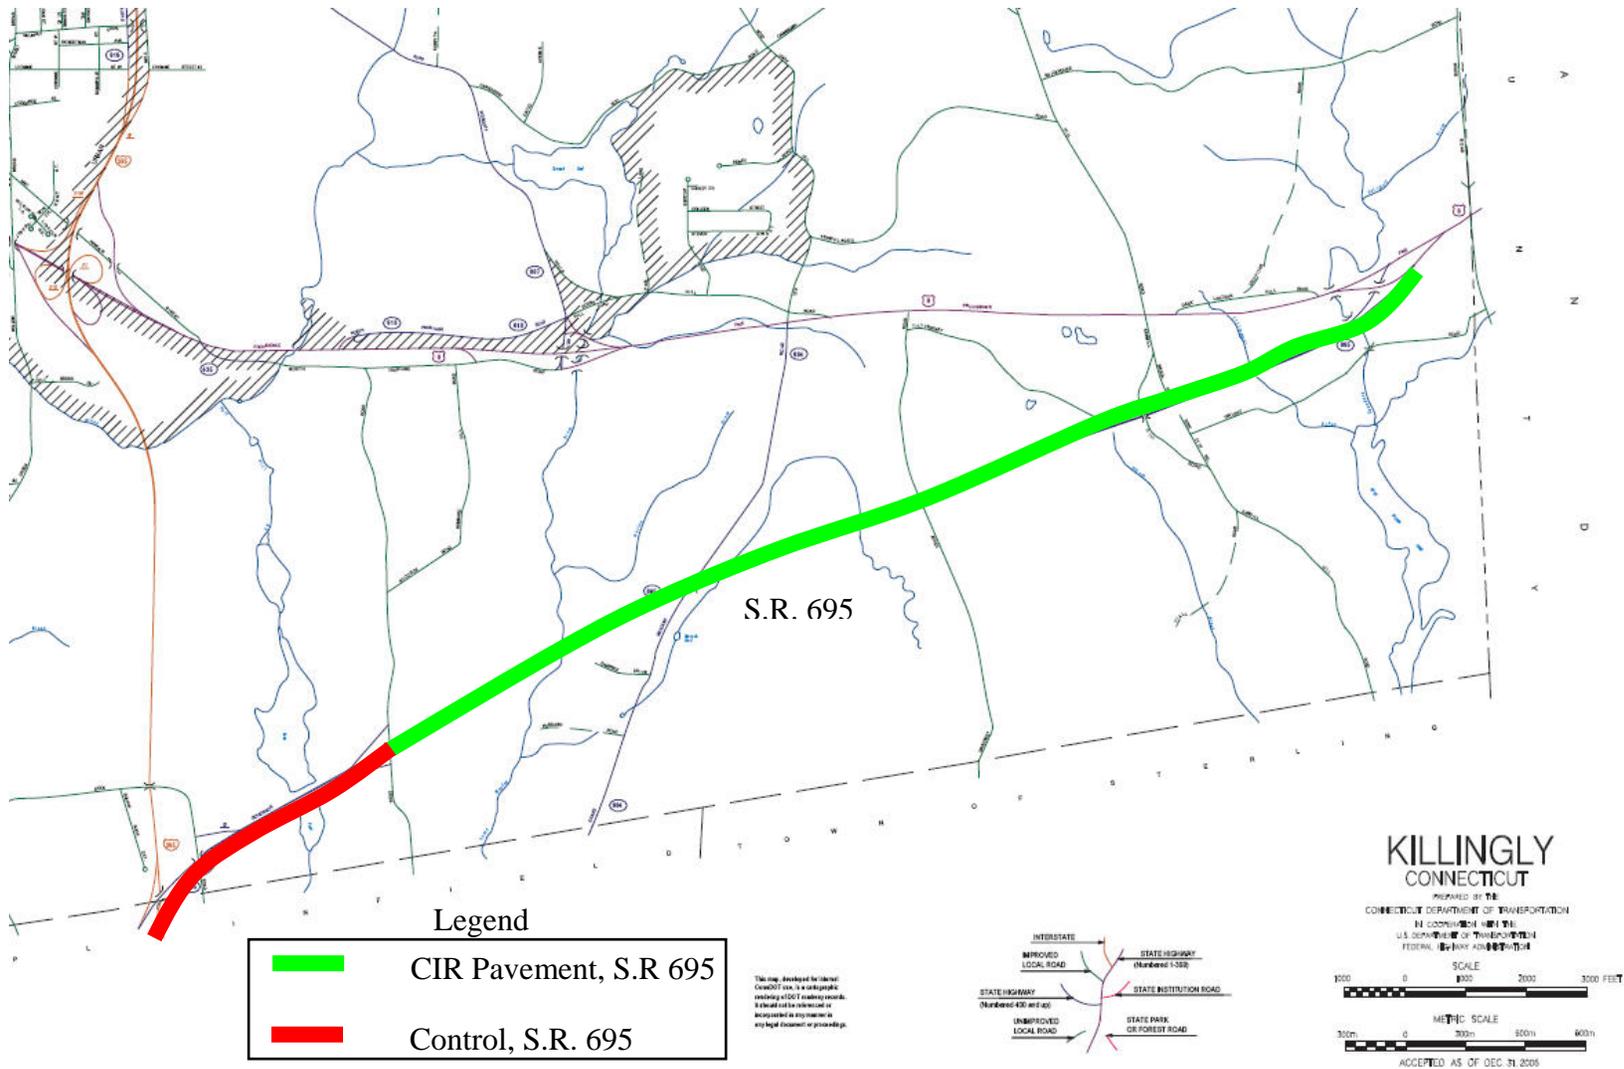
The section of S.R. 695 from Ross Road easterly to U.S. Route 6 is referred to as the CIR pavement in this report. The section west of Ross Road is referred to as the control pavement. A map depicting these two sections of S.R. 695 are presented in Figure 6.

**FIGURE 6** Map of S.R. 695 showing locations of CIR and Control pavements.

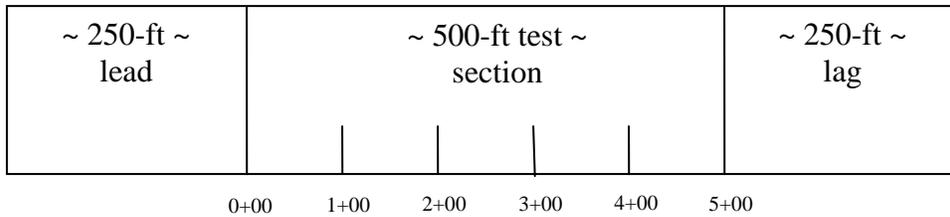
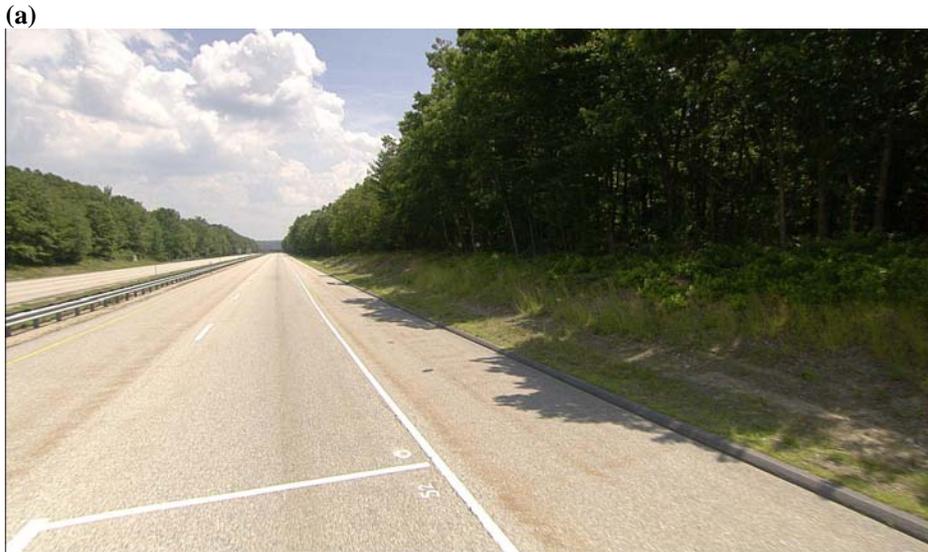
Site S1 was located at approximately 1.80 miles on a 4% uphill grade, Site S2 at approximately 3.10 miles (see Figure 4(b)) on a 2% downhill grade, and Site C at approximately 0.85 miles on a 2% to 3% uphill grade. Once the test section locations were determined, they were identified with marking tape and spray paint. Each test section also included a 250-ft lead and lag section before and after the 500-ft test section, for a total length of 1000 feet. All of the cores were obtained from these lead and lag sections. A typical layout for these test sections is shown below in Figure 7(a), and typical marking at the start of the section is shown in a photo in Figure 7(b).

(b)  
**FIGURE 7** (a) Typical test section layout. (b) Test section S2 at its start @ 0-ft, Photologged in 2008.

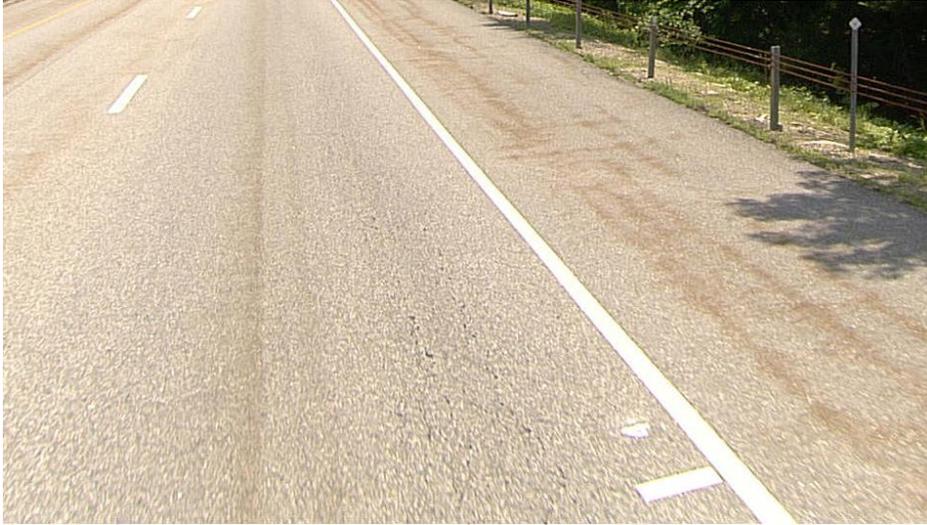
Low to moderate levels of fatigue cracking were observed in the right wheel path throughout the length of Site S1 (see Figure 8). The right wheel path was more susceptible to fatigue cracking than the left wheel path because of the existence of a longitudinal joint in the right wheel path. The left wheel path was virtually free of fatigue cracking, except for a short stretch approximately 50-ft long.

**FIGURE 8** Site S1 @ 400 feet from start of test section. Evidence of fatigue cracking in the right wheel path is visible.

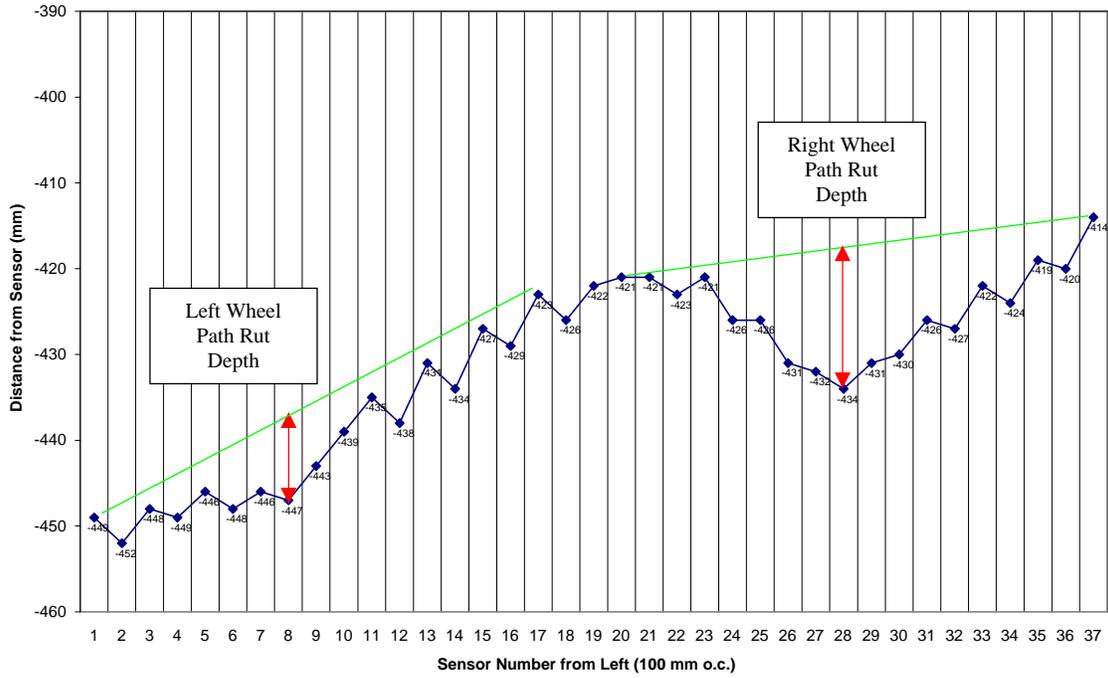
Full-Width Transverse Profile for Site S1 at Station 0+00

FIGURE 9 Full-width transverse profile for Site S1 at Station 0+00 of 500-ft test section. The green lines represent imaginary string lines extended. The red arrows represent the wheel path rut depths.

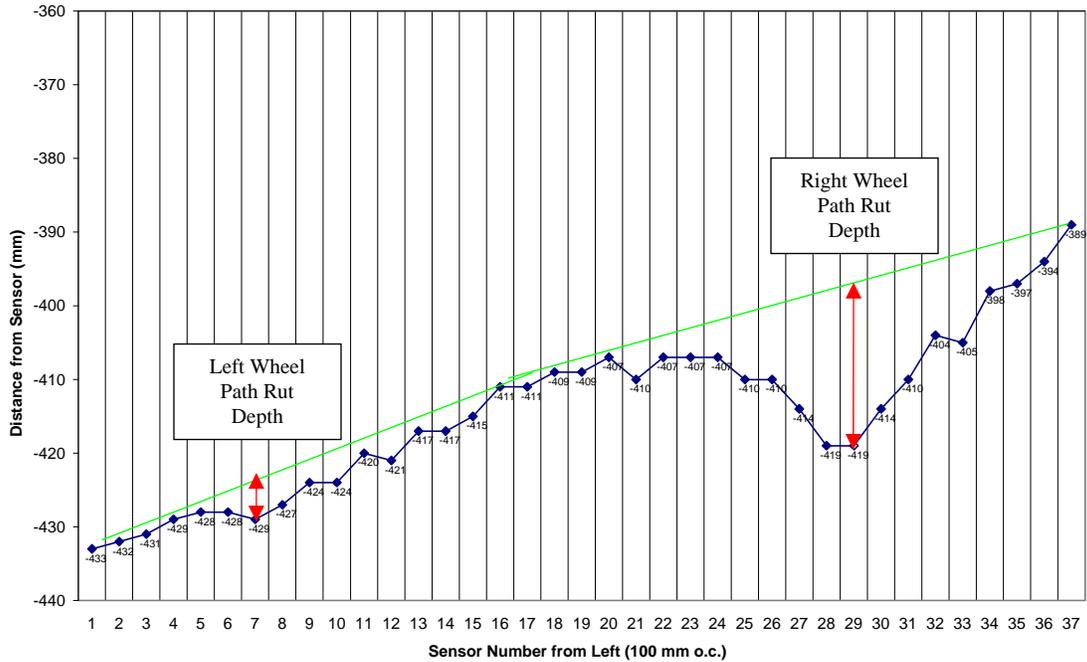
Full-Width Transverse Profile for Site 1 at Station 1+00

FIGURE 10 Full-width transverse profile for Site S1 at Station 1+00 of 500-ft test section. The green lines represent imaginary string lines extended. The red arrows represent the right wheel path rut depths.

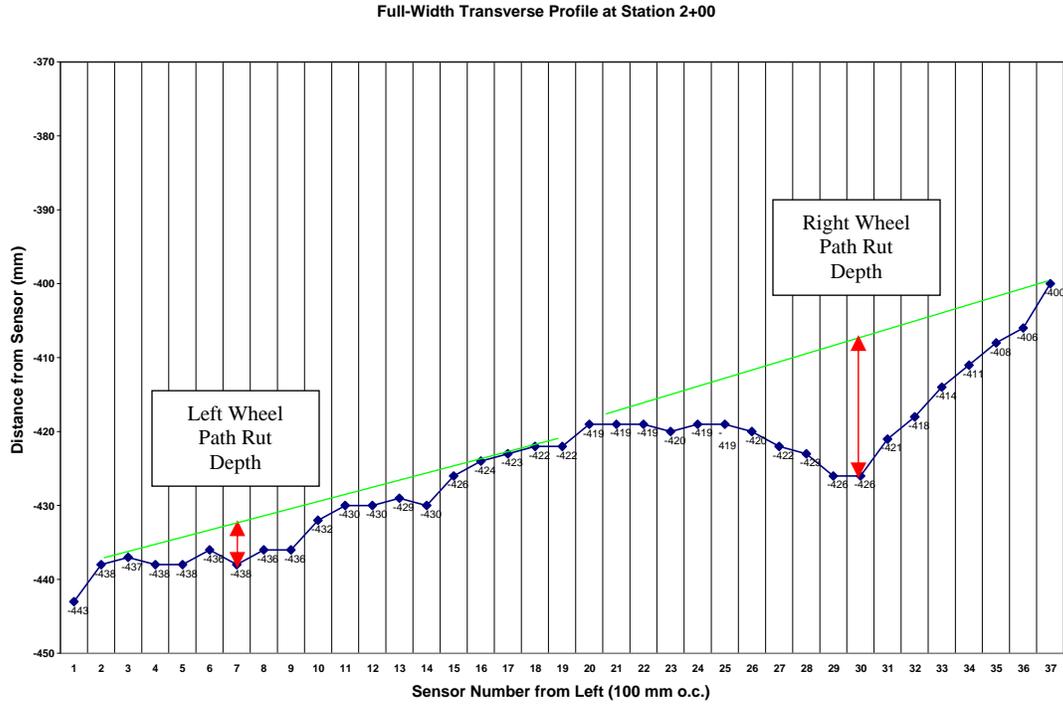
**FIGURE 11** Full-width transverse profile for Site S1 at Station 2+00 of 500-ft test section. The green lines represent imaginary string lines extended. The red arrows represent the wheel path rut depths.

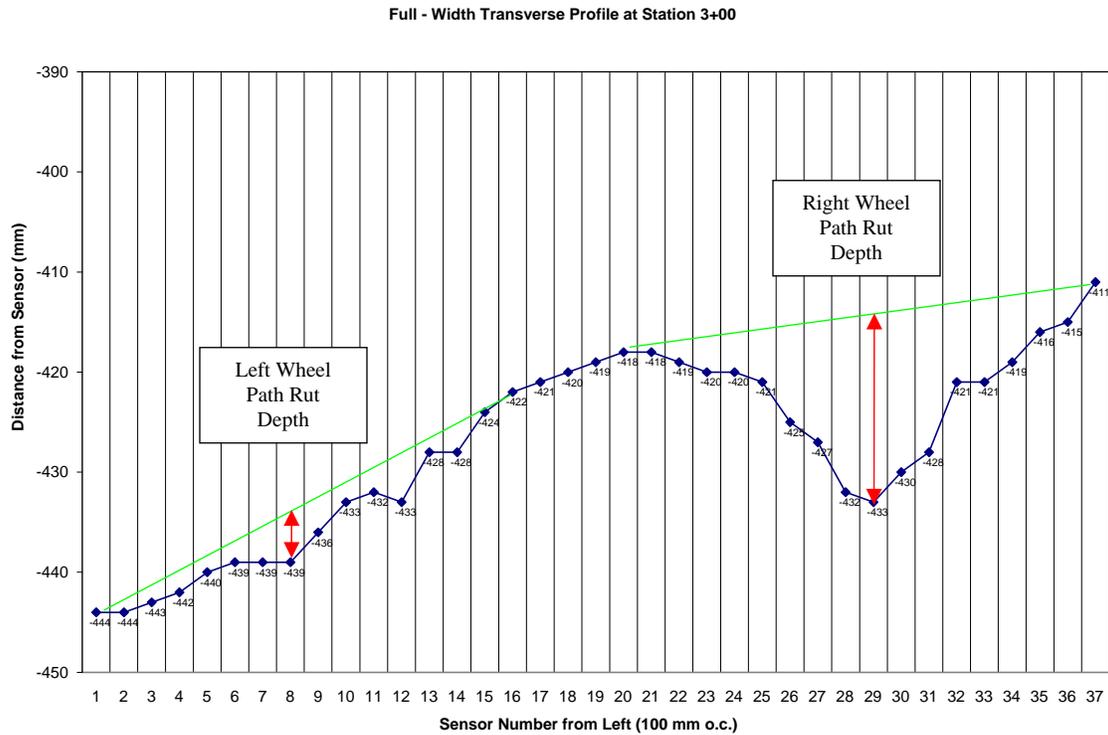
**FIGURE 12** Full-width transverse profile for Site S1 at Station 3+00 of 500-ft test section.

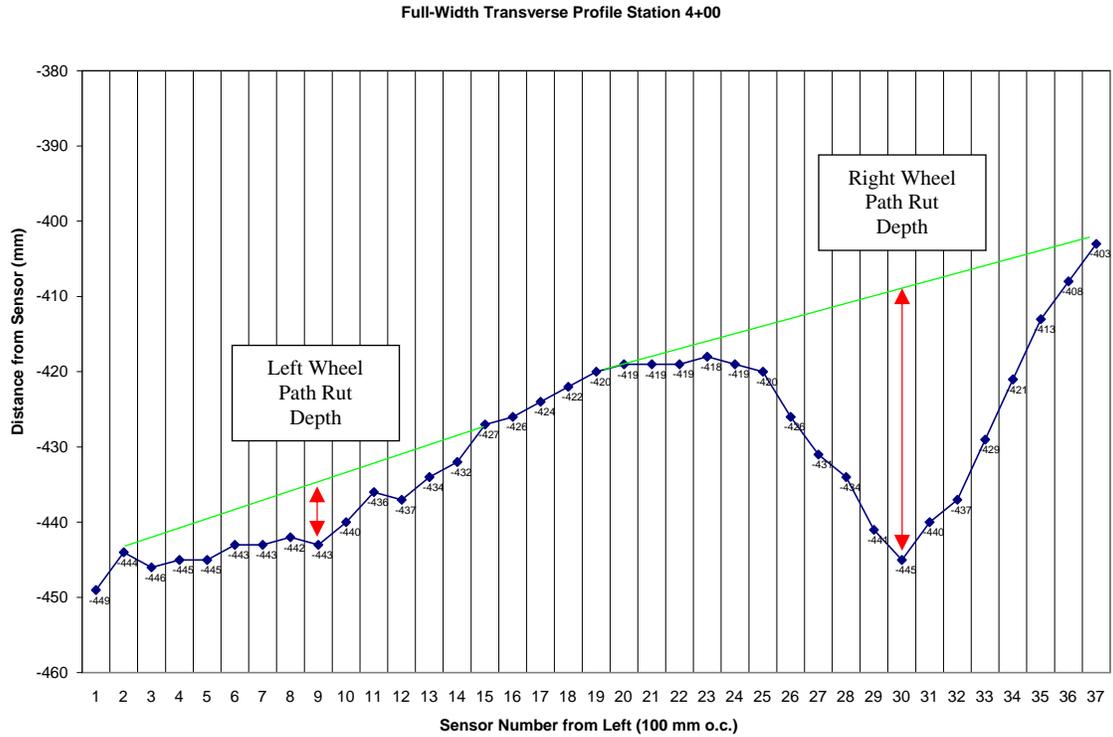
**FIGURE 13** Full-width transverse profile for Site S1 at Station 4+00 of 500-ft test section.

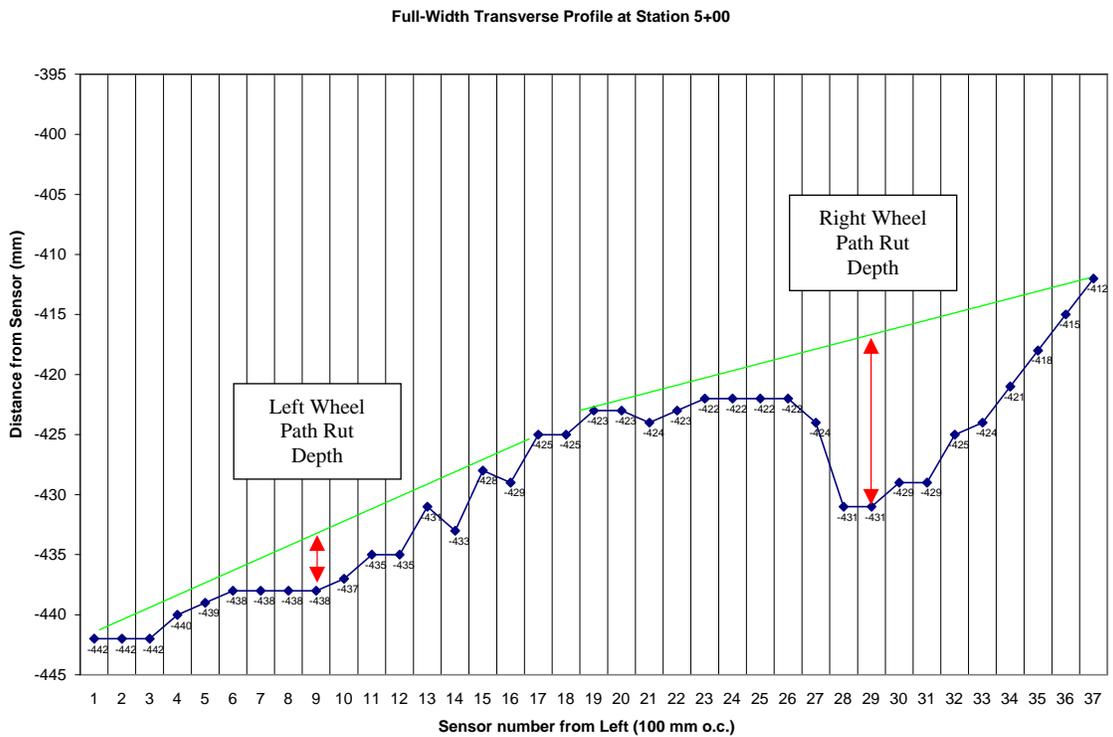
**FIGURE 14** Full-width transverse profile for Site S1 at Station 5+00 of 500-ft test section.

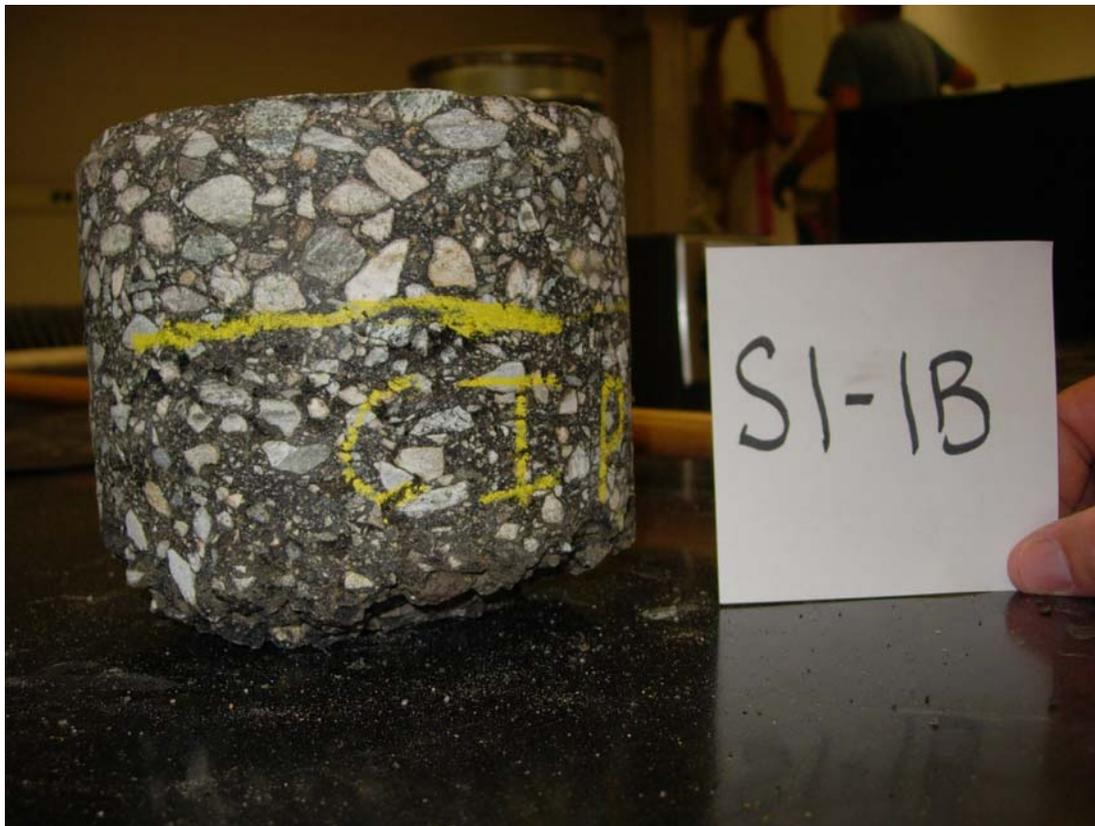
At Sites S1 and S2, where CIR base was used, the density of the CIR layer ranged from a low of 80.8 percent to a high of 89.2 percent compaction. These results validate the densities measured approximately one year after construction, which were mentioned in the Introduction of this report. Again, the densities measured at that time ranged from a low of 83.1% to a high of 89.9%. It should be noted that those tests were performed in accordance with another method, AASHTO T 166, "Bulk Specific Gravity of Compacted Asphalt Mixtures using Saturated Surface-Dry Specimens." Some differences between results using these different methods should be expected. Poor compaction in the CIR layer was apparent upon visual inspection of the cores, as can be seen in Figure 15. Note the open texture in the bottom CIR layer in Figure 15, in contrast to the top HMA layer.

**FIGURE 15** Core S1-1B obtained from Site S1. Note open texture in bottom CIR layer.

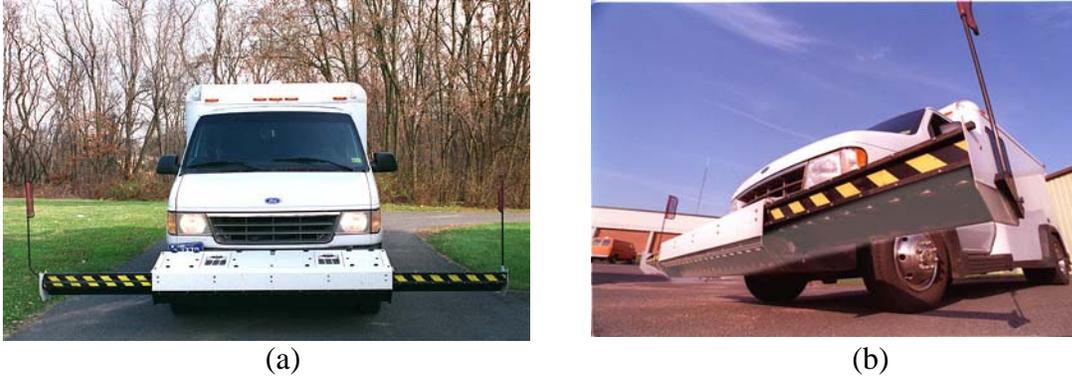
from the sensor to the pavement surface. When the rut bars are fully extended, a full transverse profile of a pavement lane can be measured. Photos of the van are shown below in Figure 16 with the rut bars fully extended.

**FIGURE 16** (a) ConnDOT Photolog van with rut bars extended fully to 3.6 meters. (b) view showing sensors located at 100 mm on center.

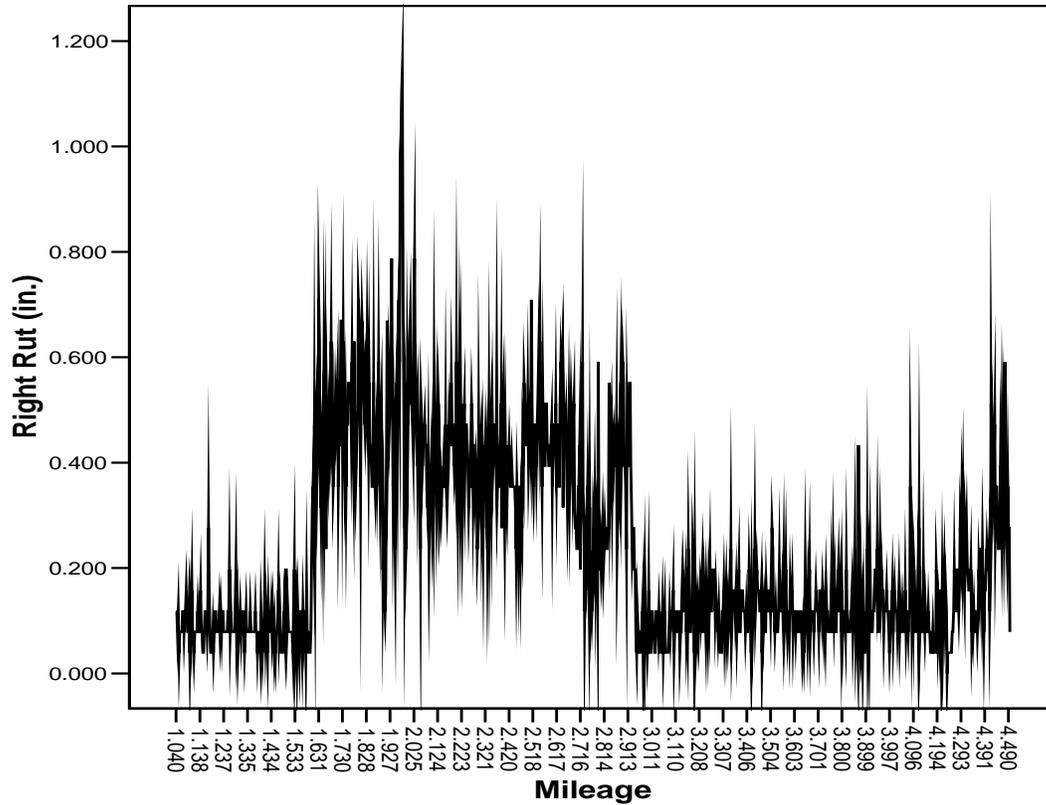
**FIGURE 17** Right wheel path rut depths versus mileage for S.R. 695 EB pavement over CIR base determined from 2.4 meter transverse profiles.

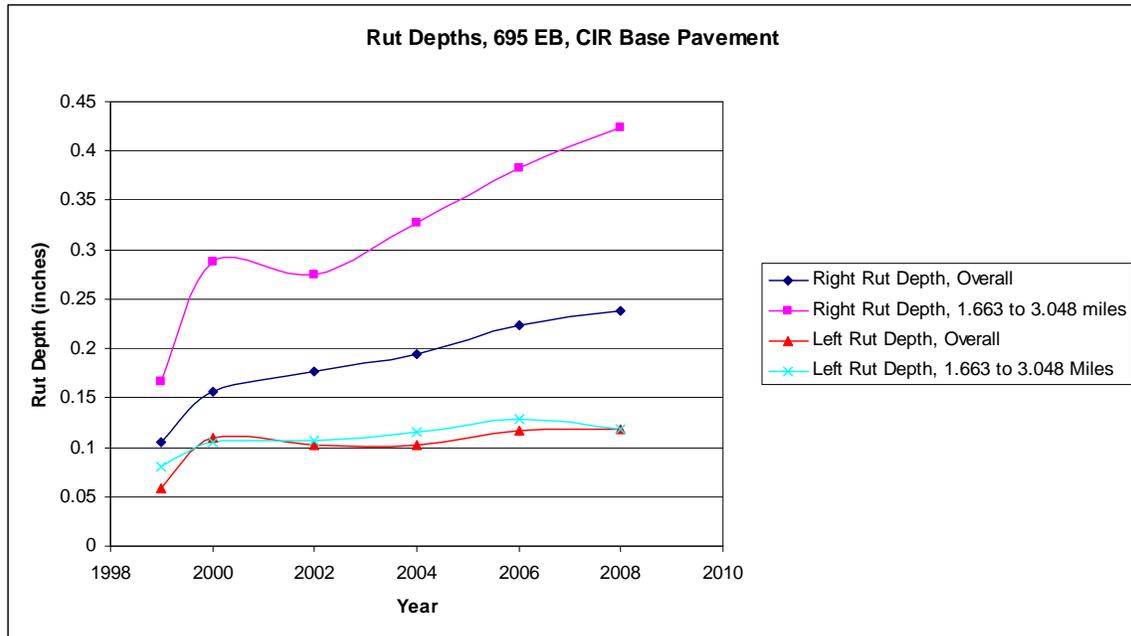
**FIGURE 18** Rut depths on S.R. 695 EB over CIR base for right and left wheel paths split on the section between 1.663 to 3.048 miles. These were determined from 2.4 meter transverse profiles.

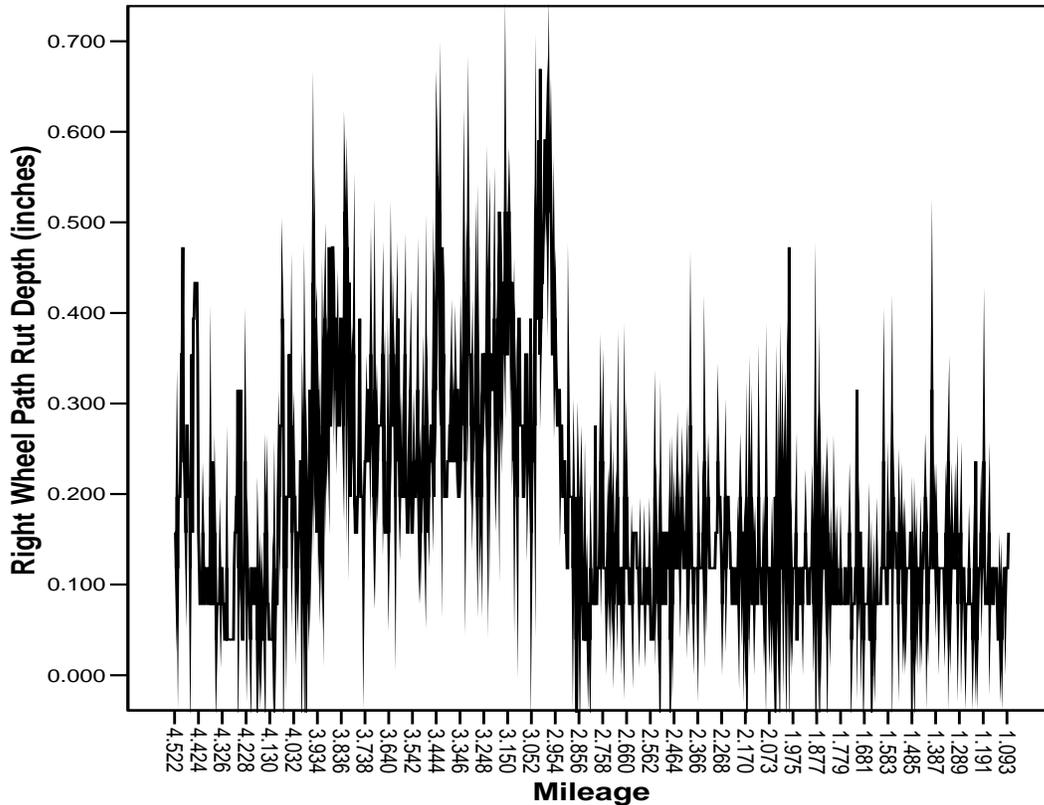
**FIGURE 19** Right wheel path rut depths versus mileage for S.R. 695 WB determined from 2.4 meter transverse profiles.

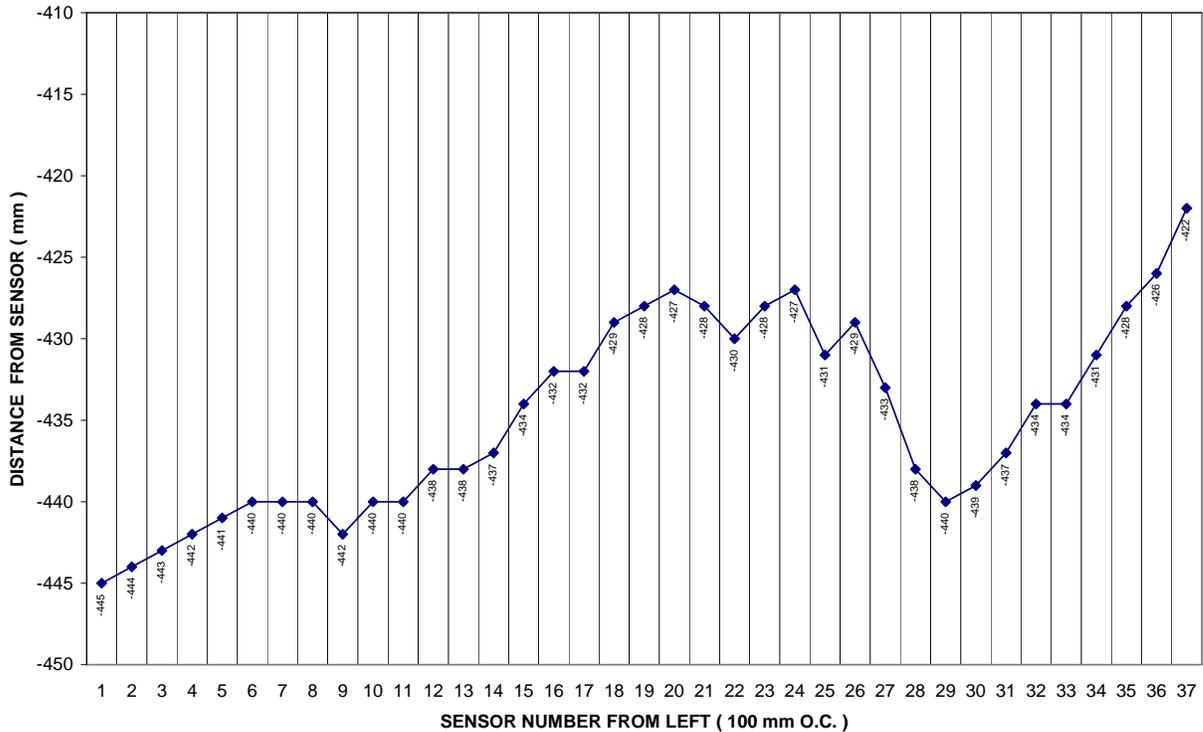
S.R. 695 EB Full-Width Transverse Profile @ 1.712 Miles

FIGURE 20 Full-Width Transverse Profile, S.R. 695 EB at 1.712 Miles.

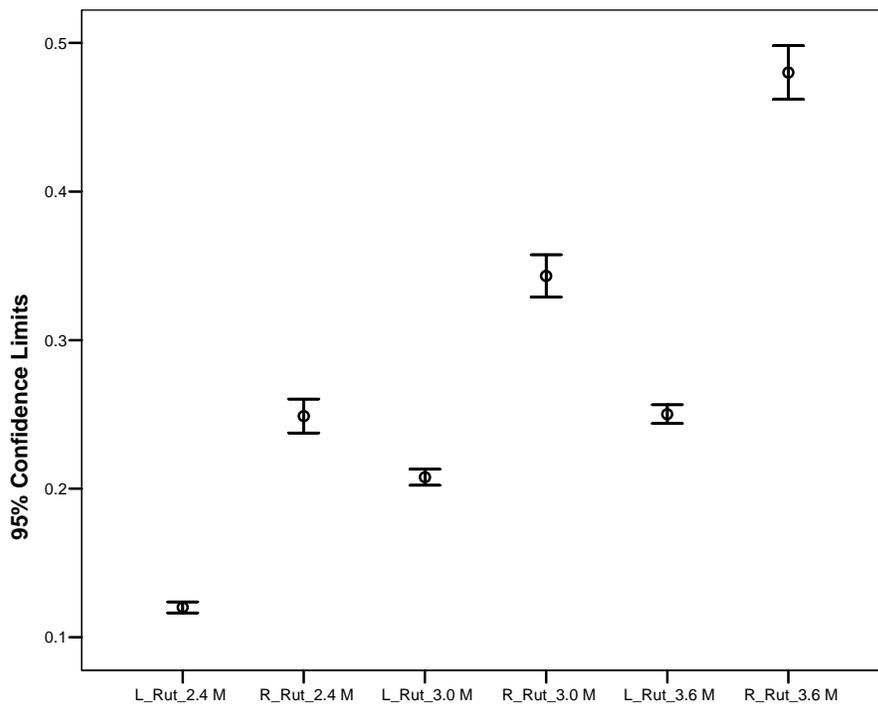
**FIGURE 21** 95% Confidence Levels for Rut Depths, S.R. 695 EB over CIR Base.

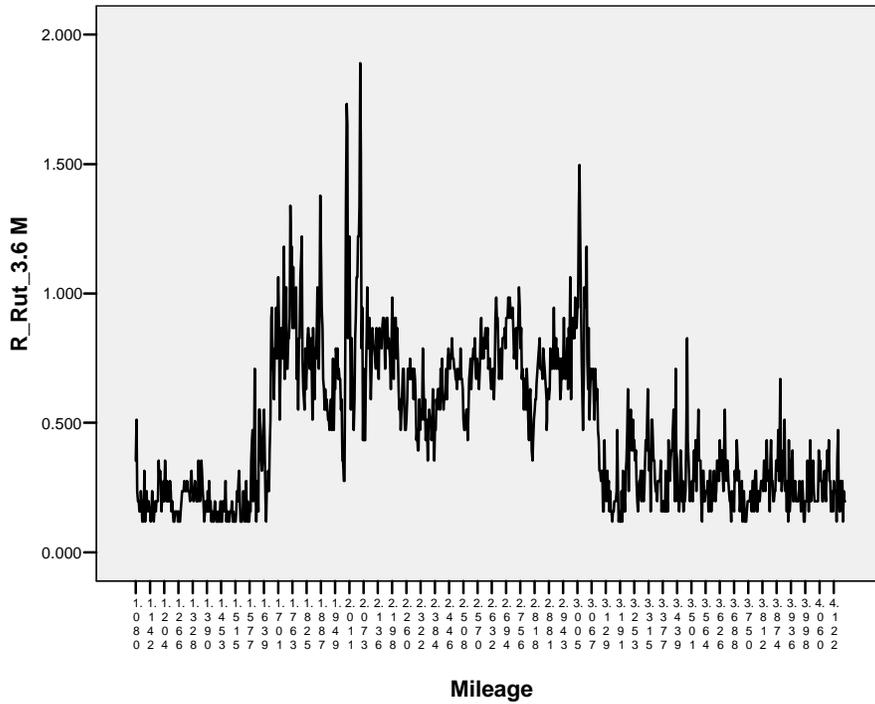
While a significant difference between the magnitudes of the rut depths was found, simple line charts demonstrate that rut depths determined from partial width profiles do provide relative indicators of rut severity. These are shown below in Figures 22 to 25. Notice that each of these three graphs follow the same pattern, but their magnitudes are different.

**FIGURE 24** Simple Line Chart of Rut Depths Determined from Transverse Profiles of 3.6 Meters Versus Mileage for S.R. 695 EB over CIR Base.

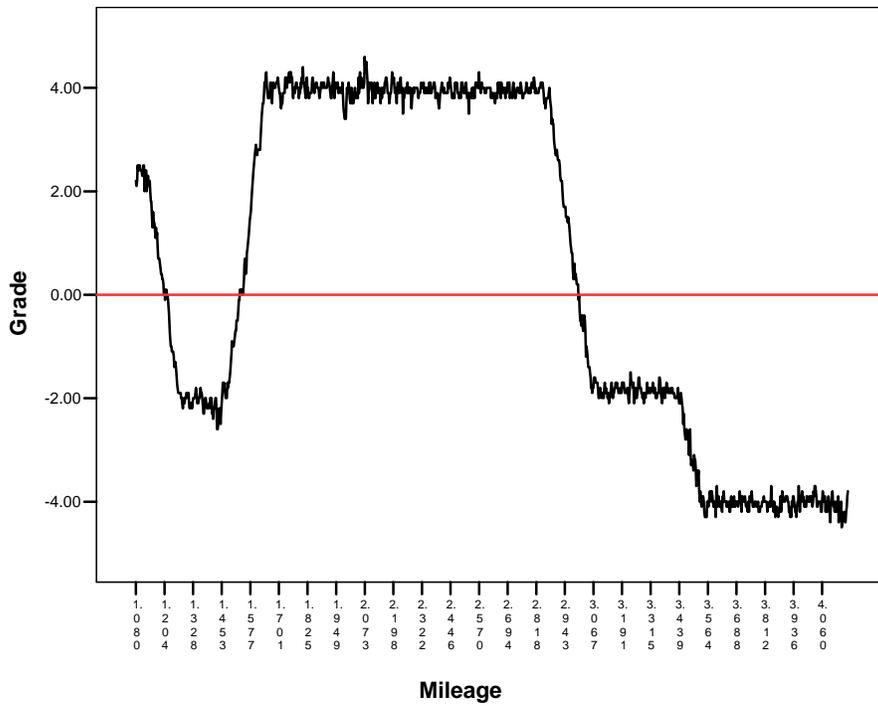
**FIGURE 25** Simple Line Chart of Grade Versus Mileage for SR 695 EB over CIR Base.

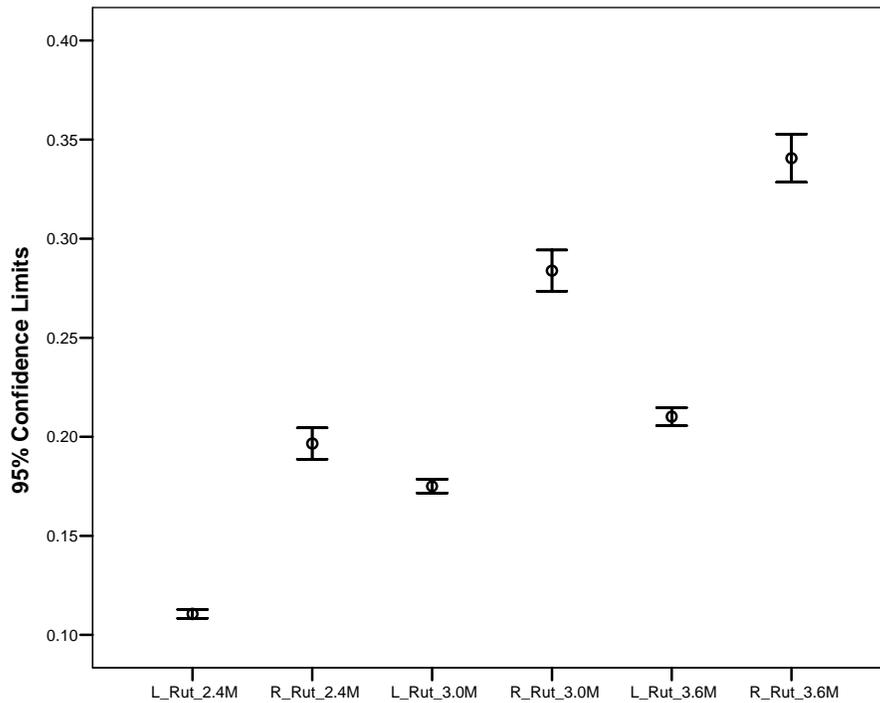
**FIGURE 26 95% Confidence Levels for Rut Depths, S.R. 695 WB over CIR Base.**

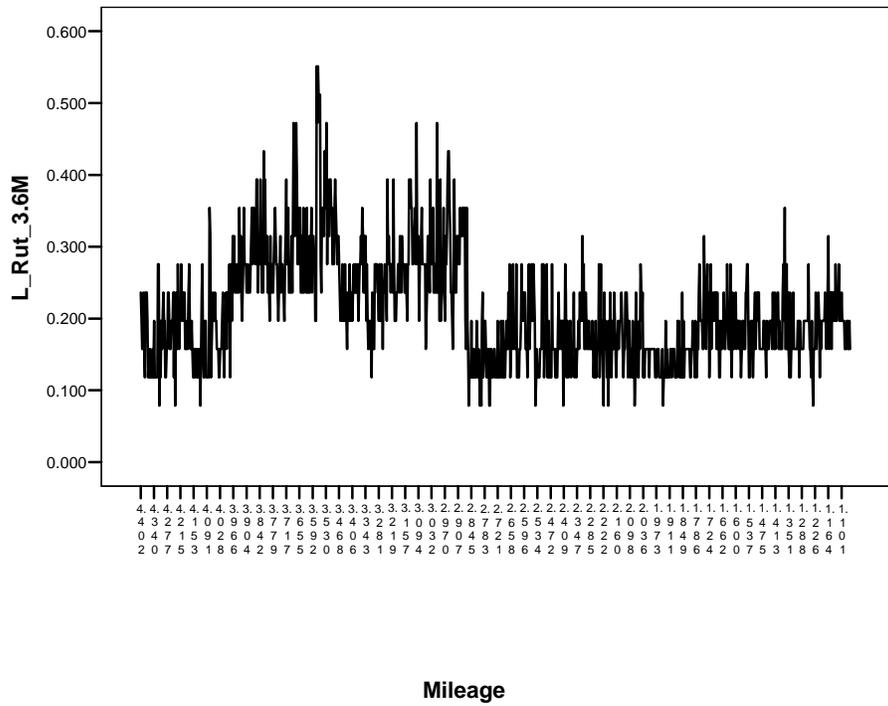
**FIGURE 27** Simple Line Chart of Left Wheel Path Rut Depths Determined from Transverse Profiles of 3.6 Meters Versus Mileage for S.R. 695 WB over CIR Base

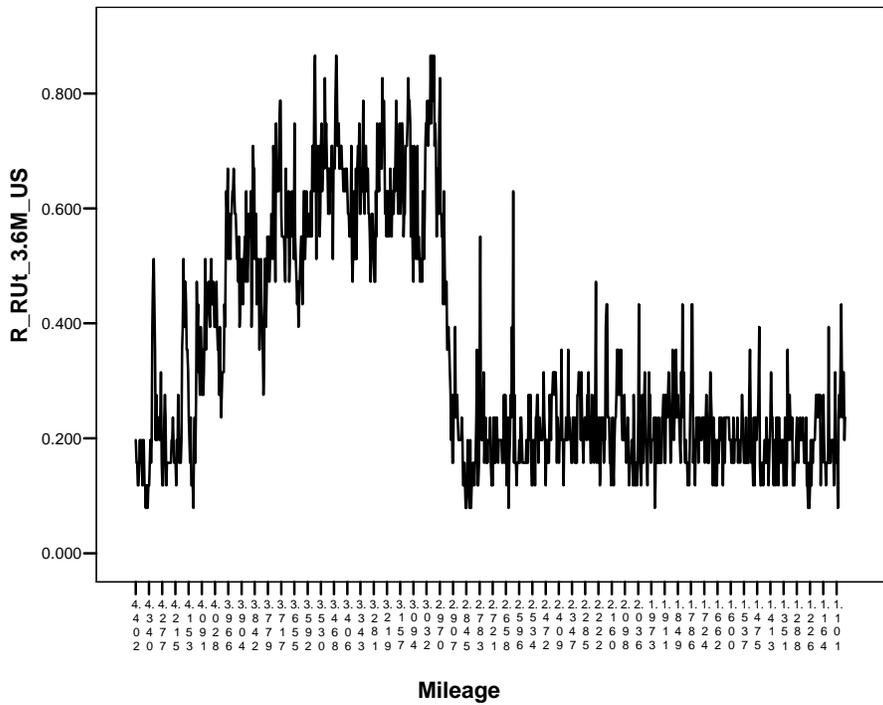
**FIGURE 28** Simple line chart of right wheel path rut depths determined from transverse profiles of 3.6 meters versus mileage for S.R. 695 WB over CIR base.

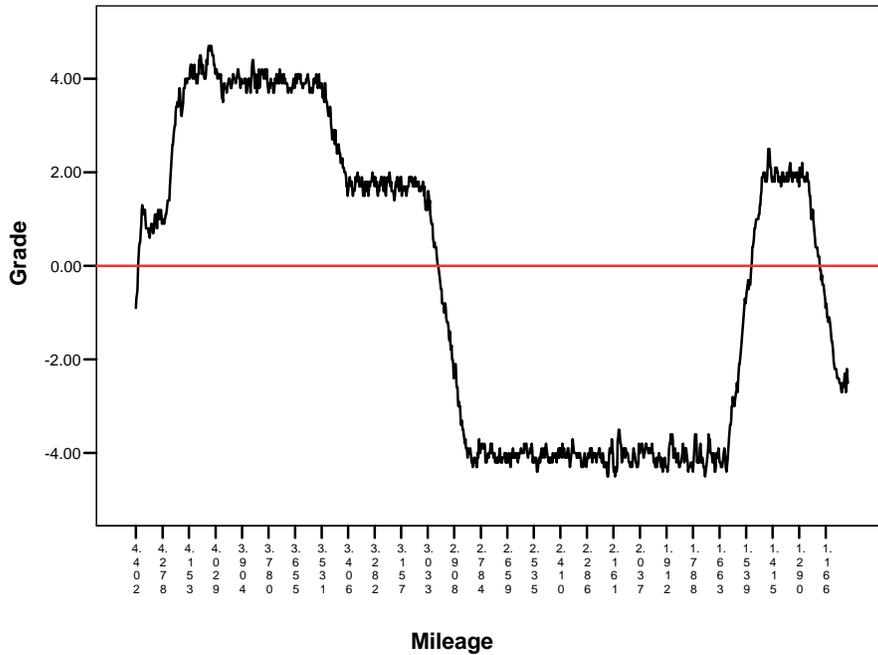
**FIGURE 29** Simple Line Chart of Grade Versus Mileage for SR 695 WB over CIR Base.

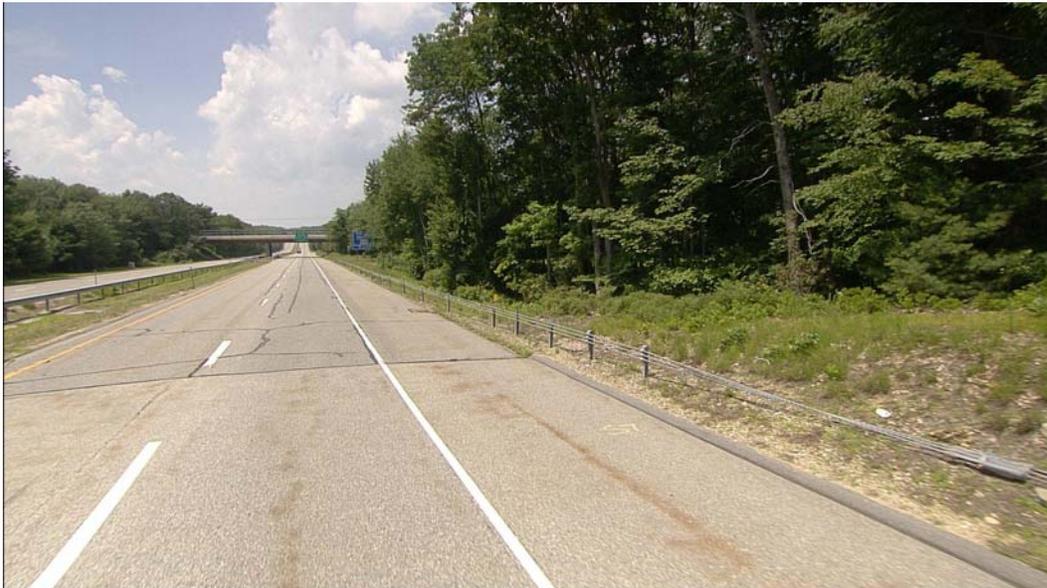
Photolog WiseCrax software was used to analyze cracking of the low-speed lane of S.R. 695. 2008 data were analyzed first. The control pavement (mileage less than 1.08 miles) was already crack sealed by 2008, while the CIR pavement was not crack sealed (see Figure 30). This may have biased the results, as sealed cracks are more readily identified, and appear more severe than if they are not crack sealed.

**FIGURE 30** Photo showing that the control pavement was crack sealed, while the CIR pavement was not in year 2008.
