**Evaluation of a Cold In-Place Recycled  
Rehabilitation Treatment**

**Final Report**

Research Project: SPR-2259

Report No. CT-2259-F-09-2

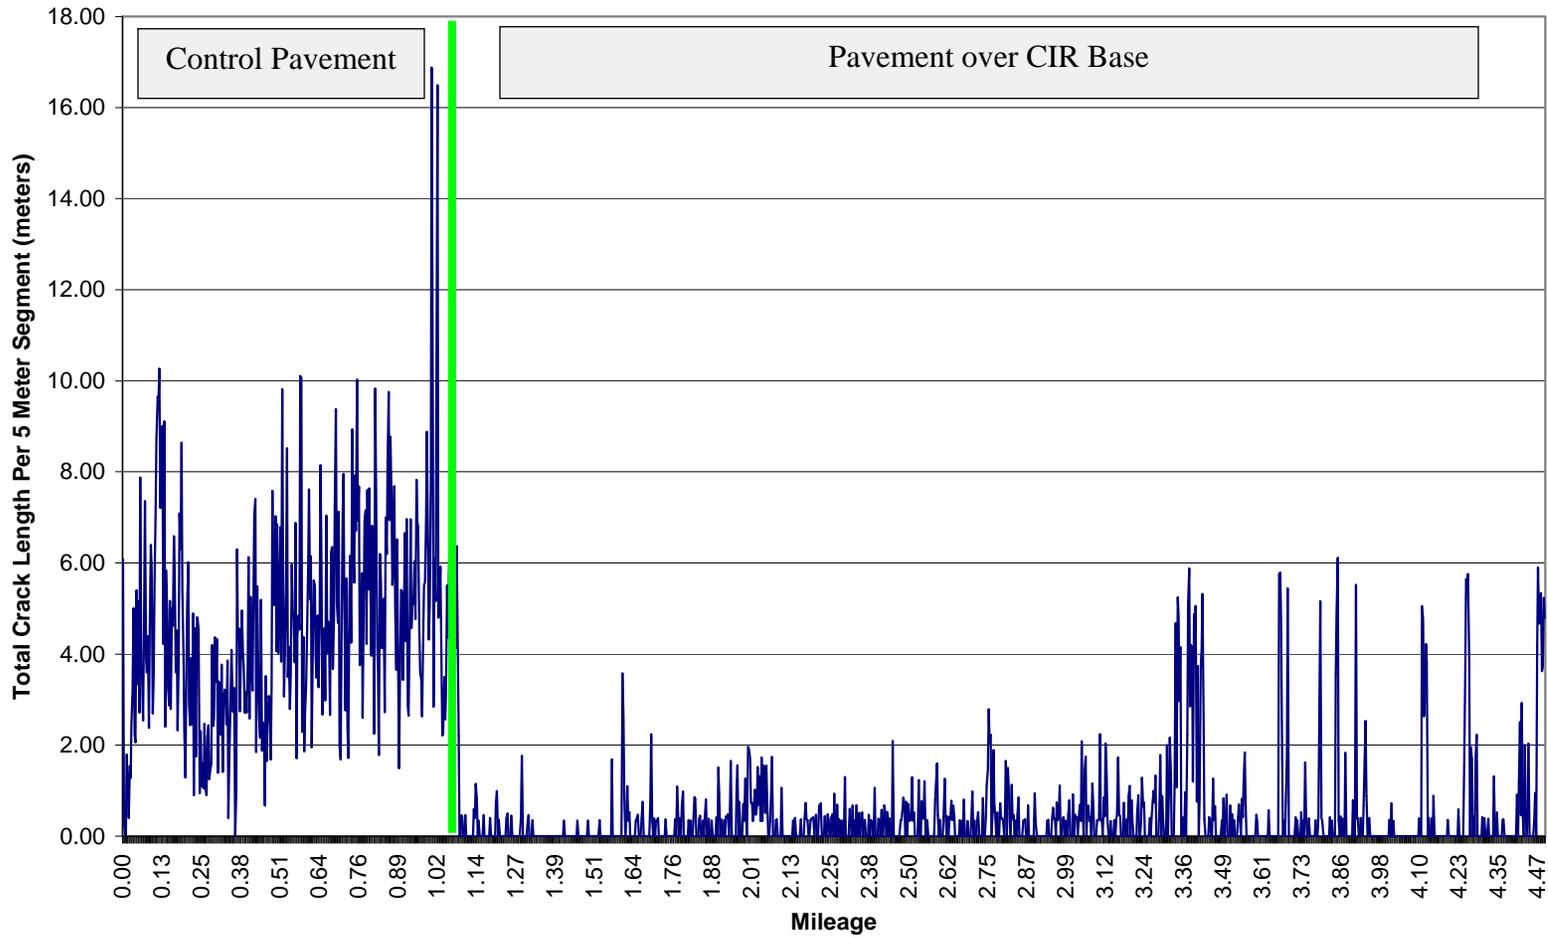
**Total Crack Length per 5 Meter Segment Versus Mileage, S.R. 695 EB**

**FIGURE 31** Total 2008 crack length per 5 meter segment versus mileage for the low speed lane of S.R. 695 eastbound.

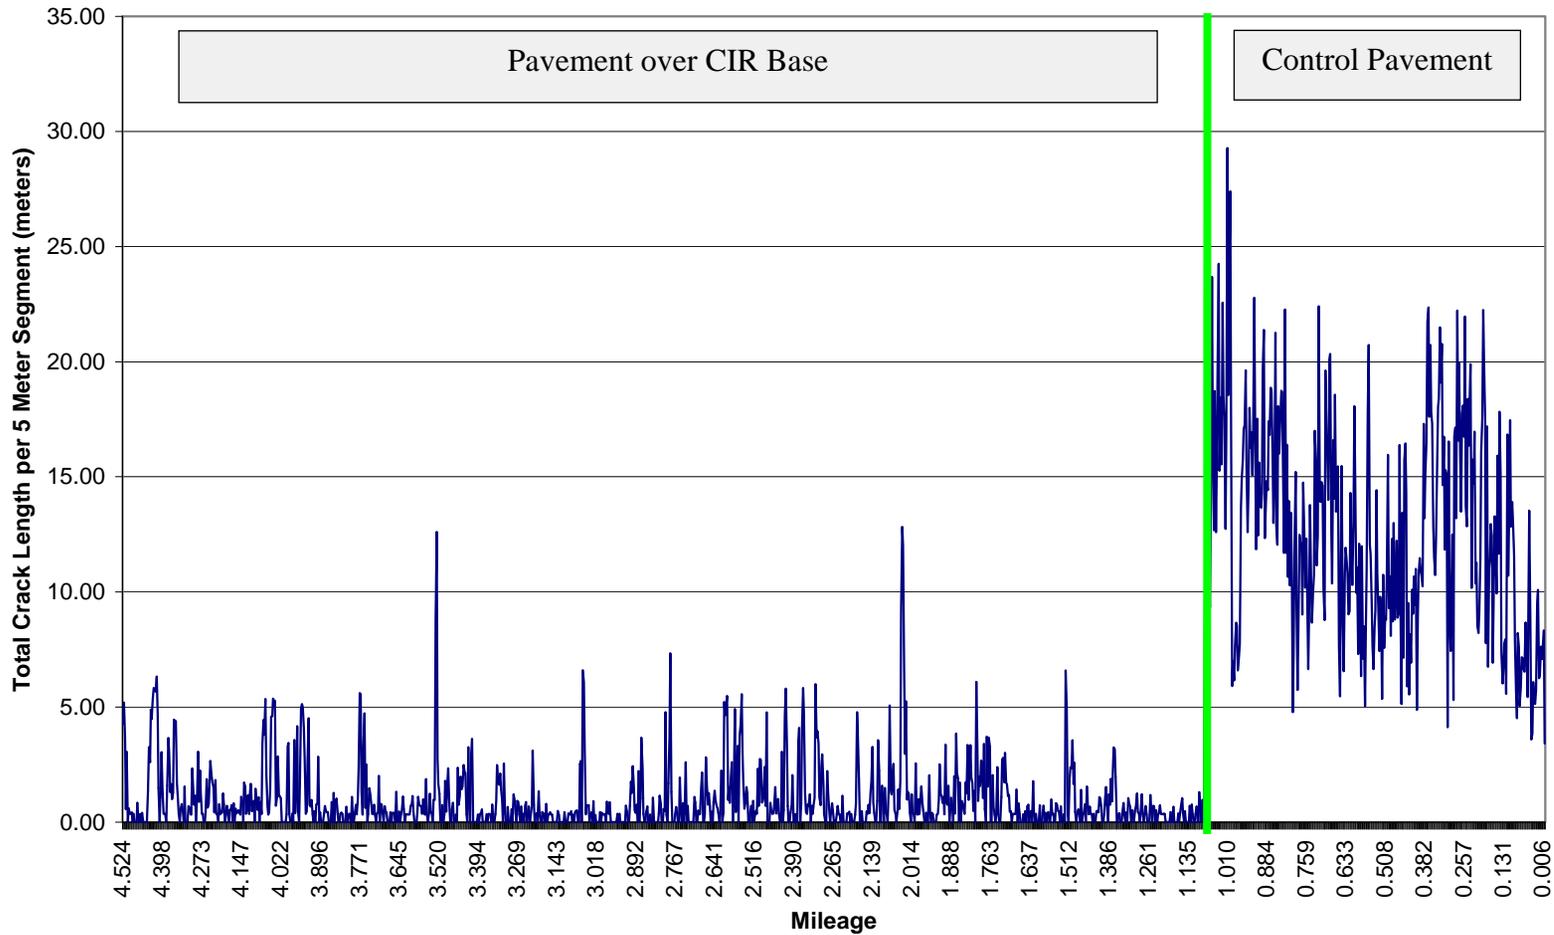
**Total Crack Length per 5 Meter Segment Versus Mileage, S.R. 695 WB**

**FIGURE 32** Total 2008 crack length per 5 meter segment versus mileage for the low speed lane of S.R. 695 westbound.

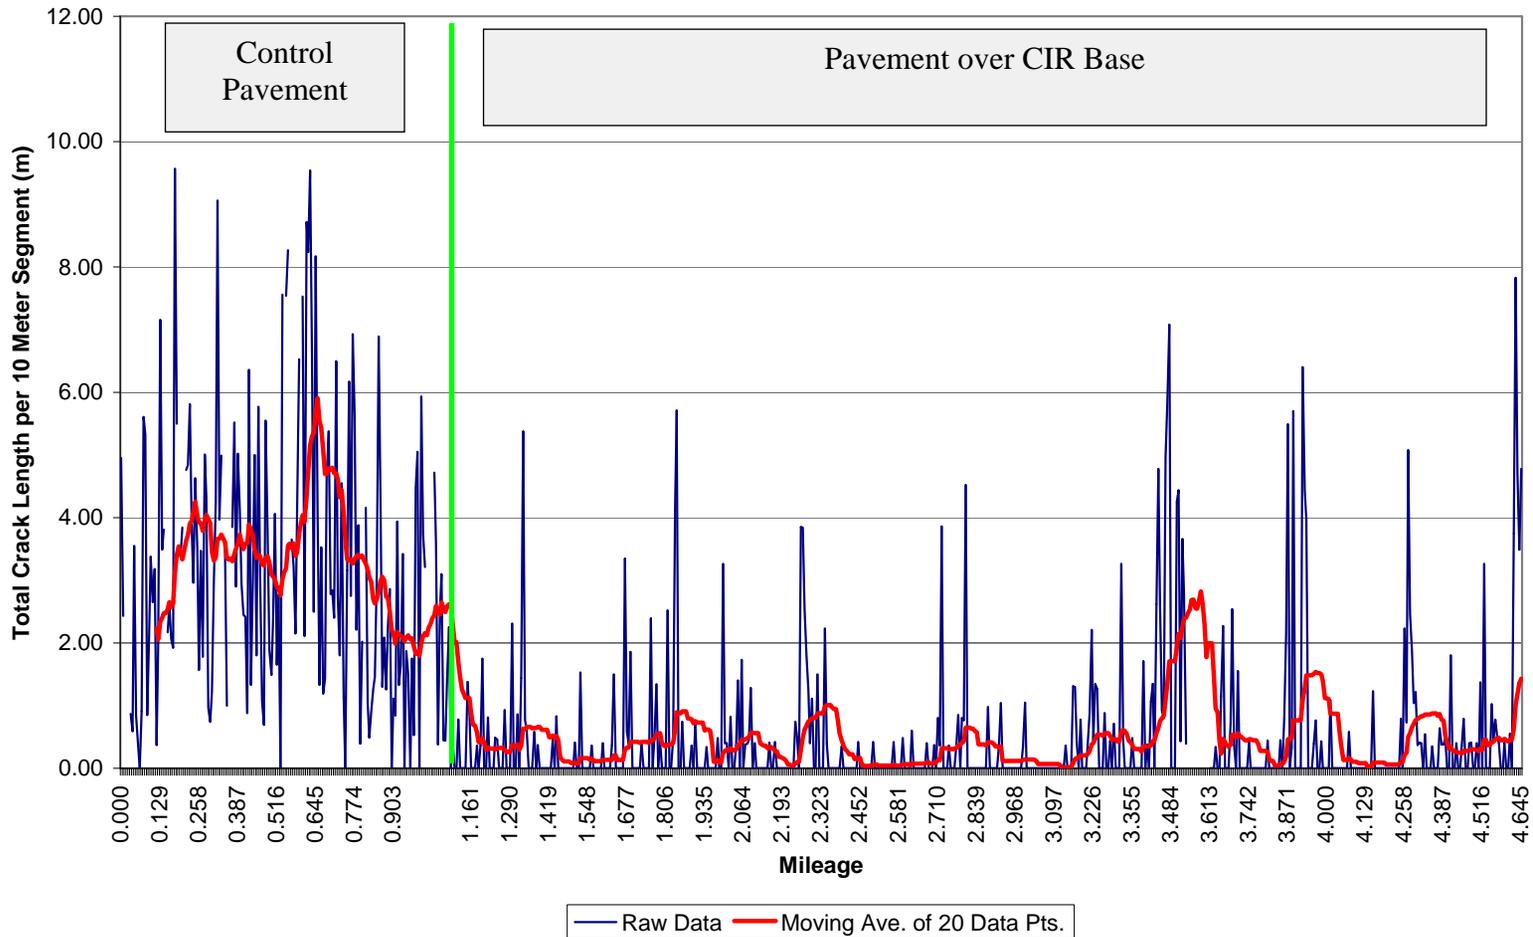
**Total Crack Length per 10 Meter Segment Versus Mileage, S.R. 695 EB, Year 2004**

**FIGURE 33** Total crack length per 10 meter segment for S.R. 695 EB, year 2004, no filters set (all data). Note: severe spikes, such as between 3.484 and 3.613 miles, often indicate invalid data.

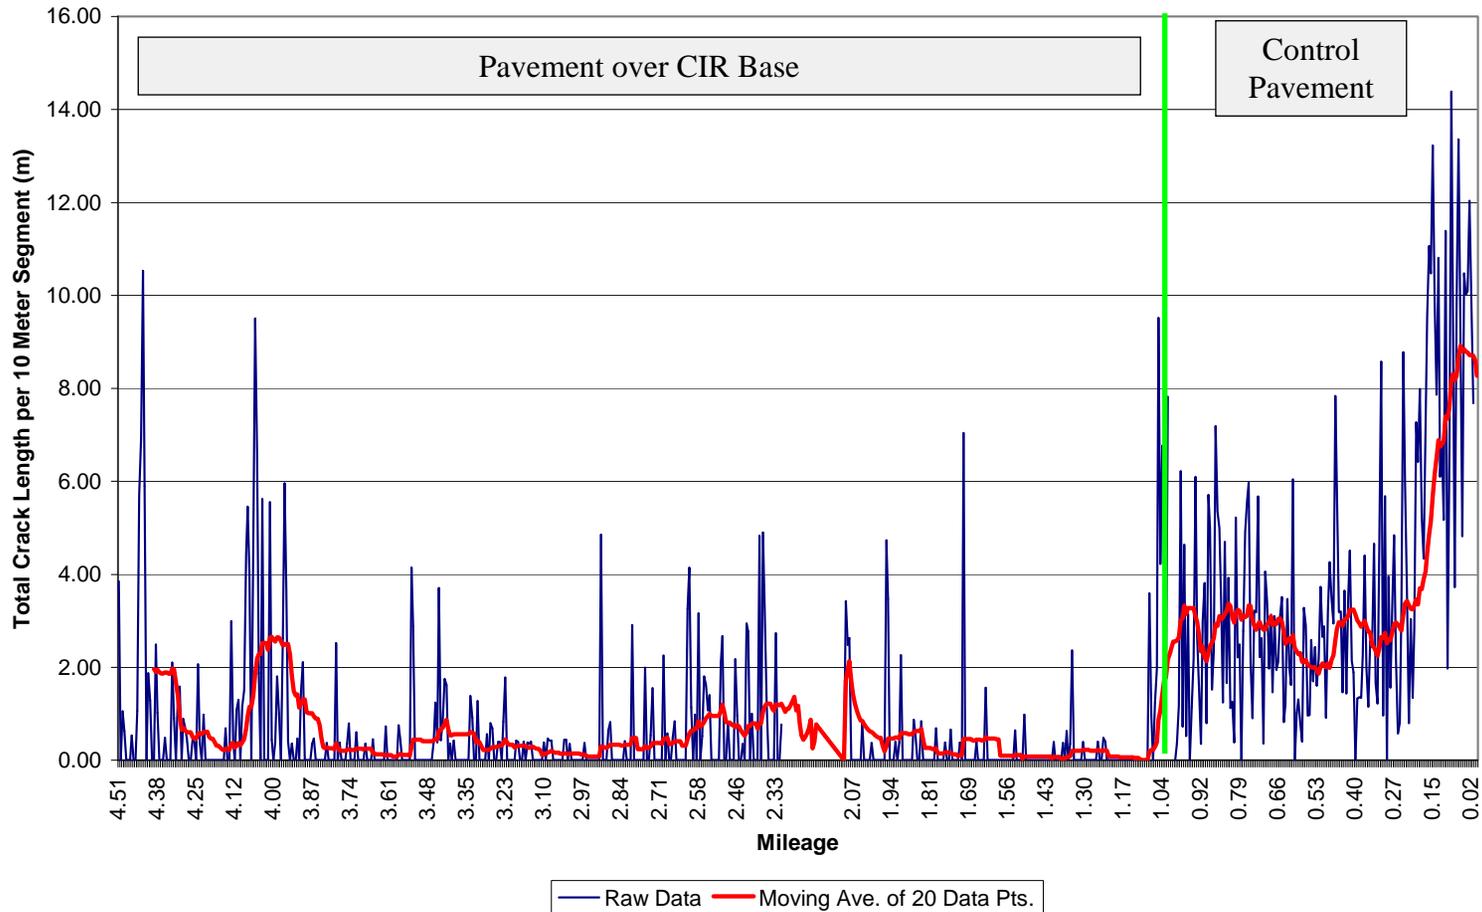
**Total Crack Length per 10 Meter Segment Versus Mileage, S.R. 695 WB, Year 2004**

**FIGURE 34** Total crack length per 10 meter segment for S.R. 695 WB, year 2004, no filters set (all data). Note: severe spikes, such as between 2.33 and 2.07 miles, often indicate invalid data.

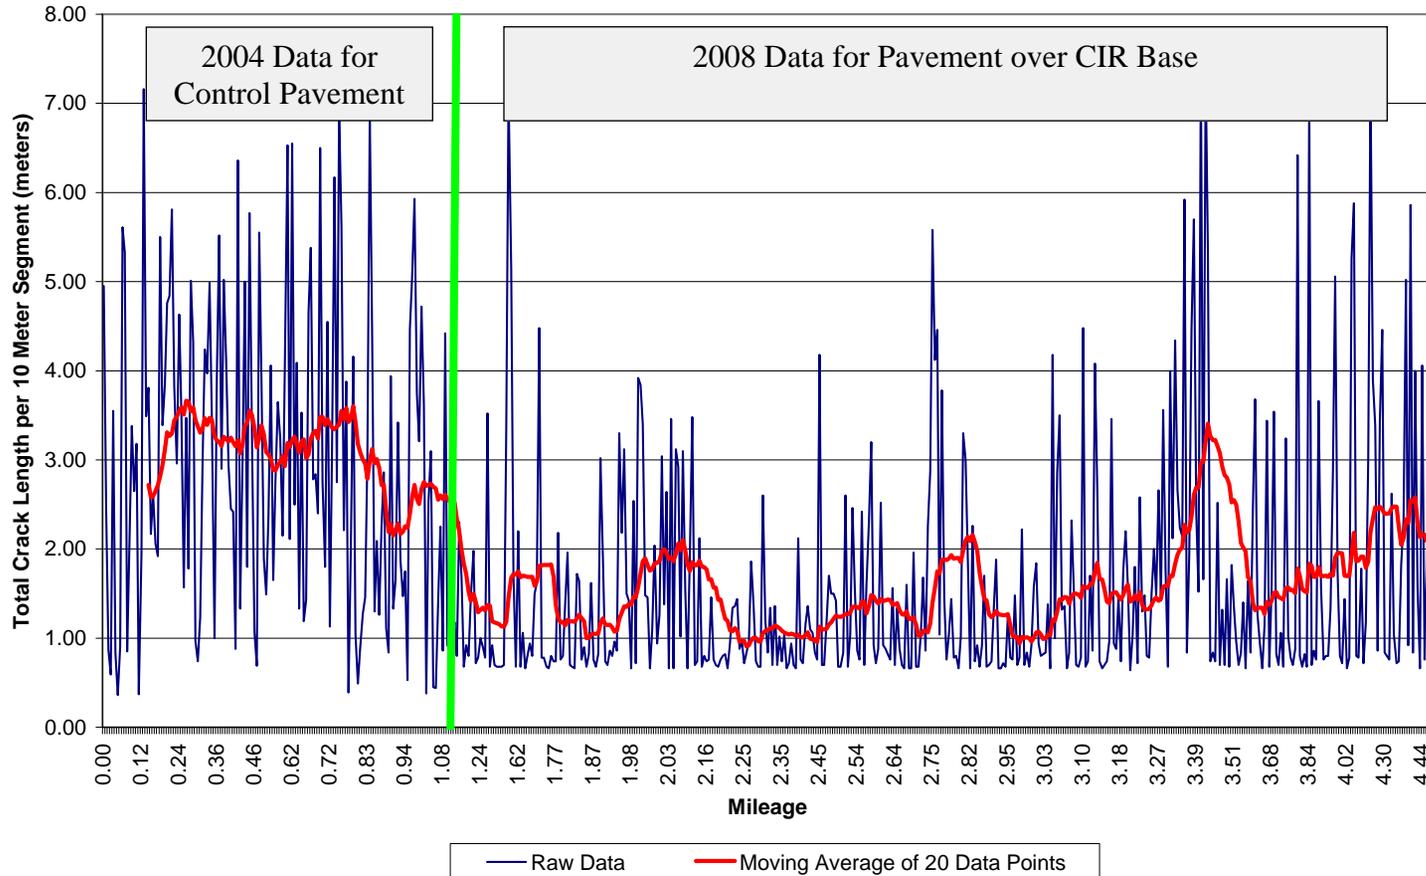
**Total Crack Length per 10 Meter Segment Versus Mileage, S.R. 695, 2004 and 2008 Combined**

**FIGURE 35** S.R. 695 EB Crack length data for 2008 pavement over CIR base (>1.08 miles) merged with 2004 control pavement data (<1.08 miles), crack lengths greater than 7.5 meters filtered-out. Note that the 2004 control data ranges approximately between 2.00 and 4.00 meters, while the CIR pavement ranges approximately between 1.0 and 3.0 meters.

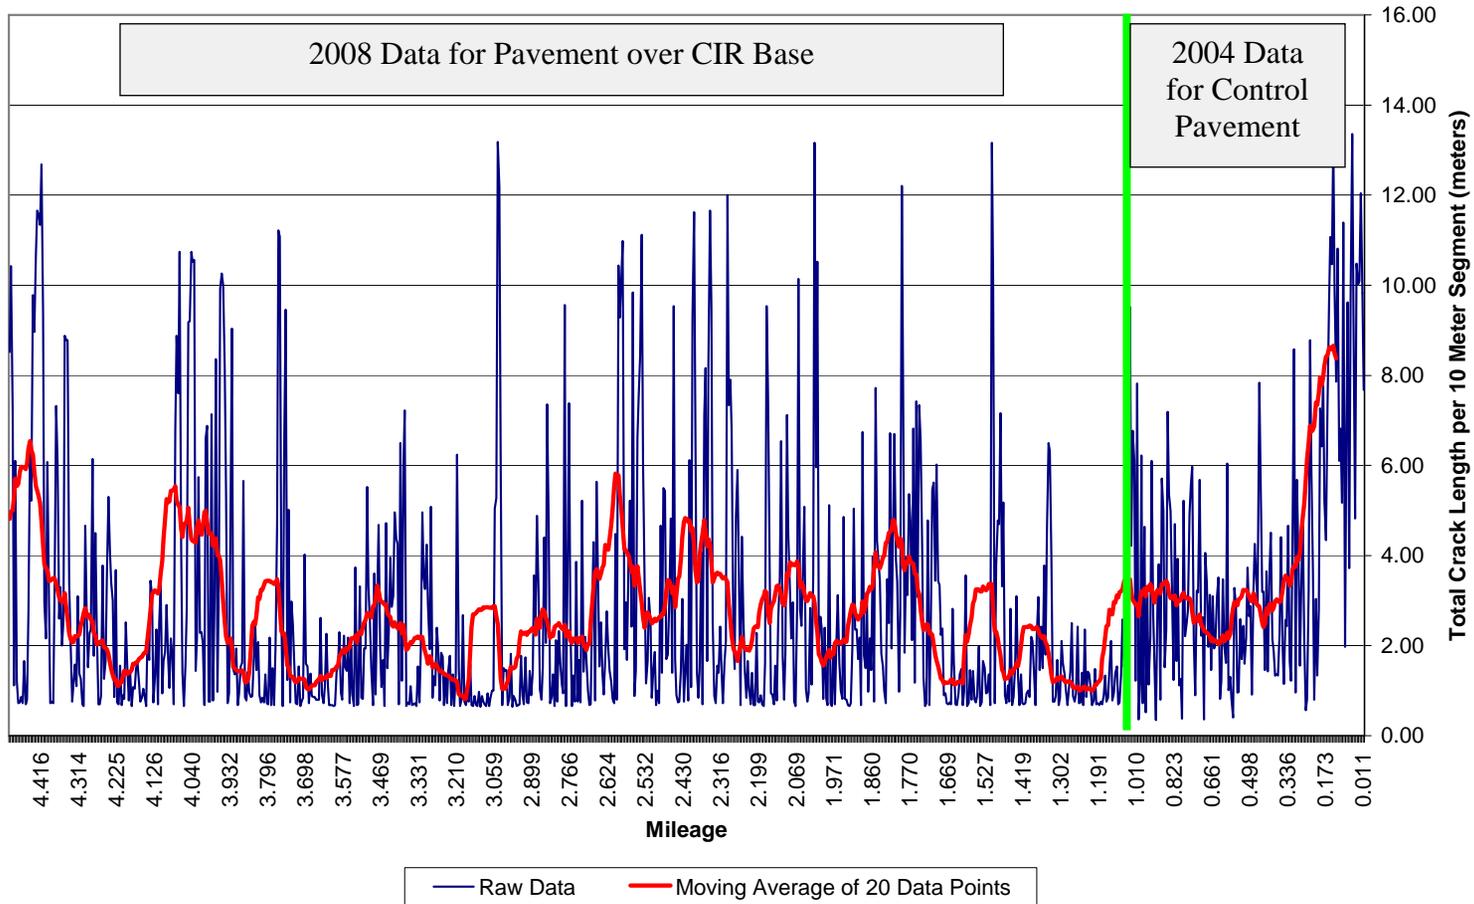
**Total Crack Length per 10 Meter Segment Versus Mileage, S.R. 695, 2004 and 2008 Combined**

**FIGURE 36** S.R. WB Crack length data for 2008 pavement over CIR base (>1.06 miles) merged with 2004 control pavement (<1.06 miles).

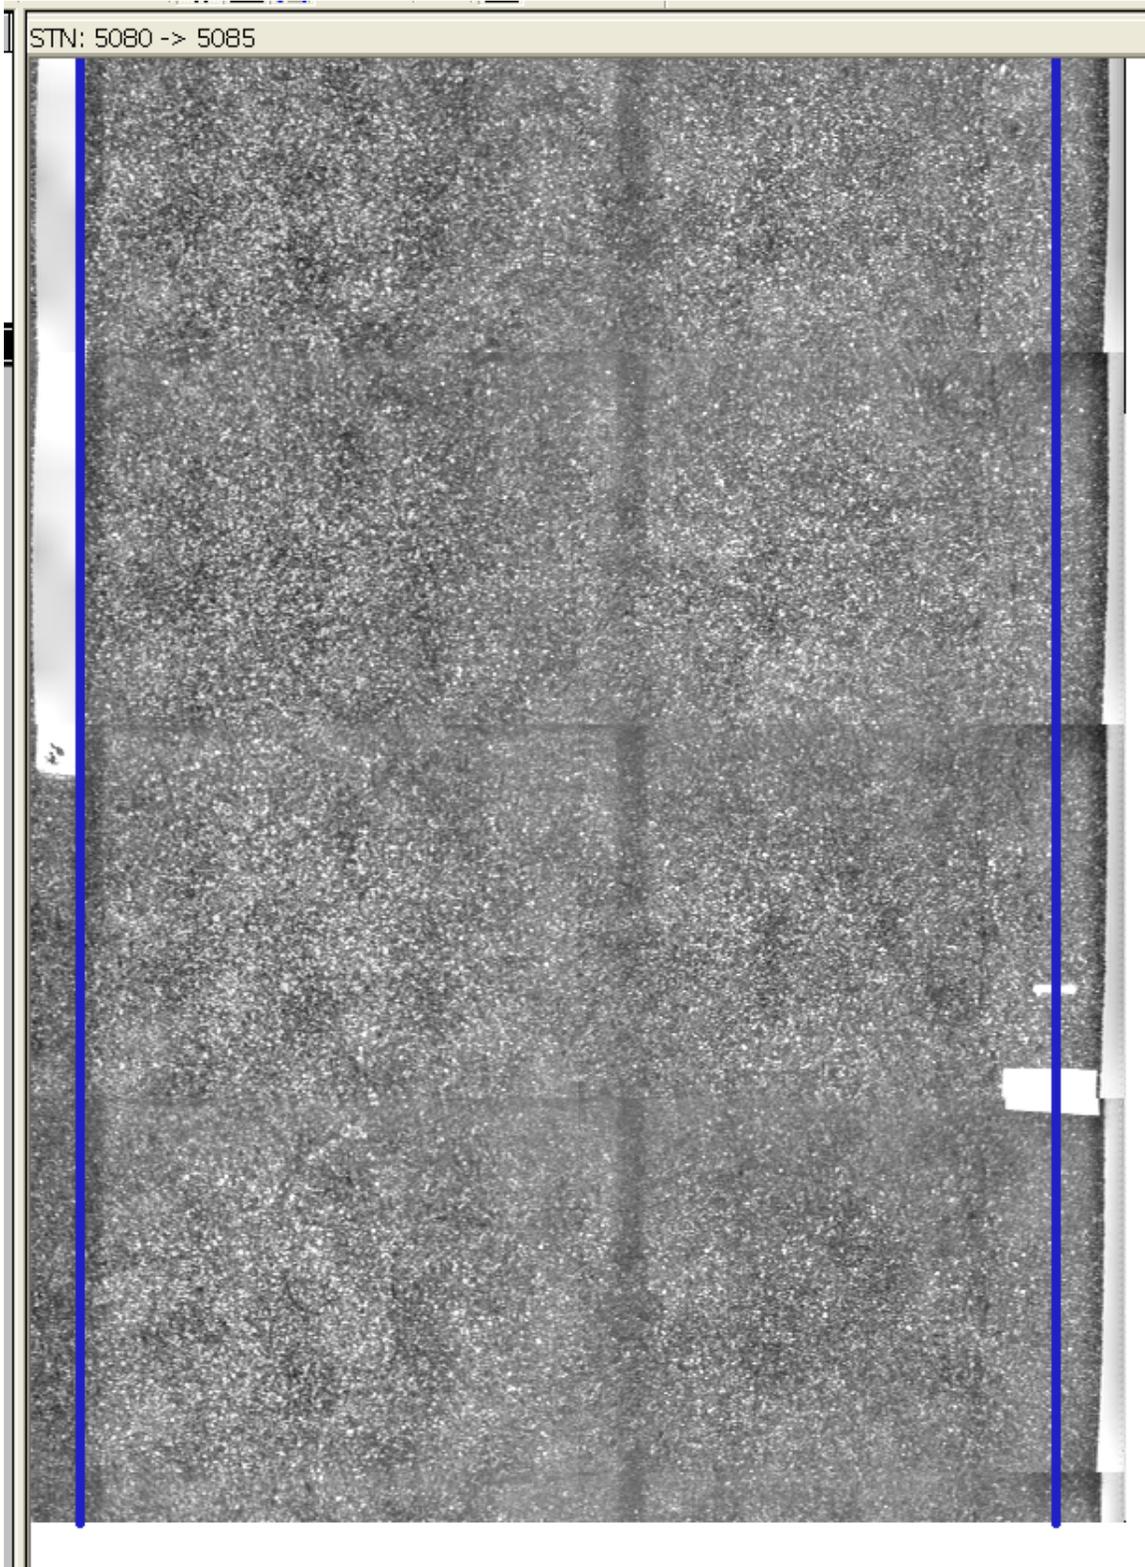
**FIGURE 37** Wisecrax image file from chainage 5.080 to 5.085 kilometers, which corresponds with mileage 3.135 to 3.142 on S.R. 695 EB where Site S2 is located at Station 1+00.

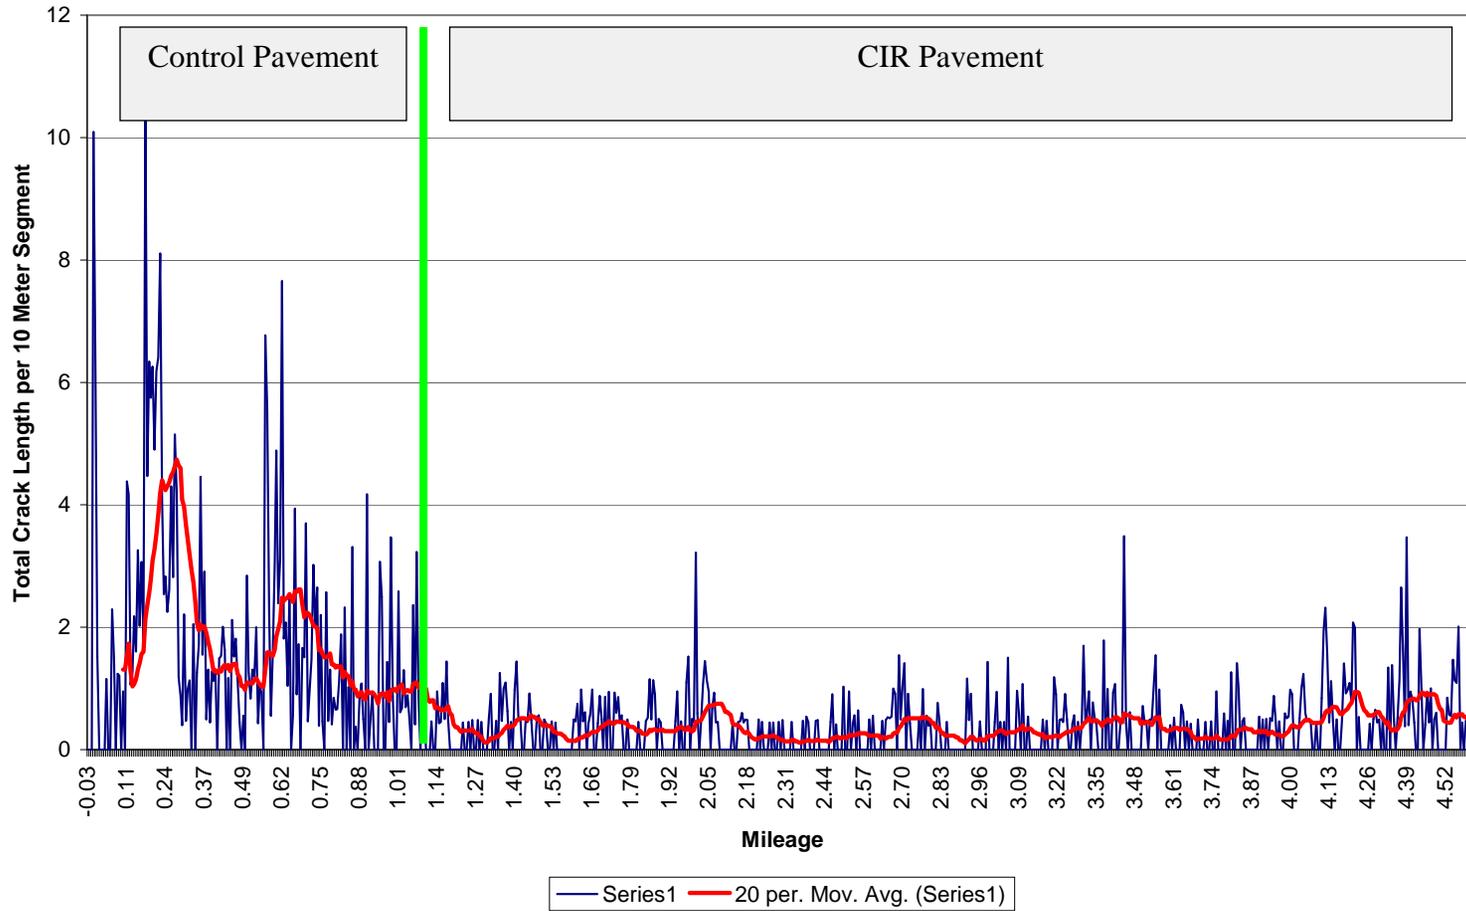
2002 Total Crack Length per 10 Meter Segment versus Mileage, S.R. 695 EB

Figures 38 and 39 plot total crack lengths per 10 meter segment versus mileage for S.R. 695 eastbound (low-speed lane) for the years 2002 and 2001, respectively. These data were collected prior to any crack sealant material being applied to the pavement. Once again, it can be seen that the control pavement had more cracking than the CIR pavement, although the control pavement was 4 years older than the CIR pavement.

FIGURE 38 Total crack length per 10 meter segment versus mileage on S.R. 695 EB for 2002.

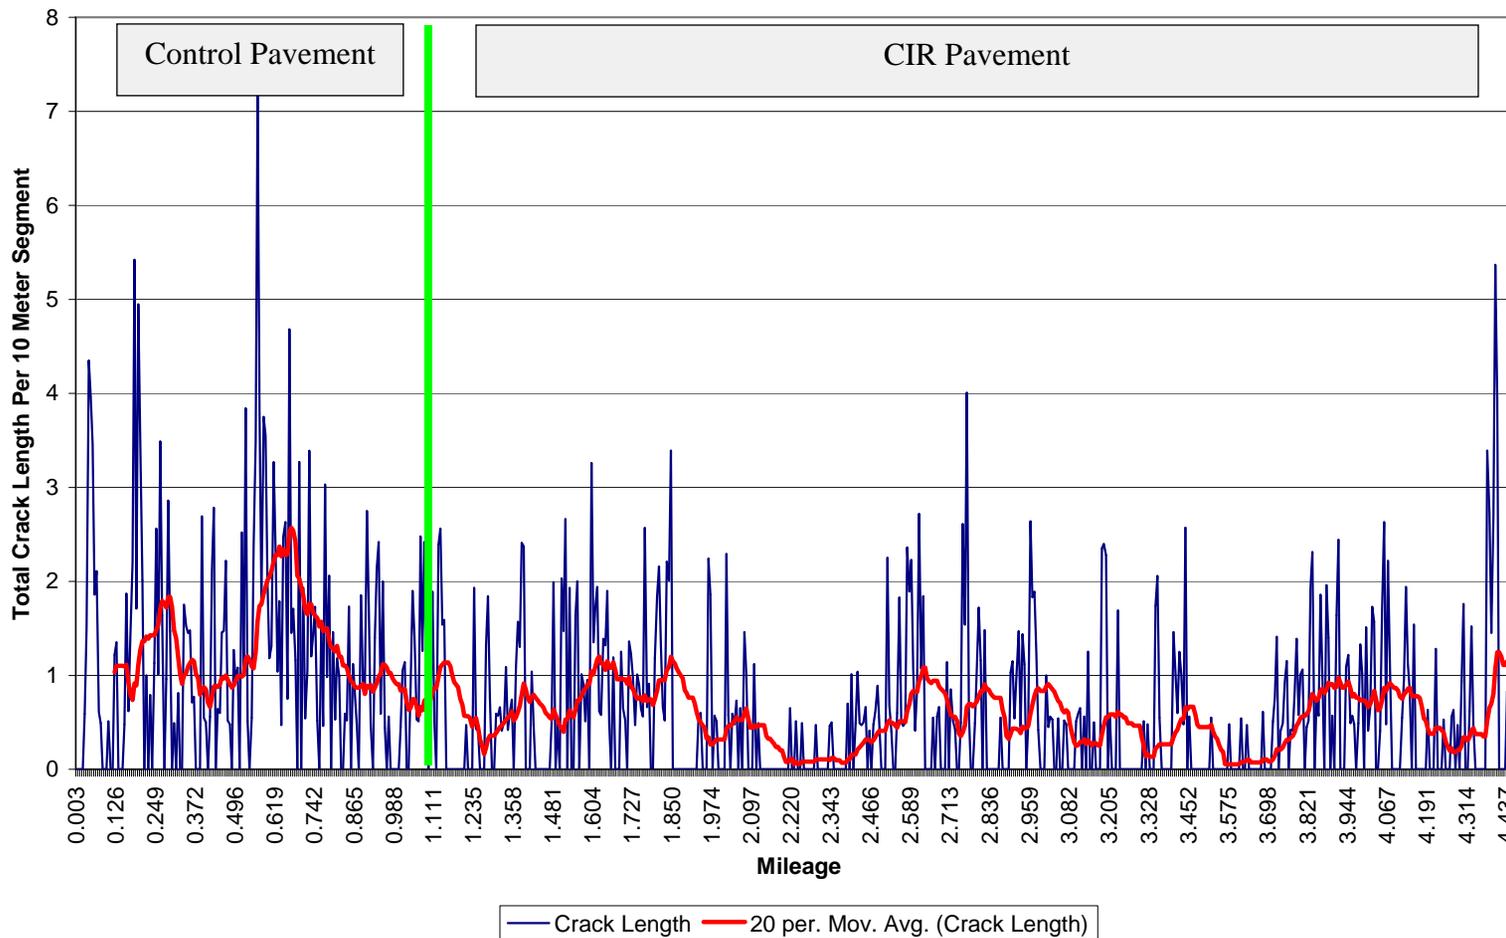
S.R. 695 EB, Total Crack Length per 10 Meter Segment Versus Mileage, 2001

FIGURE 39 Total crack length per 10 meter segment versus mileage on S.R. 695 EB for 2001.
