PRELIMINARY APPLICATION FOR THE LOCAL BRIDGE PROGRAM

Bridge Location: West Queen Street over Quinnipiac River

Bridge Number: 04564 Length of Span: 39 feet

**BRIDGE NO. 04564
WEST QUEEN STREET over QUINNIPIAC RIVER
SOUTHINGTON, CT**

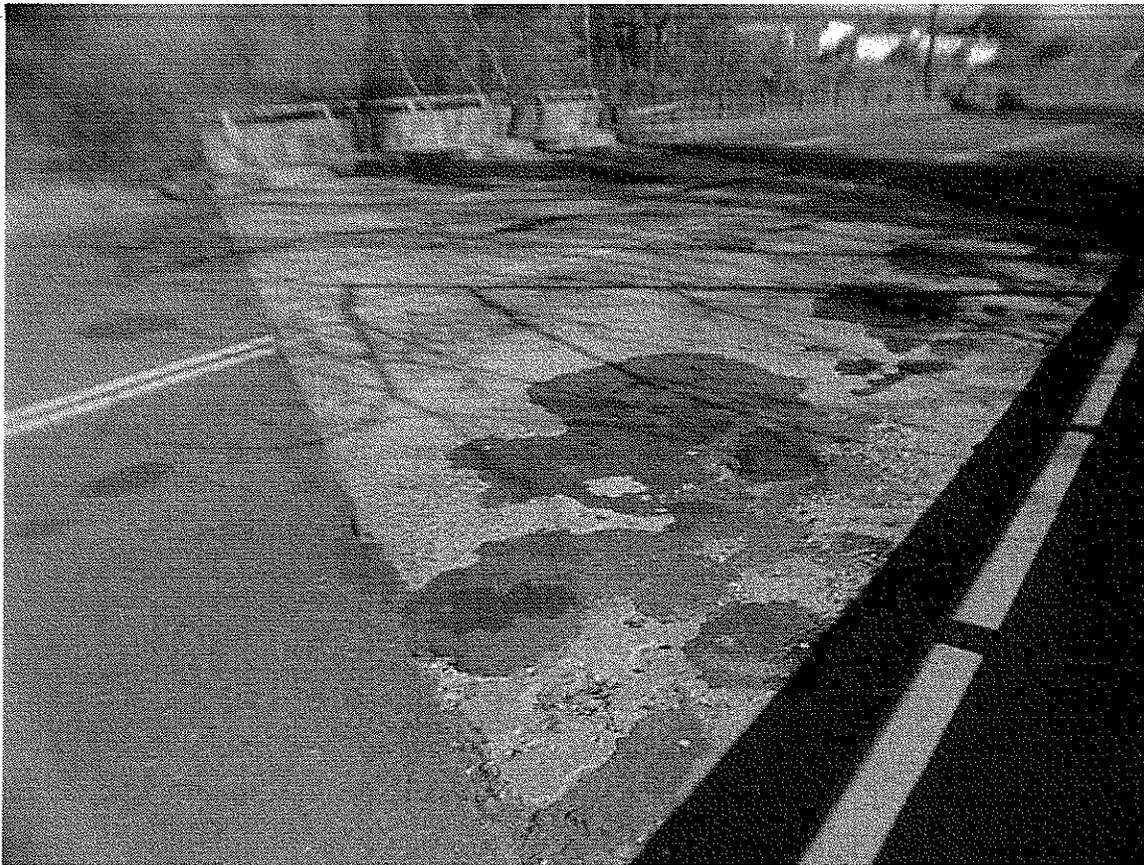
The exposed concrete bridge deck exhibits hollow areas, spalling and deteriorated asphalt patches over approximately 22% of the deck surface and was rated "4"-poor by the last ConnDOT inspection in 2005.

Bridge deck surface with over 22% hollow, spalls & patches.

OVERLAY	N	
DECK STR. CONDITION	4	Bare concrete shows approximately 450 square feet +/- of numerous large and small spalls roughly patched with bituminous concrete, some bituminous patches are breaking up and (2) isolated spalls shows rusted rebars. Also large areas of hollow concrete, areas of light scale, and areas of hairline cracking. Bands of sand along shoulder areas from 2 to 4 feet with concrete chips. Total surface deterioration equals approx. 22% +/- of the deck area. General note; used chain drag to locate areas of hollow concrete. See photos & attached sketch.
CURBS	6	Curbs show isolated vertical cracks, areas of light to medium scale and some snow plow damage at ends.
MEDIAN	N	
SIDEWALKS	6	Rating based on previous reports. Up to 2 inches +/- of sand cover.
PARAPET	6	Parapets show random hairline vertical cracks with efflorescence.
RAILING	7	Single pipe rail and "H" posts shows spotty light rust.

The proposed scope of this project is to replace the existing culvert top slab with a new reinforced concrete deck with membrane waterproofing and bituminous concrete overlay. The overall length of the project is estimated to be approximately 200 feet with approach paving and guide rail work.

The rehabilitation will be designed in accordance with AASHTO & ConnDOT standards to accommodate HS-25 load capacity. Construction will be in accordance with the ConnDOT Standard Specifications, Form 816. Aesthetics, initial costs and future maintenance requirements will be considered in the design.
