October 7, 2002

Please find enclosed preliminary data on environmental work carried out on the Sigourney Street building by our contractors, Environmental Health and Engineering. We plan to prepare interim reports summarizing this information but are releasing it as received to help target building remediation efforts. Included are results of the boroscope assessment of the 16th, 17th, 18th and 19th floors carried out on 06/27/2002, and 07/15-16/2002; results of the in-wall spore-trap sampling done on all floors on 06/27/2002 and 07/15 – 17/2002; and an Environmental Health and Engineering report on evaluation of the restrooms in the Sigourney Street building for water leaks and fungal growth.

Table 1 Results of Analyses for Non-Viable Fungal Spores in Wall Samples Collected on the Fifth Floor at 25 Sigourney Street, Hartford, Connecticut, July 17, 2002

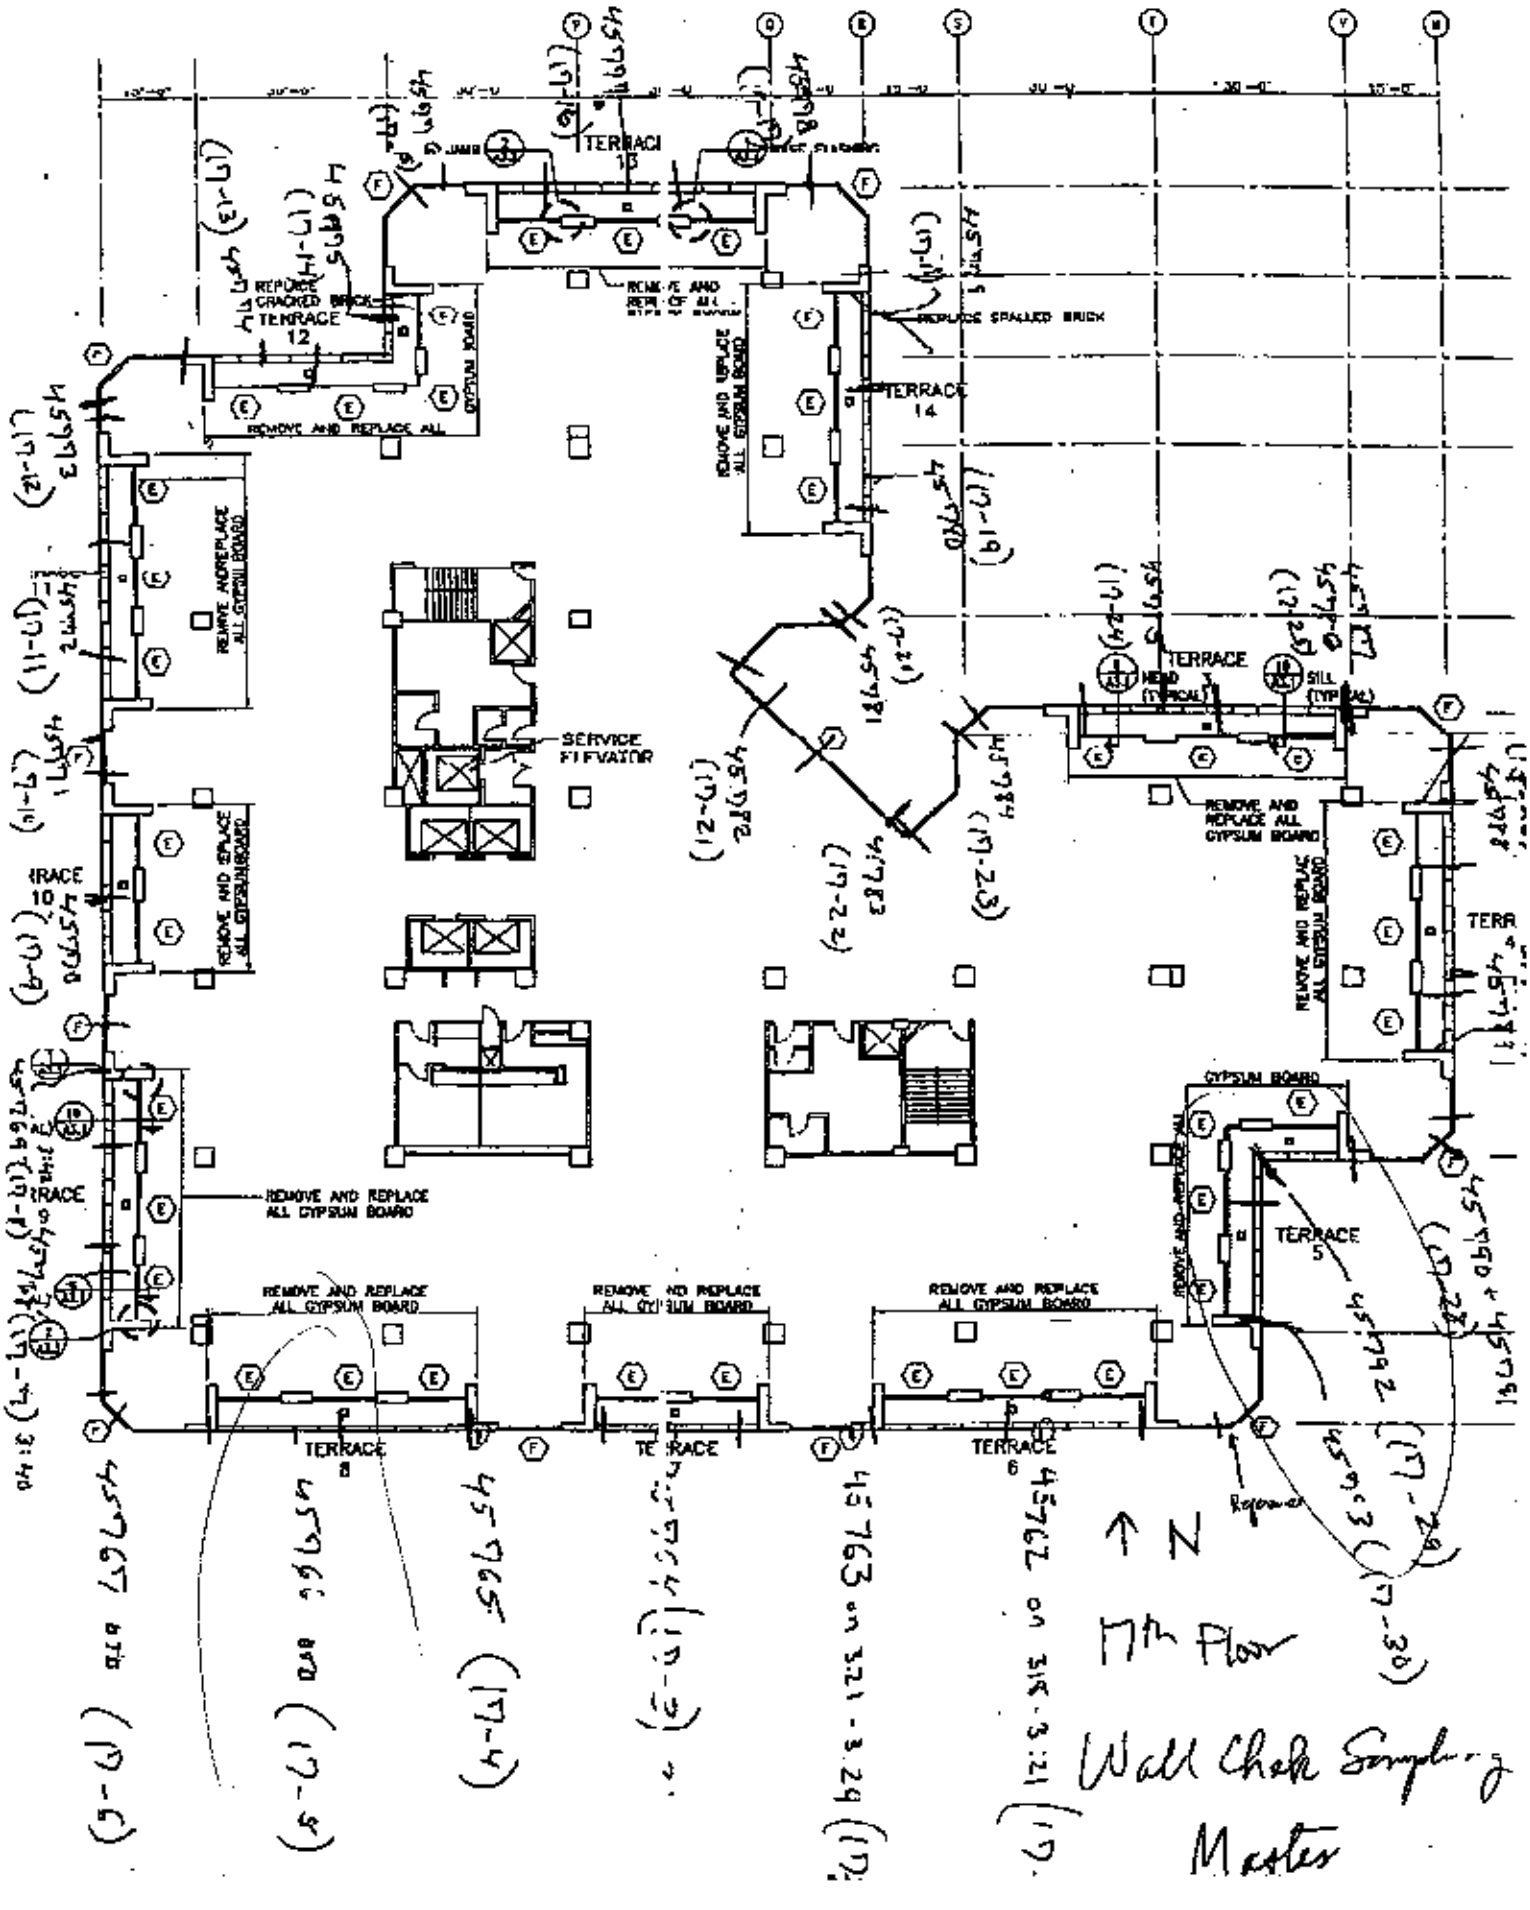
TERRACE 13
REPLACE CRACKED BRICK
TERRACE 12
REMOVE AND REPLACE ALL GYPSUM BOARD
REMOVE AND REPLACE ALL GYPSUM BOARD
REPLACE SPALLED BRICK
TERRACE 14
REMOVE AND REPLACE ALL GYPSUM BOARD
SERVICE ELEVATOR
TERRACE
HEAD (TYPICAL)
SILL (TYPICAL)
REMOVE AND REPLACE ALL GYPSUM BOARD
TERRACE 10
REMOVE AND REPLACE ALL GYPSUM BOARD
REMOVE AND REPLACE ALL GYPSUM BOARD
GYPSUM BOARD
TERRACE 5
REMOVE AND REPLACE ALL GYPSUM BOARD
REMOVE AND REPLACE ALL GYPSUM BOARD
REMOVE AND REPLACE ALL GYPSUM BOARD
REMOVE AND REPLACE ALL GYPSUM BOARD
TERRACE 8
TERRACE 7
TERRACE 6
N
7th Floor
Wall Check Sampling
Master

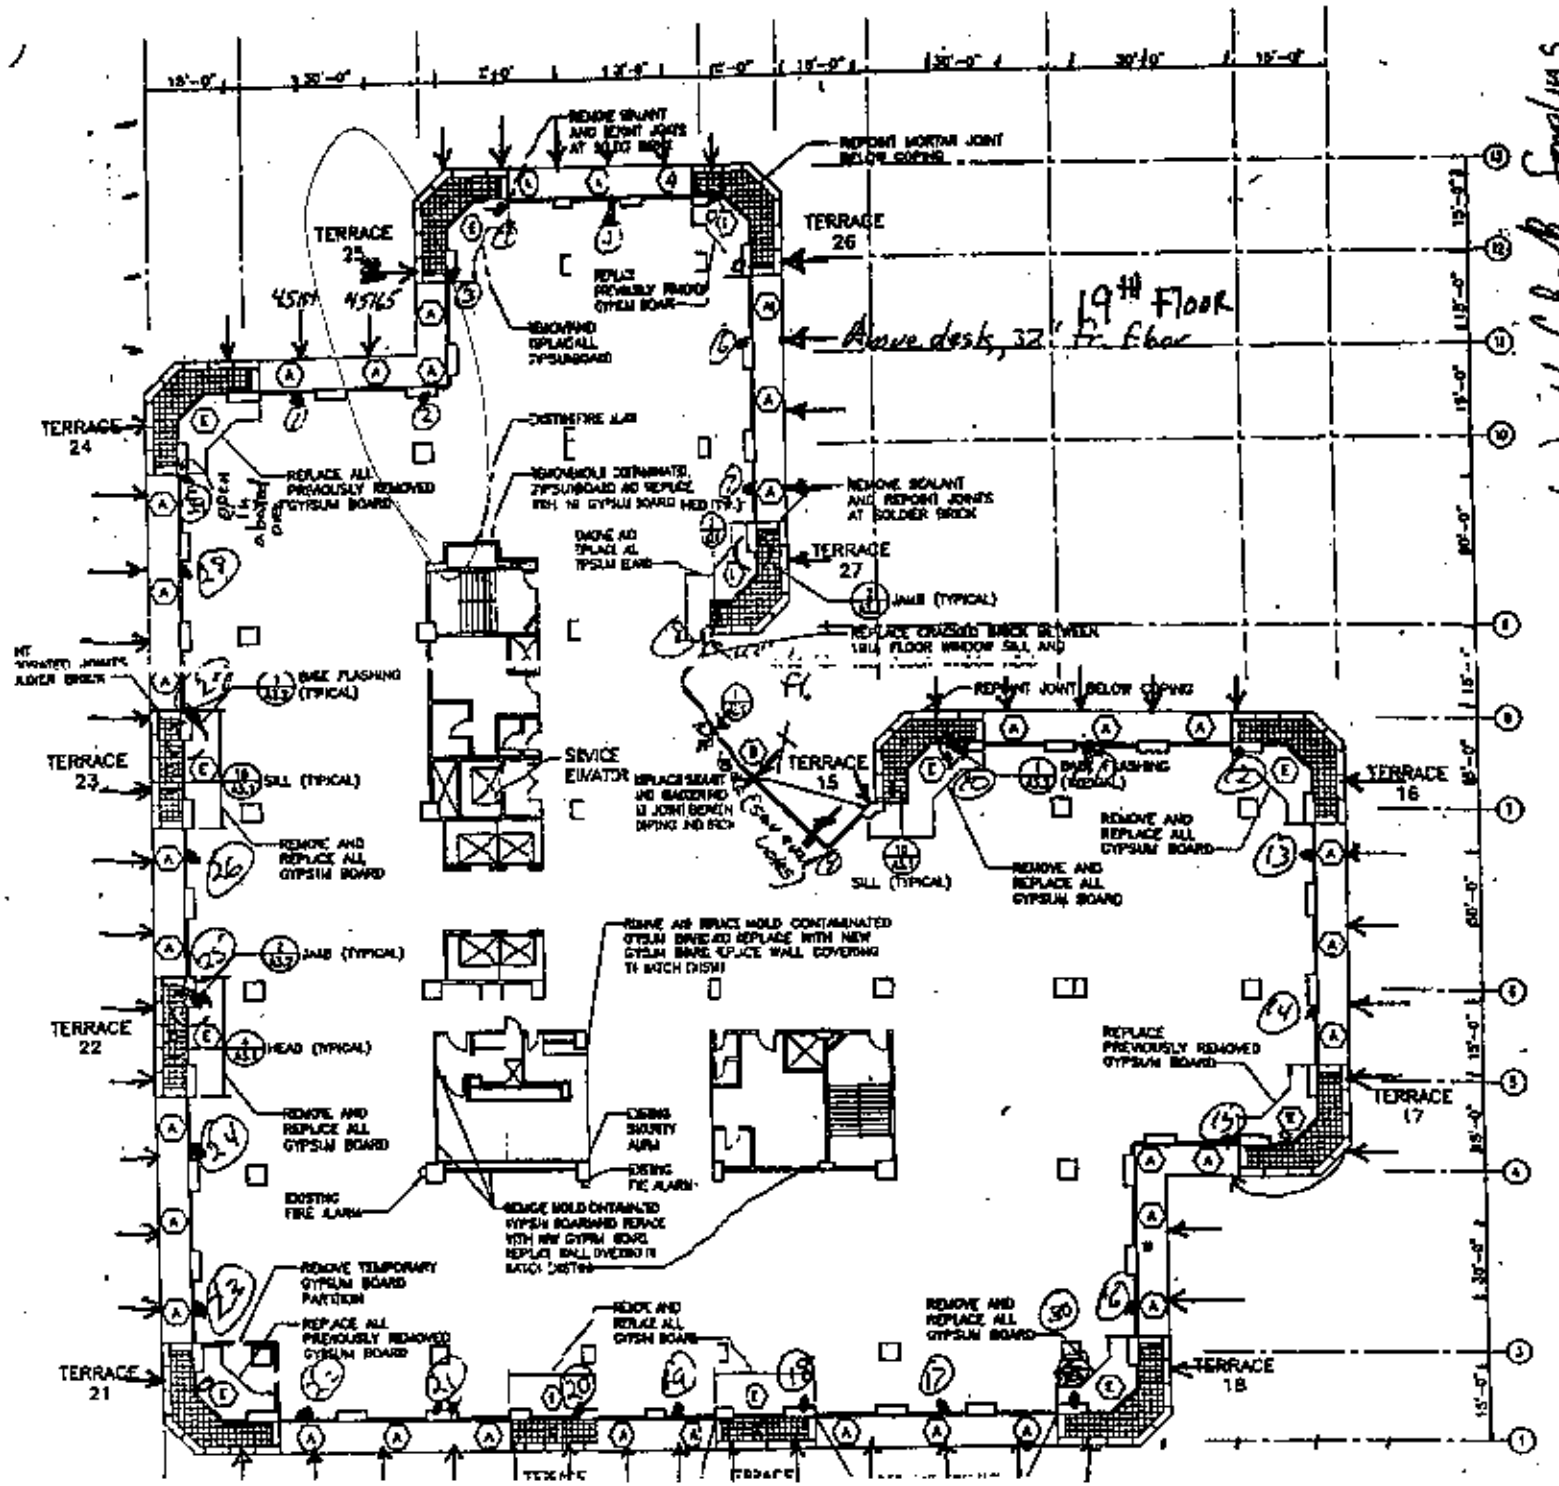
TERRACE 25
TERRACE 26
TERRACE 24
TERRACE 27
TERRACE 23
TERRACE 15
TERRACE 16
TERRACE 22
TERRACE 17
TERRACE 21
TERRACE 18
REPOINT MORTAR JOINT BELOW COPING
REMOVE SEALANT AND REPOINT JOINTS AT SOLDIER BRICK
REPLACE PREVIOUSLY REMOVED GYPSUM BOARD
REMOVE AND REPLACE ALL GYPSUM BOARD
JAMB (TYPICAL)
SILL (TYPICAL)
HEAD (TYPICAL)
BASE FLASHING (TYPICAL)
SERVICE ELEVATOR
EXISTING FIRE ALARM
EXISTING SECURITY ALARM
REMOVE TEMPORARY GYPSUM BOARD PARTITION
19th Floor
Above desk, 32" Fr. Floor
Wall Check Sampling
Master
19th Floor

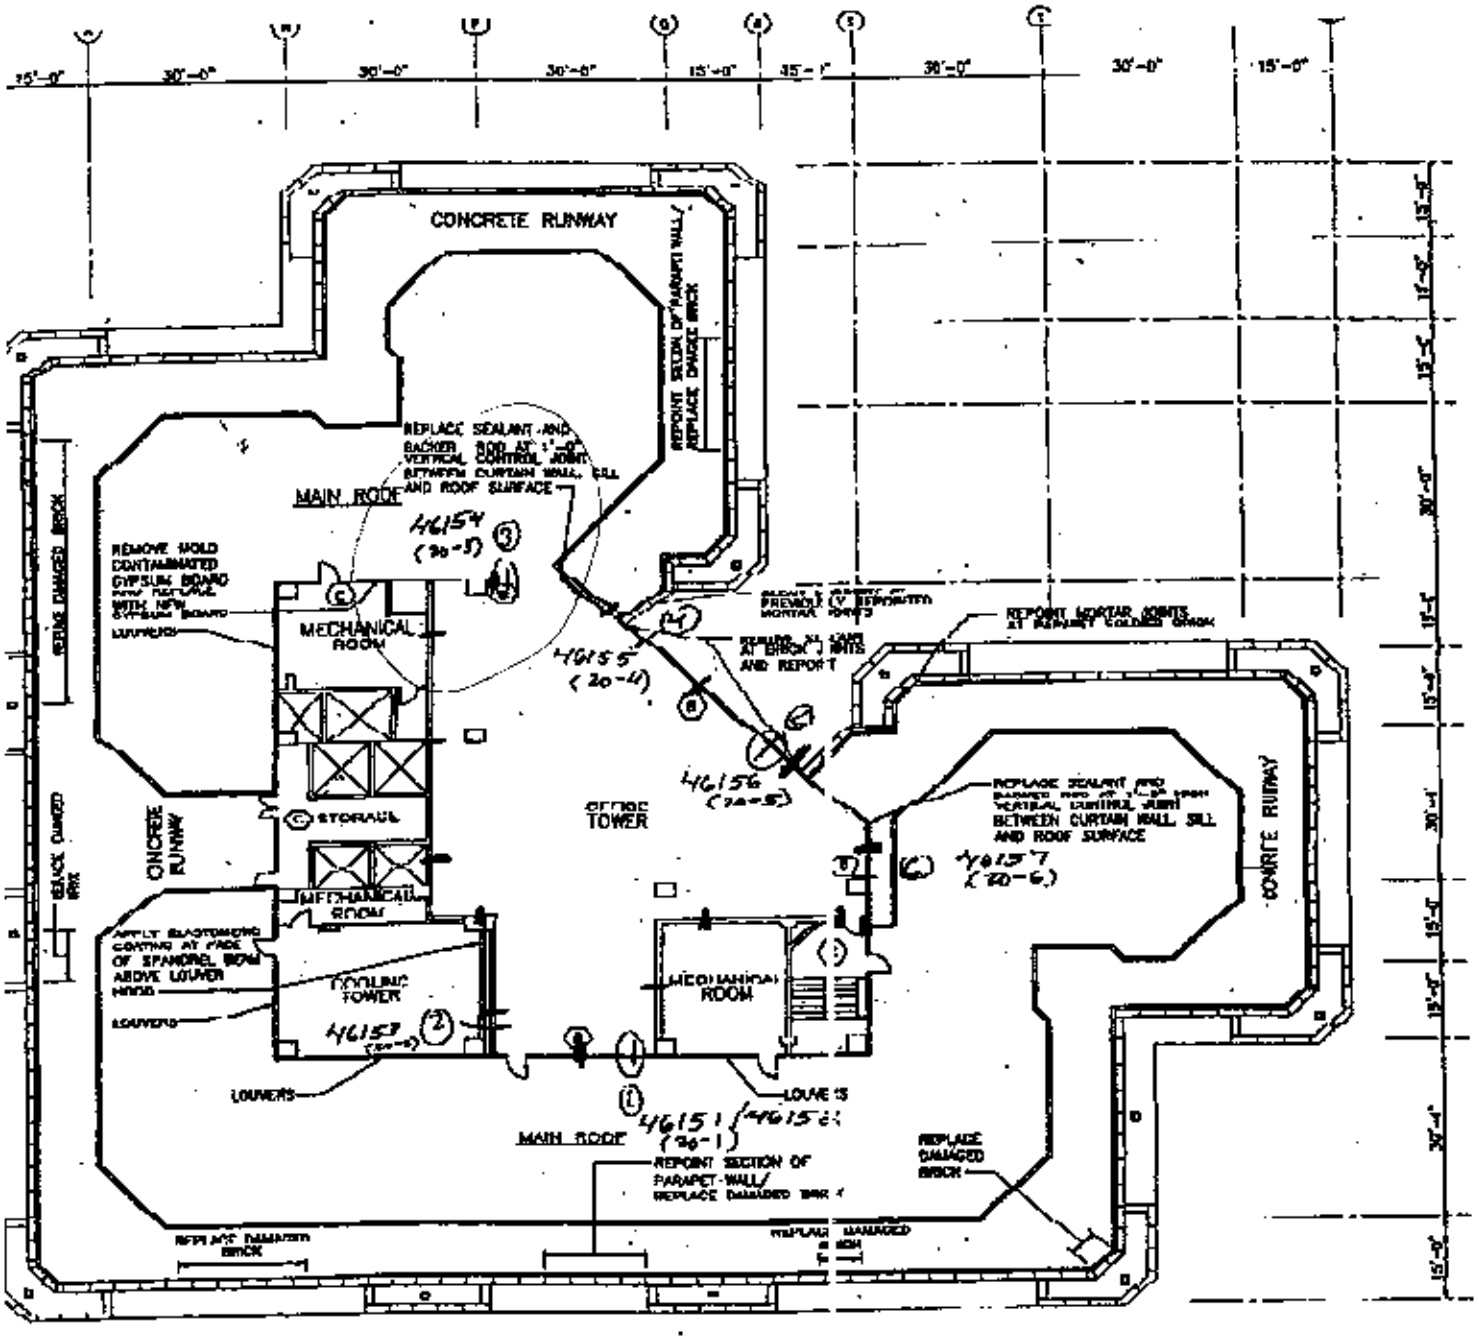
20th Floor

Sample ID	Location	Total Concentration[1] (spores/m^3)	Species Type and Concentration (spores/m^3)
46151	20-1	<23	
46152	20-1 Dup	533	Basidiospores[2] 511 Other brown 22
46153	20-2	22	Other brown 22
46154	20-3	178	*Stachybotrys chartarum (atra)* 156 Other brown 22
46155	20-4	22	Other brown 22
46156	20-5	<23	
46157	20-6	200	*Cladosporium* 89 *Penicillium/Aspergillus* types[3] 89 Smuts, *Periconia*, Myxomycetes[2] 22
