Lessons Learned
Catenary Work Items

NEW HAVEN MAIN LINE

CATENARY REPLACEMENT BETWEEN STRUCTURES 236 AND 356A
CATENARY SYSTEM INTERIM CONTACT WIRE LOWERING

Metro-North Railroad Bridges in Greenwich, CT
CDOT Project Nos. 56-248, 301-0042/0044

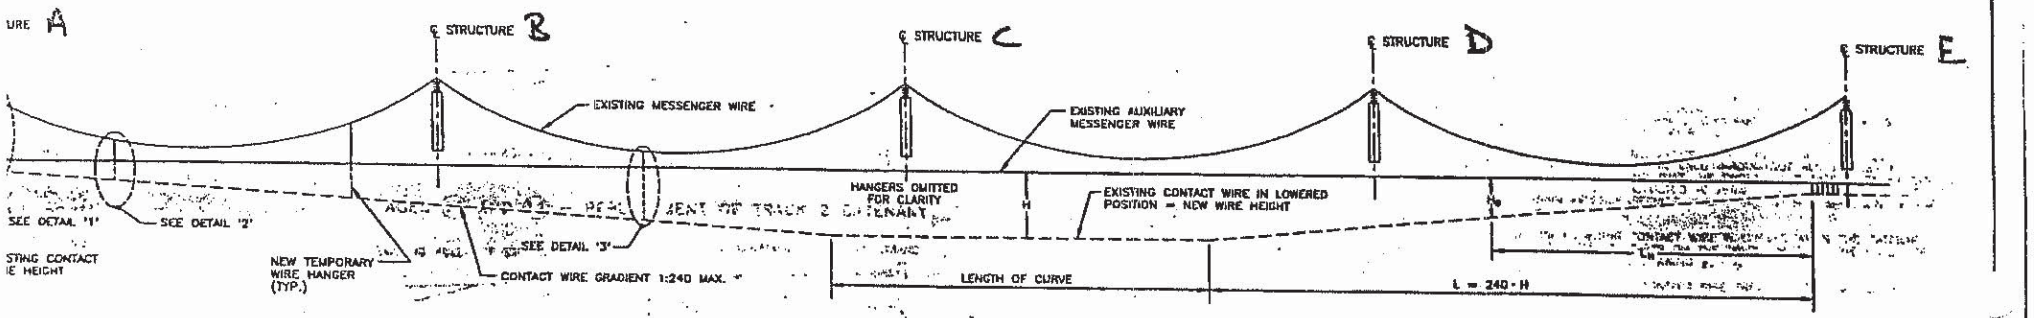
SKETCH #1 (TO UNDERSTAND LINEAR FOOT BUST)

3.) TEMPORARY CONDITIONS: Lowering of Existing Catenary – There was an apparent conflict between the Engineer's linear foot quantity estimate and actual distance required to achieve the specified contact wire temporary transition gradient. The Project did not have the Engineer's estimate back-up available to it, but does recommend that a careful review be made between the pay limit wording in the Special Provisions verses the specified temporary contact wire gradient given (see attachment "A", sketch #1). The addition of Change Order Item #O6B0001 may have been avoided, at least in part, had this been addressed prior to bid. It is also recommended that the Engineer eliminate the conflict regarding the temporary gradient given on page 196 of the Special Provisions, which differs from that given on Drawing L-15, which also differs from the value in Note 11 on Drawing G-8. In an effort to reduce cost, the Project used the less stringent gradient to lessen the linear feet lowered as much as possible.

NOTE: HAD THE FIELD CONDITION LOOKED LIKE BELOW, WE WOULD HAVE PAID FROM STRUCTURE B TO STRUCTURE D. (ACCORDING TO PAY ITEM LANGUAGE)

BUT, IN REALITY WE WENT PAST STRUCTURES A & E

THEREFORE WE HAD TO PAY FROM A TO E

IN ACCORDANCE WITH PAY ITEM LANGUAGE.

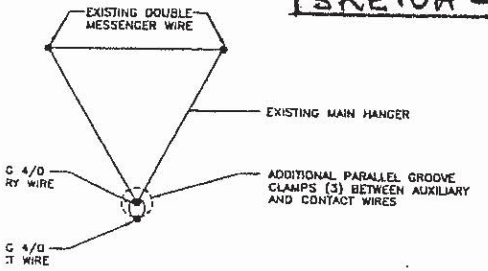
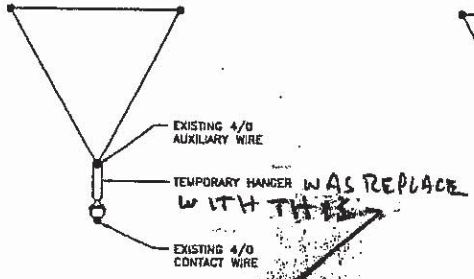
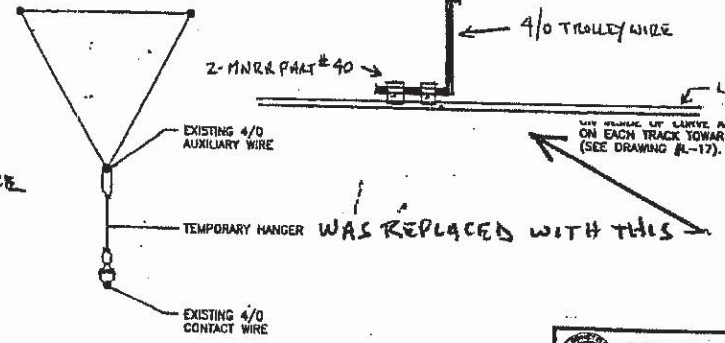
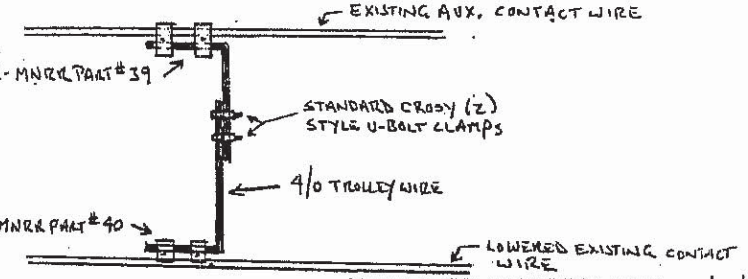
SKETCH #2 TO UNDERSTAND TEMP. HANGERS

2.) TEMPORARY CONDITIONS: Lowering of Existing Catenary – MNRR did not approve the type of temporary hangers that were shown on Drawing L-15 when submitted by the Contractor. Their argument was that since the existing contact wire was fastened in a rigid manner to the messenger wire(s), MNRR desired that the temporary condition be capable of providing that same level of rigidity. As a result, MNRR accepted a proposal by the Contractor to fabricate hangers from two pieces of trolley (contact) wire. Standard MNRR parts were used to attach them to the existing catenary and common Crosby style u-bolts were used to join the two pieces together. This enabled the hanger length to be adjusted in the field (see attachment "A", sketch #2). This method worked well and pleased the Railroad. However, had the Engineer previously been made aware of the Railroad's dissatisfaction with the hangers shown on Drawing L-15, the Change Order Item #O6A0002 would have been avoided.

WAS REPLACE WITH THIS

WAS REPLACED WITH THIS

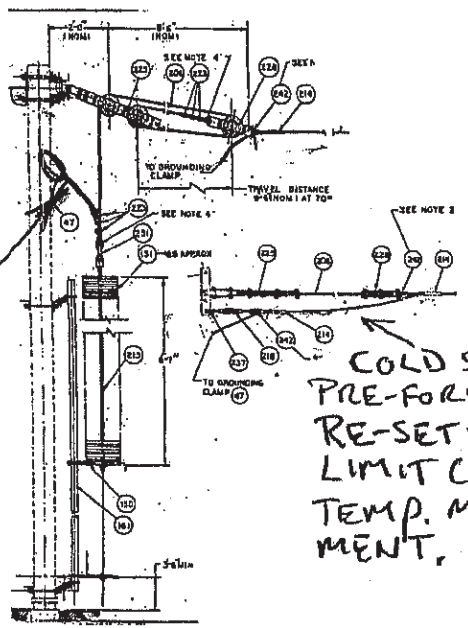
ATTACHMENT "C"

5.) TEMPORARY CONDITIONS: Temporary Cross-overs – One of the most difficult aspects of the Project was making the new Auto-Tension (A.T.) catenary function properly next to the existing Fixed-Tension (F.T.) catenary. This is most difficult at the interlock cross-over tracks, where a F.T. cross-over wire turns out from a A.T. mainline track. The A.T. wire height remains constant, but the F.T. wire height rises and falls with temperature. Tolerances are tight in these "turn-out" areas. In response to this matter, the Project devised a system to prevent the inherent problems of combining the two wire types. By modifying a MNRR deep knuckle assembly with extra hangers going from one wire run to the other, combined with movement restrictions placed at the A.T. wire balance weight, the problem was solved (see attachment "C"). Utilizing this method offered the advantages of A.T. catenary while minimizing the risks associated with sagging and hogging (rising) of the existing F.T. system. It is recommended that this procedure be passed on for use in future projects.

ANOTHER S.S. ROPE WAS USED TO RESIST RISING OF THE FIXED-TENSION MESSENGER

TEMP. 3/8" STAINLESS WIRE ROPE TO AID IN PREVENTING SAGGING OF X-OVER WIRE

NOTE: CROSS-OVER WIRE ALSO SUPPORTED FROM CLOSEST STRUCTURE, EVEN IF NEW DESIGN DOES NOT CALL FOR THAT (LIMIT SPAN LENGTH)

SLACK EXTENDED AND FASTENED TO POLE BY LOOPING AROUND LACING TO LIMIT HOT TEMP. MOVEMENT

COLD STOP PRE-FORM RE-SET TO LIMIT COLD TEMP. MOVEMENT.

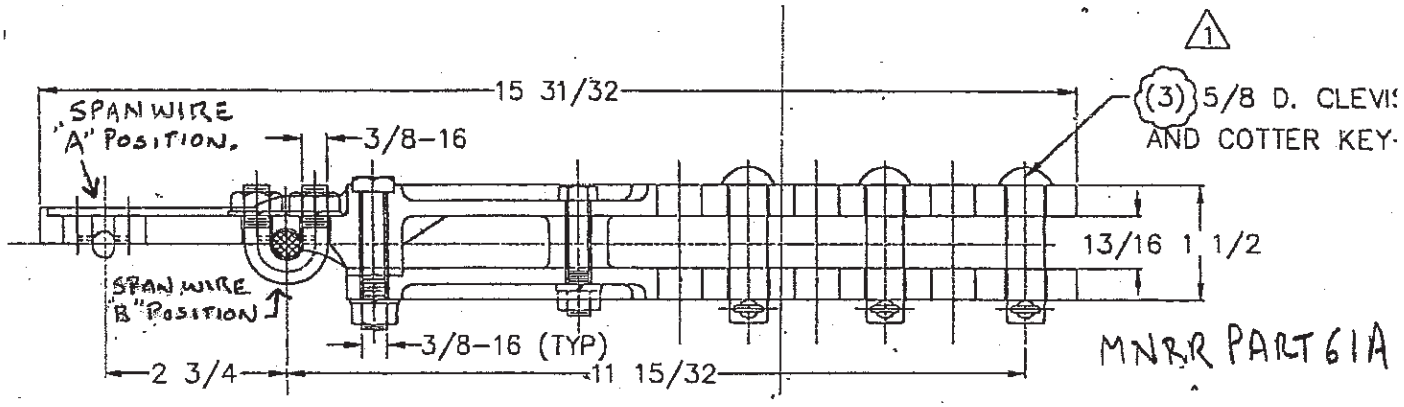
ATTACHMENT "D"

PO-1's & PO-2's as shown on Drawing E-4 can generally accommodate system depths between 18 and 23 inches. This is primarily due to the fact that the PO-6, 9 & 10 shown on Drawing E-7 can accommodate an additional 3 inches of system depth than indicated on the drawing. This just naturally increases the system depth the PO-1 & 2 can handle.

Below are examples of why the pull-off's can be used for larger system depths than the MNRR standards show. Luckily for the Project, many pull-off installation allocations were not in line with the standard, enabling the Project to not have to justify them being installed in a manner that did not conform with the E-4 & 7 drawings.

These are examples of Pull-off's whose installation allocations did not conform with the E-4 and E-7 drawings, but were fine in the field. [EXCEPT 246X, TK4).

The following could guide the possible revision of drawings E-4 & 7
PO-6: (9" to 12")
PO-9: (12" to 18")
PO-10: (9" to 18")
PO-1 & PO-2: (18" to 23")
PO-3, 4 & 12: (24" and greater)

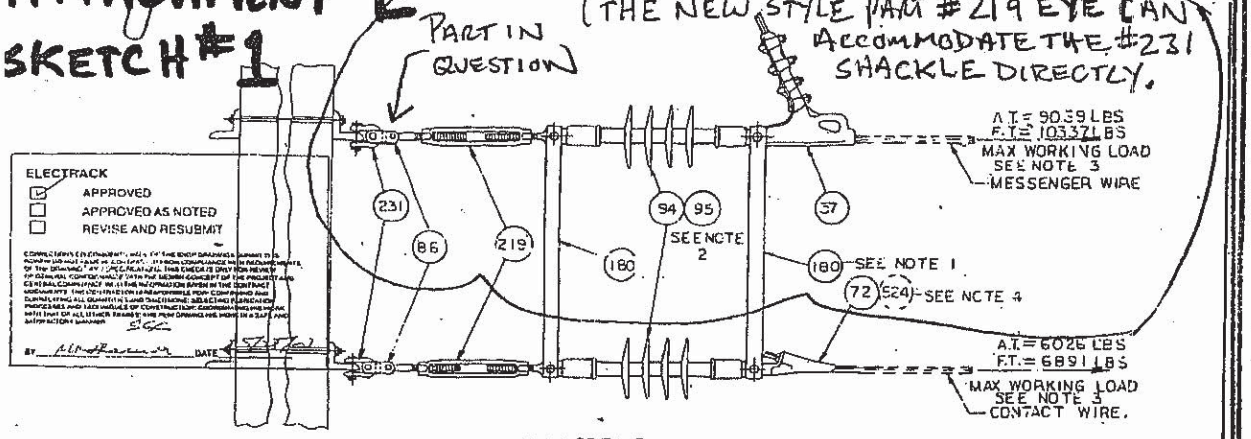
ATTACHMENT "E"
SKETCH #1

27.) INSTALLATION OF NEW CATENARY WIRE: Assembly Shop Drawing – The CDEA-5 assemblies had an improperly documented change that appeared to be generated by the manufacturer. This caused enough confusion with the MNRR catenary inspectors to note it here. The Project recommends that this drawing conflict be corrected. A different style turnbuckle was introduced by the Dossert Co., and that style appeared to eliminate the need for another component (Part #86) that was allocated to be in the assembly. However, the changed assembly shop drawing was never re-issued to the Project. Attachment "E", sketch #1 is given to better illustrate the recommendation.

(THE NEW STYLE PART #219 EYE CAN ACCOMMODATE THE #231 SHACKLE DIRECTLY.

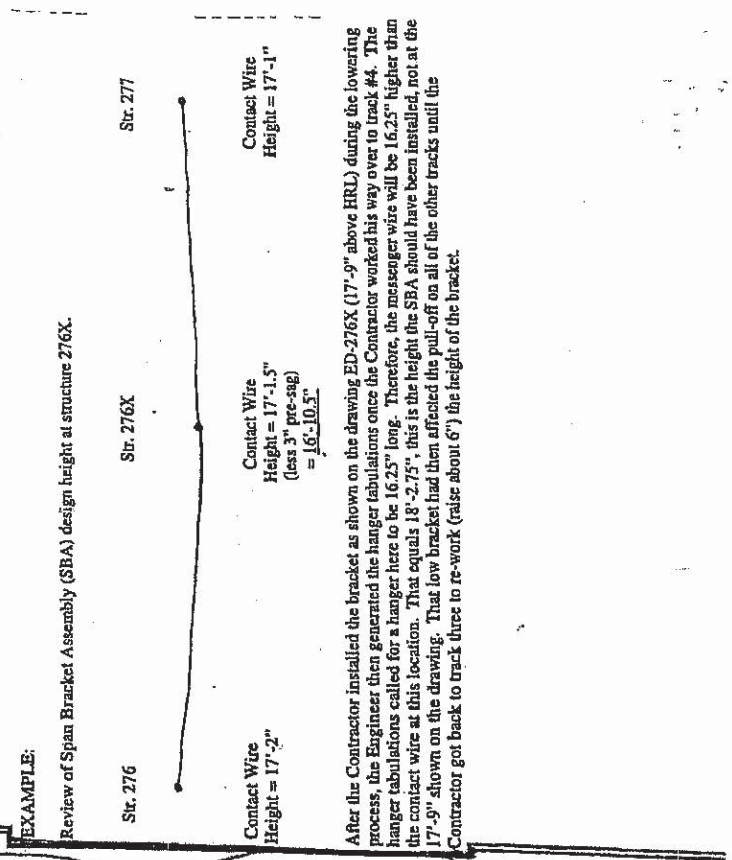
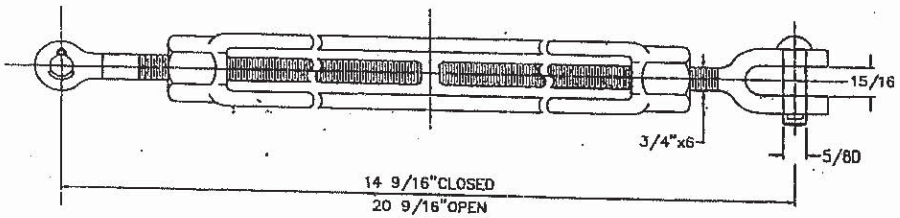
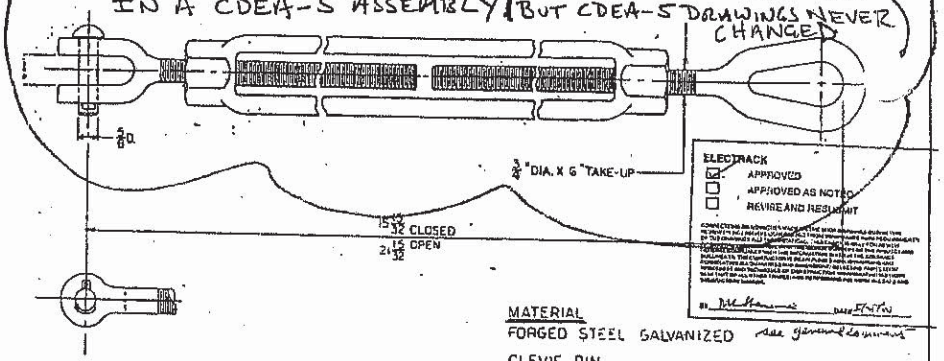
SKETCH #2

THIS WAS THE ORIGINAL PART #219, IN WHICH A PART #86 WAS REQ'D WHEN USED IN A CDEA-5

WHEN DOSSERT INTRODUCED THIS STYLE PART #219 DUCCI BEGAN TO ELIMINATE ~~THE~~ PART #86 IN A CDEA-5 ASSEMBLY (BUT CDEA-5 DRAWINGS NEVER CHANGED)
