**Docket No. 217 – Development and Management Plan Inspection**

Northeast Utilities Service Company Certificate of Environmental Compatibility and Public Need for the construction of a 345-kV electric transmission line and reconstruction of an existing 115-kV electric transmission line between Connecticut Light and Power Company’s Plumtree Substation in Bethel, through the towns of Redding, Weston, and Wilton, and to the Norwalk Substation in Norwalk, Connecticut.

**Date:** October 5, 2005

**Location:** 345kV Underground Route

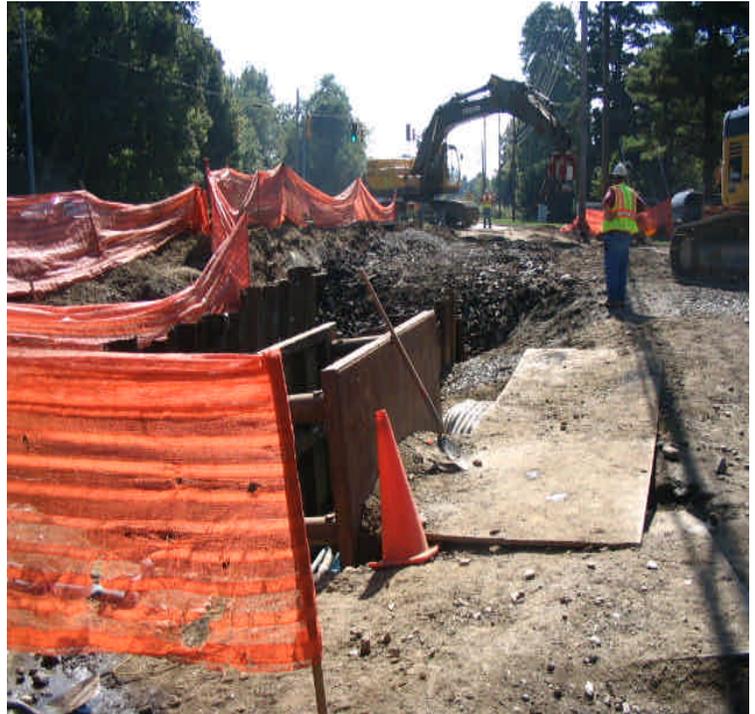
**Photo on the left shows the backfill pile at the Wilton HS jack and bore with silt fence well installed. Photo on the right shows the receiving pit side of the work. (10/5/05)**

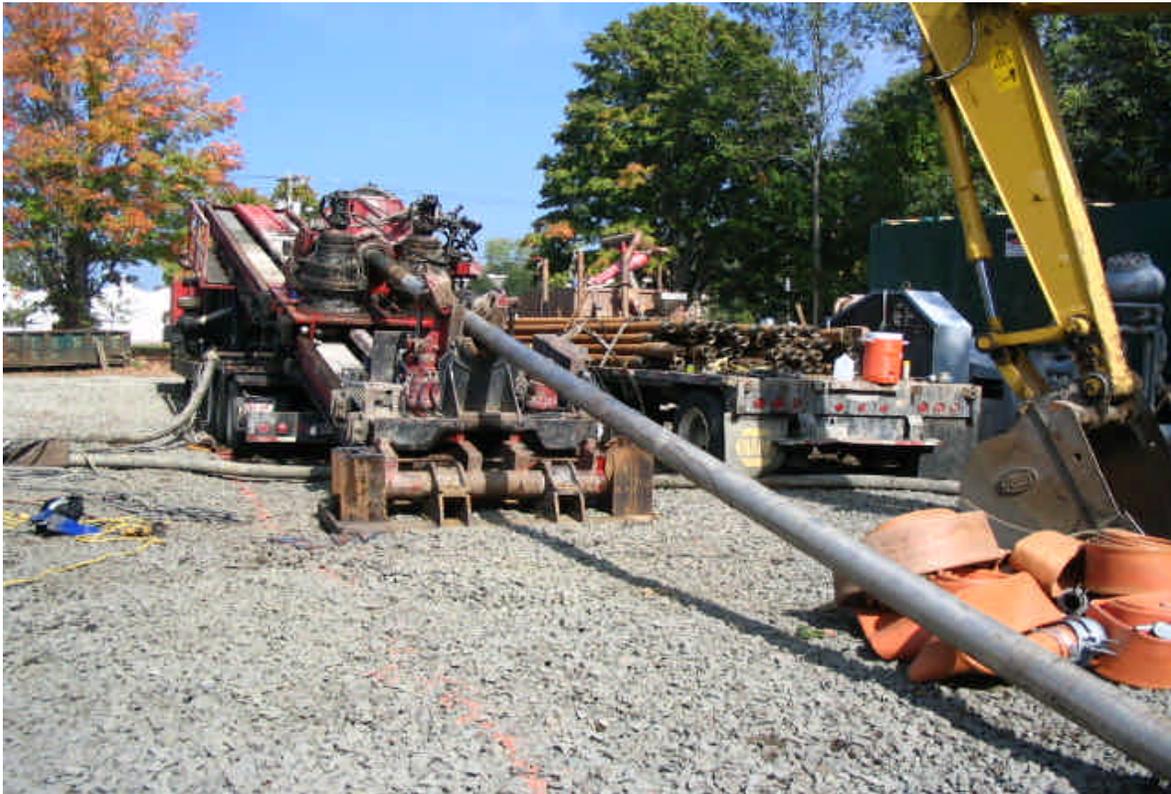
345kV Horizontal Directional Drill: Equipment is in place at School Rd. to begin the HDD under the Norwalk River. (10/5/05)

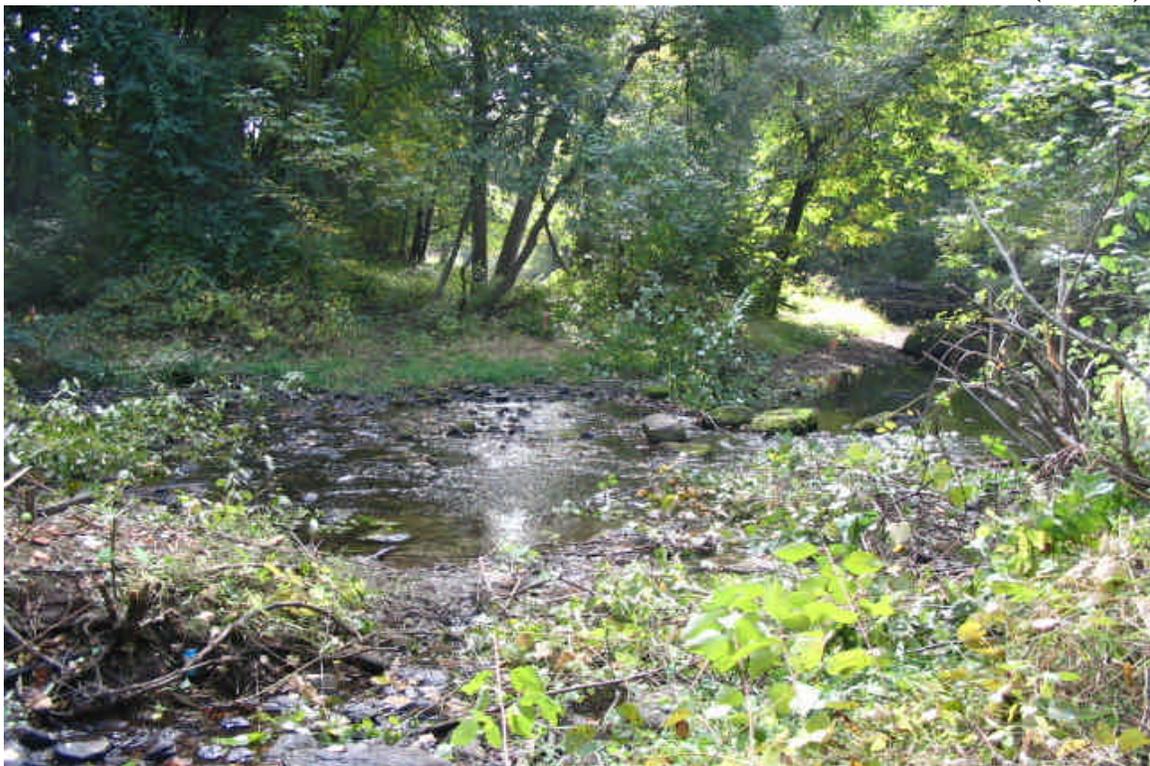
View of the Norwalk River in the vicinity of the HDD. The river meanders several times within the drill section. (10/5/05)
