Docket No. 217 – Development and Management Plan Inspection

Northeast Utilities Service Company Certificate of Environmental Compatibility and Public Need for the construction of a 345-kV electric transmission line and reconstruction of an existing 115-kV electric transmission line between Connecticut Light and Power Company’s Plumtree Substation in Bethel, through the towns of Redding, Weston, and Wilton, and to the Norwalk Substation in Norwalk, Connecticut.

Date: December 14, 2005

Location: 345kV Underground Route

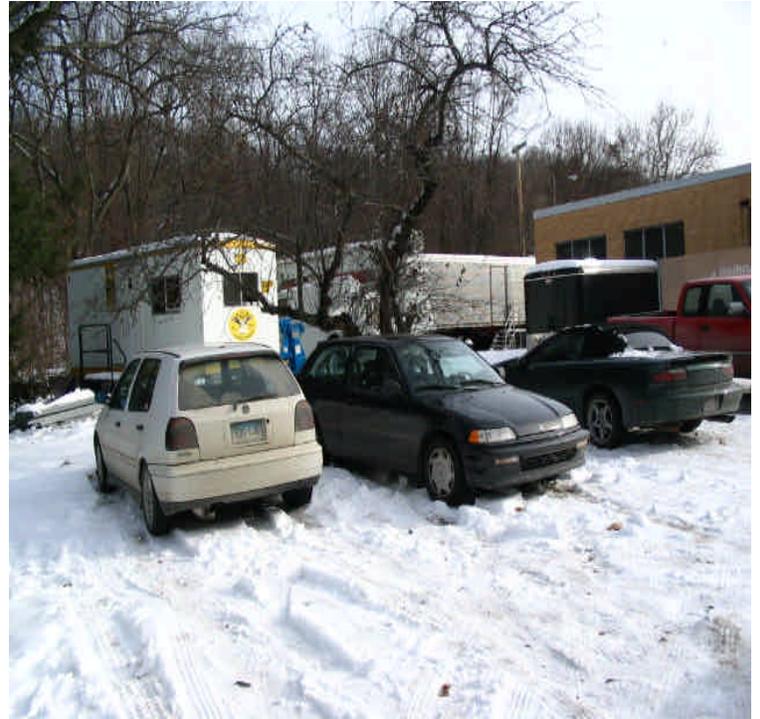
345kV (Rt 7 CL&P yard): Photo on the left shows an area where the silt fence around the stockpile is sagging. The fence should continue to be maintained . Vehicles and trailers are using the yard.
12/14/05
