Docket No. 217 – Development and Management Plan Inspection

Northeast Utilities Service Company Certificate of Environmental Compatibility and Public Need for the construction of a 345-kV electric transmission line and reconstruction of an existing 115-kV electric transmission line between Connecticut Light and Power Company's Plumtree Substation in Bethel, through the towns of Redding, Weston, and Wilton, and to the Norwalk Substation in Norwalk, Connecticut.

Date: May 10, 2006

Location: Overhead Line (Composite 345kV and 115kV Gallows Hill to Archers Lane,
345kV H-Frame Hoyts Hill to Gallows Hill, and Norwalk Section)

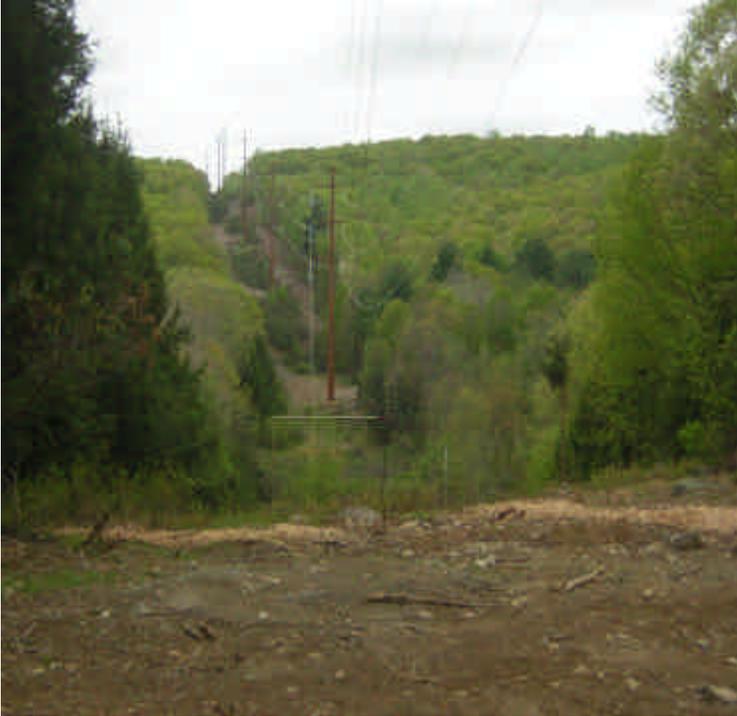
Photo on the left shows a view of the looking along the ROW towards Rt 53. **(H-Frame):** Photo on the right shows the wetland crossing south of structure #11 in the Bethel Res. Section in good shape. 5/10/06.

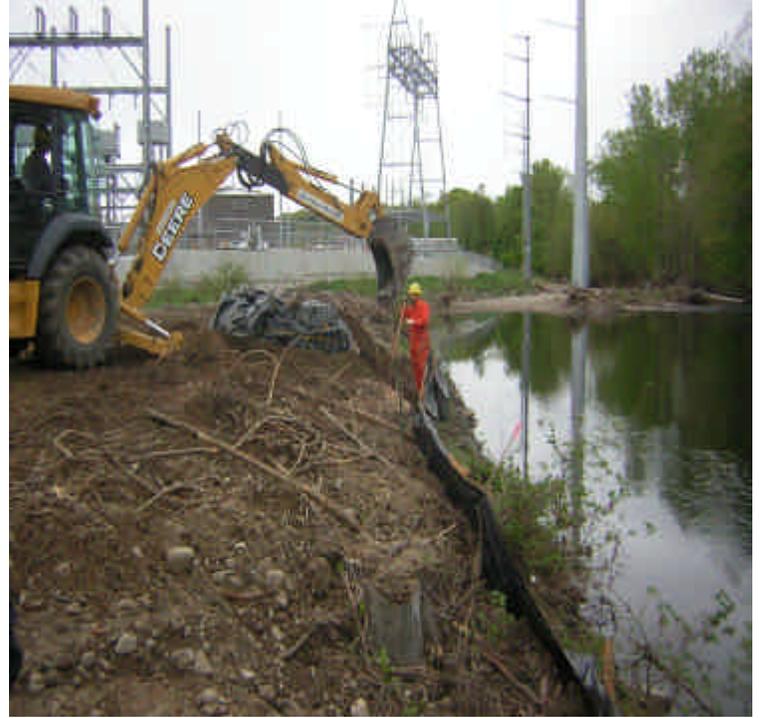
Photo on the left shows a view of the ROW in the area of Costa Lane. Silt fence on the side slope here should be monitored although wetlands are not immediately adjacent. (Norwalk Section)
Photo on the right shows the work area adjacent to the substation. 5/10/06.

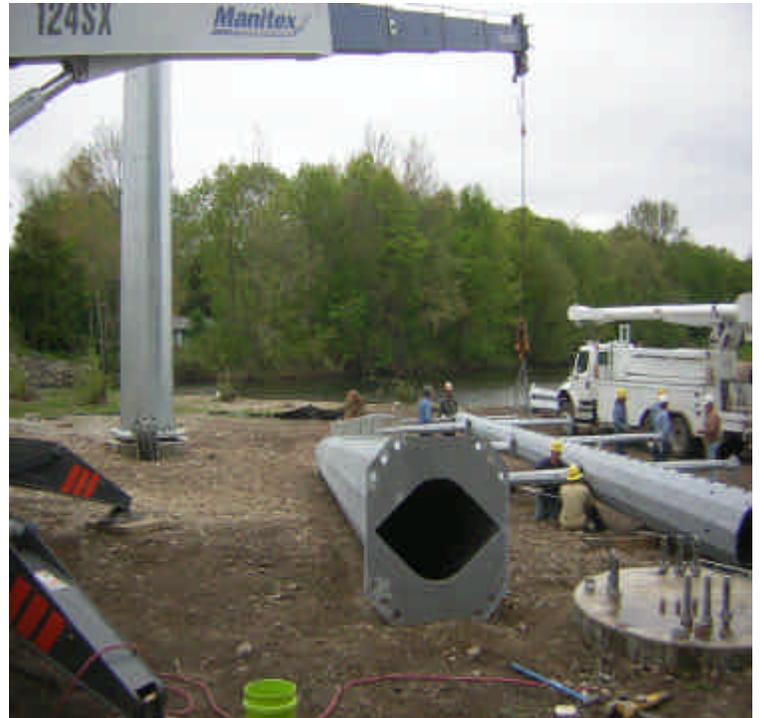
(Norwalk Section) Photo on the left shows an area of silt fence to clean up and a potential problem spot to continue monitoring. Additional controls should be considered here due to the proximity of the river. Photo on the right shows work north of Broad St. 5/10/06.

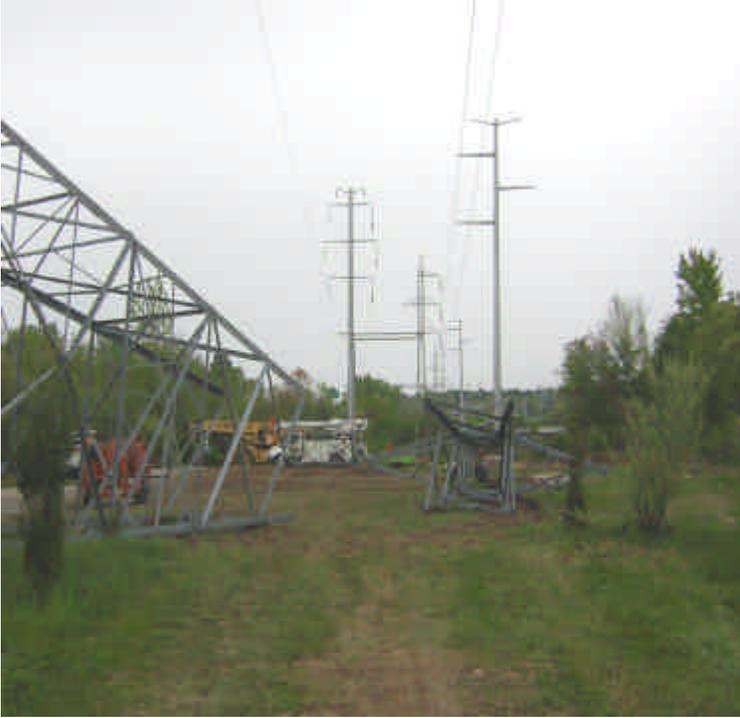
Perry Ave: Photo on the left shows structures being removed along the ROW to the south of Perry Ave. Photo on the right shows a work area adjacent to the recently flooded wetland channel. 5/10/06

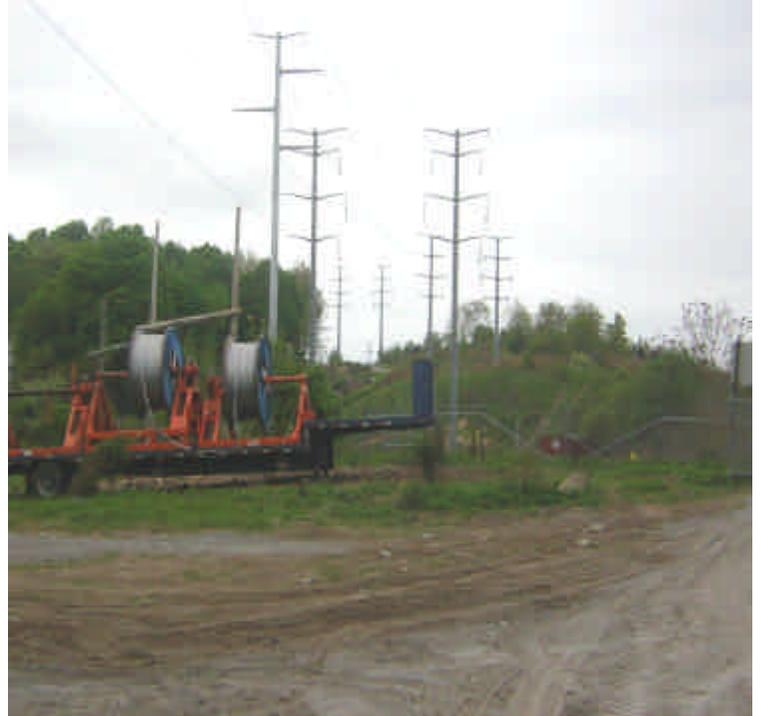
Photo on the left shows where soil was placed over the silt fence in a tight workspace in this area. The pile was being pulled back after the inspection. Fence should be repaired if necessary. Photo on the right shows the ROW to the north of Perry with spools set up. 5/10/06
