Docket No. 217 – Development and Management Plan Inspection

Northeast Utilities Service Company Certificate of Environmental Compatibility and Public Need for the construction of a 345-kV electric transmission line and reconstruction of an existing 115-kV electric transmission line between Connecticut Light and Power Company's Plumtree Substation in Bethel, through the towns of Redding, Weston, and Wilton, and to the Norwalk Substation in Norwalk, Connecticut.

Date: July 26, 2006

Location: Overhead Line (Composite 345kV and 115kV Gallows Hill to Archers Lane, 345kV H-Frame Hoyts Hill to Gallows Hill, and Norwalk Section)

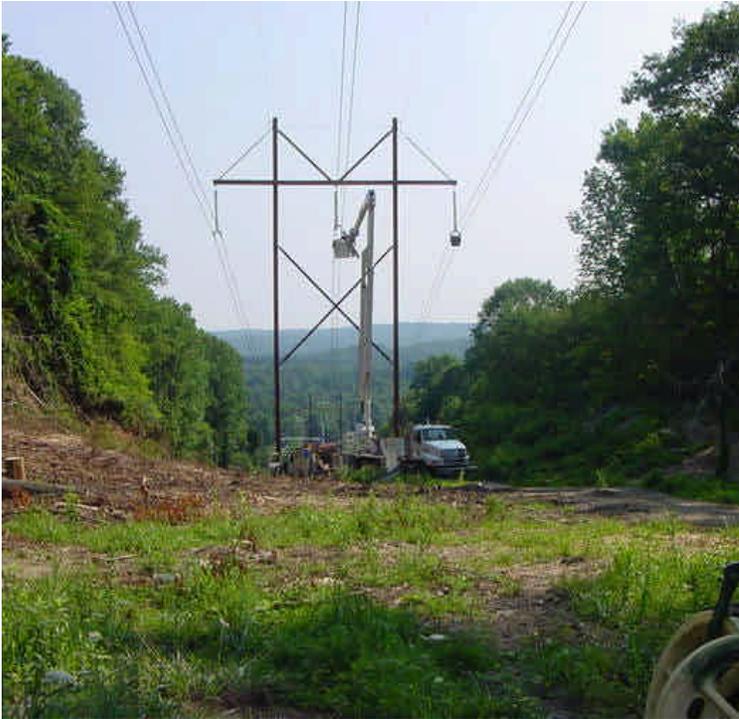
(345kV H-Frame): Photo on the left shows some danger trees marked out for clearing along this section. Photo on the right shows a view of the wetland between structures #10 and 11. Vegetation is returning where the mats had been but haybales could still be installed across the road. 7/26/06.

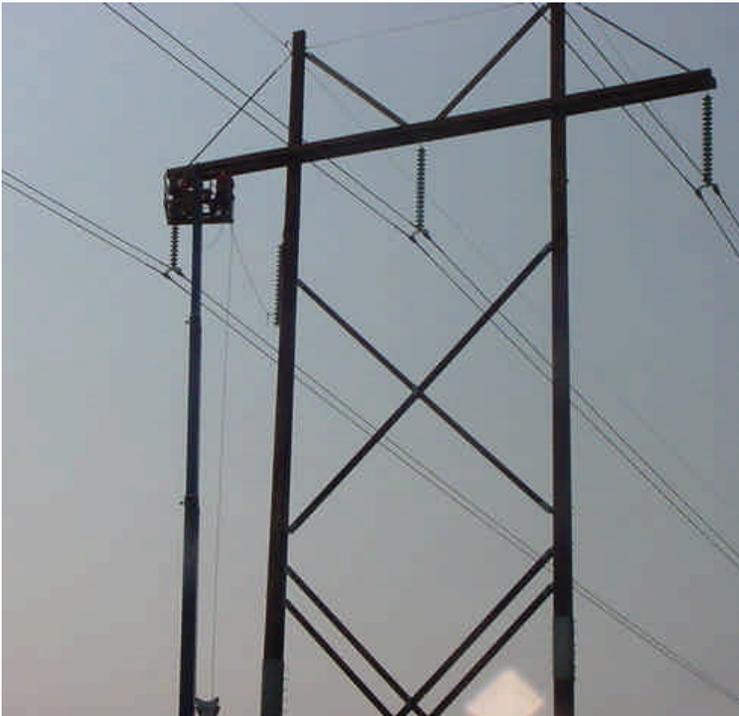
Photo on the left shows crews clipping in wire near structure #2. Photo on the right shows where some repairs were made to erosion in the access road. Wood chips were added. 7/26/06

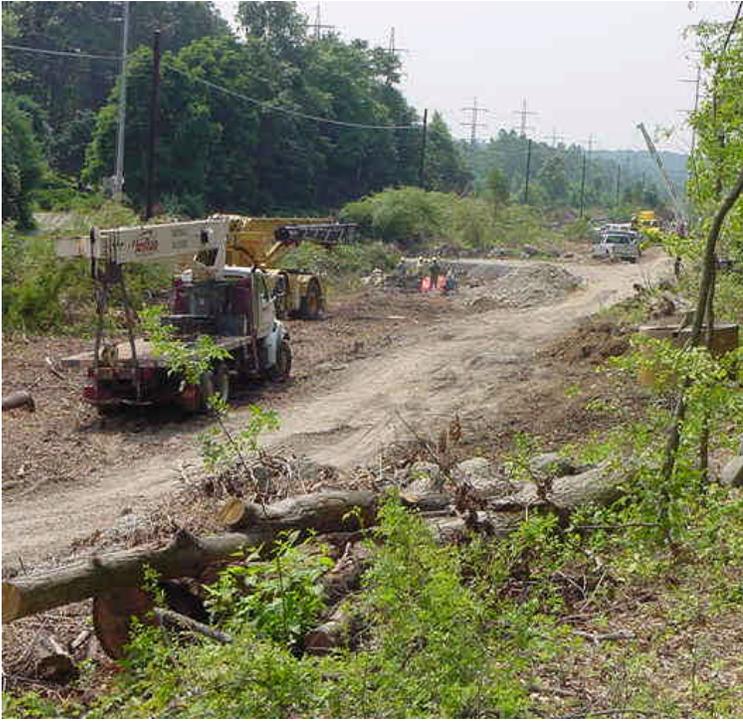
Photo on the left shows crews clipping in wire at structure #24 off John Todd Way. Photo on the right shows a view of the widened road resulting from the residential contractor's work. 7/26/06.

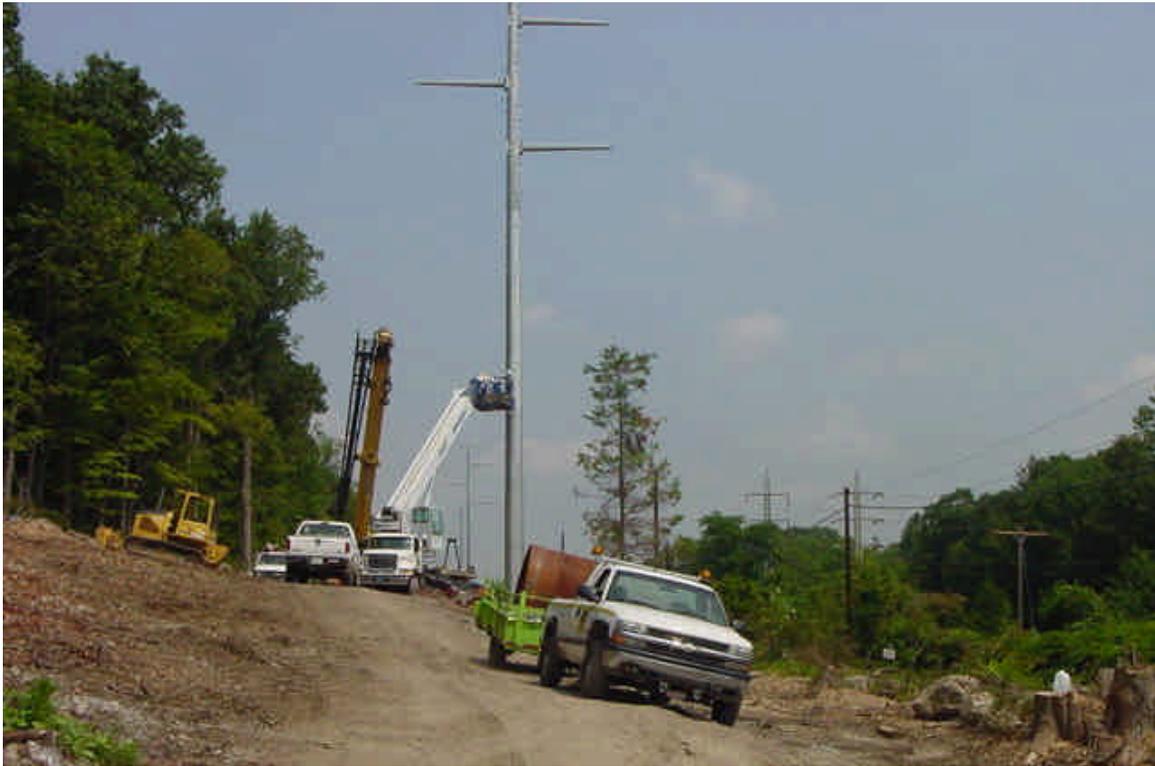
(Norwalk Section): Photo on the left shows work off Wilton Terrace, pouring foundations at structure #51. Photo on the right shows crews unloading steel near structure location #52. 7/26/06.

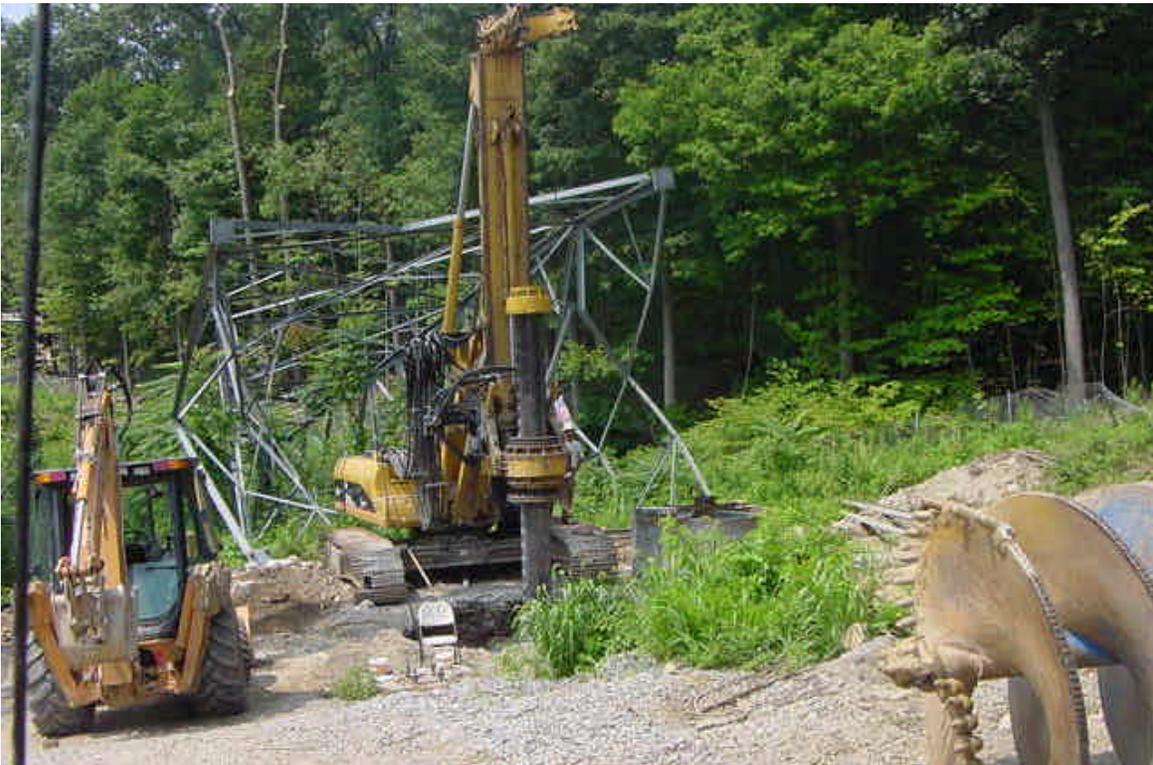
Photo shows drilling occurring at structure location #11063 off North Seir Hill Rd. 7/26/06
