Docket No. 217 – Development and Management Plan Inspection

Northeast Utilities Service Company Certificate of Environmental Compatibility and Public Need for the construction of a 345-kV electric transmission line and reconstruction of an existing 115-kV electric transmission line between Connecticut Light and Power Company's Plumtree Substation in Bethel, through the towns of Redding, Weston, and Wilton, and to the Norwalk Substation in Norwalk, Connecticut.

Date: August 22, 2006

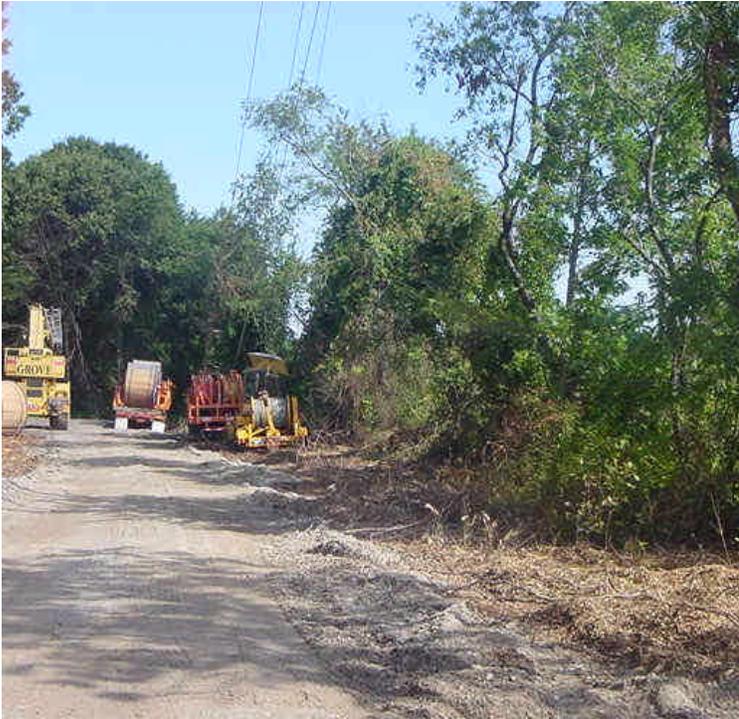
Photo on the left shows the area between structure #11030 and #11031 where Reese is storing equipment. Photo on the right shows repairs were made at the access drive near structure #11031 at Costa Lane. Erosion tends to be a problem here 8/22/06.

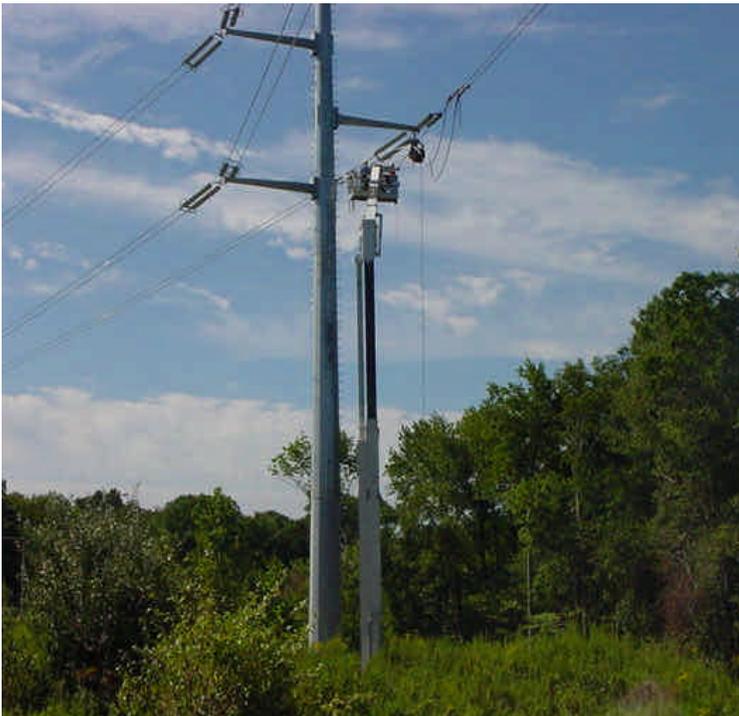
(Norwalk Section): The photo on the left shows a crew pulling wire at structure #11048. Photo on the right shows repairs were made to the silt fence at structure #11051. 8/22/06.
