**Docket No. 217 – Development and Management Plan Inspection**

Northeast Utilities Service Company Certificate of Environmental Compatibility and Public Need for the construction of a 345-kV electric transmission line and reconstruction of an existing 115-kV electric transmission line between Connecticut Light and Power Company's Plumtree Substation in Bethel, through the towns of Redding, Weston, and Wilton, and to the Norwalk Substation in Norwalk, Connecticut.

**Date:** March 23-24, 2006

**Location:** Transition Stations: Hoyts Hill, Archers Lane, Norwalk Junction

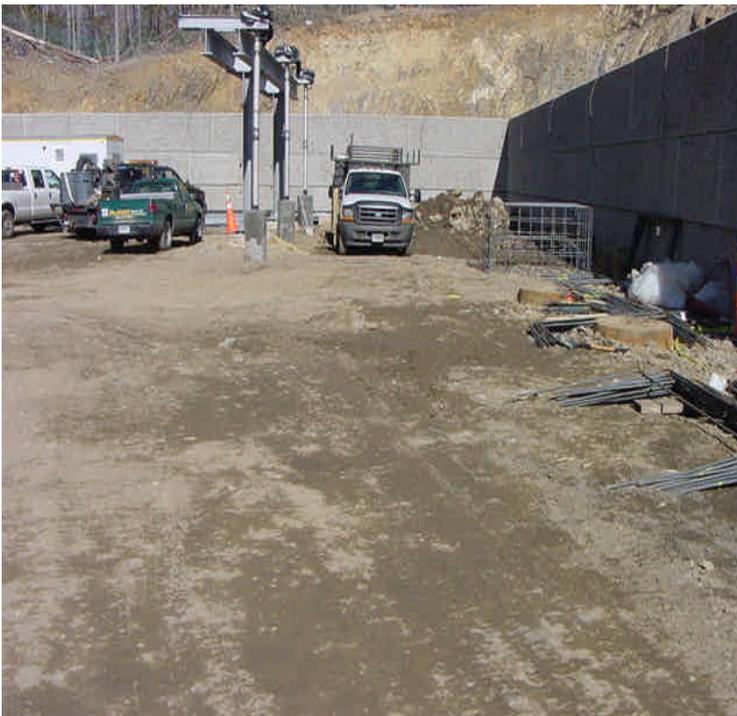
Photo on the left shows another view of the station pad. Photo on the right shows where accumulated sediment remains on the wetland side of the silt fence on the access drive to the ROW. Sediment will still need to be removed from a few areas here. 3/23/06
