Docket No. 217 – Development and Management Plan Inspection

Northeast Utilities Service Company Certificate of Environmental Compatibility and Public Need for the construction of a 345-kV electric transmission line and reconstruction of an existing 115-kV electric transmission line between Connecticut Light and Power Company's Plumtree Substation in Bethel, through the towns of Redding, Weston, and Wilton, and to the Norwalk Substation in Norwalk, Connecticut.

Date: June 14, 2006

Location: Transition Stations: Hoyts Hill, Archers Lane, Norwalk Junction

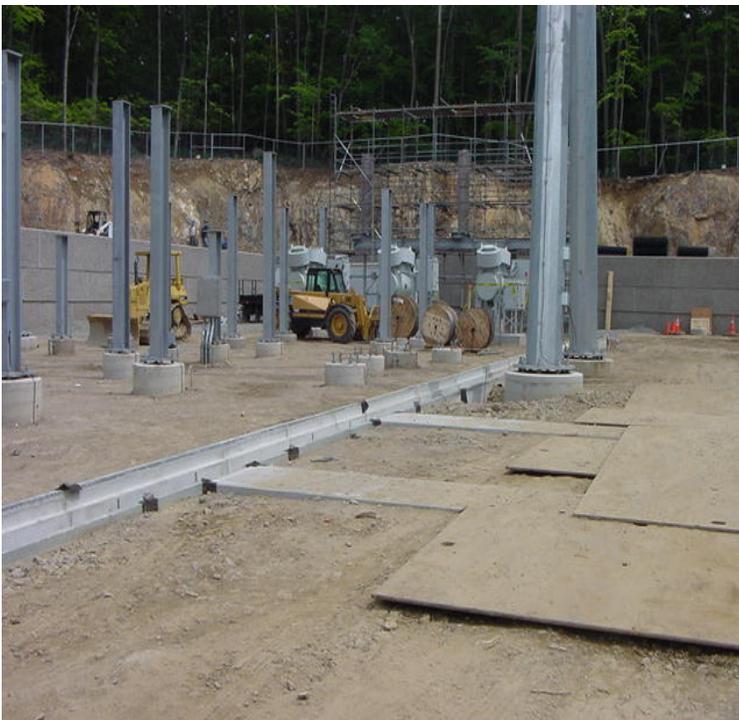
- A concrete washout was also noted at the top of slope. 6/14/06	-It is unclear which section of the project is responsible. 6/14/06	- Needs attention

Hoyts Hill Transition Station: Photo on the left shows where a concrete washout had occurred. Washout water ran down the slope in the outlet pad to the edge of the wetland. It is unclear which section of the project would be responsible for cleanup. Photo on the right shows work on the structures. 6/14/06

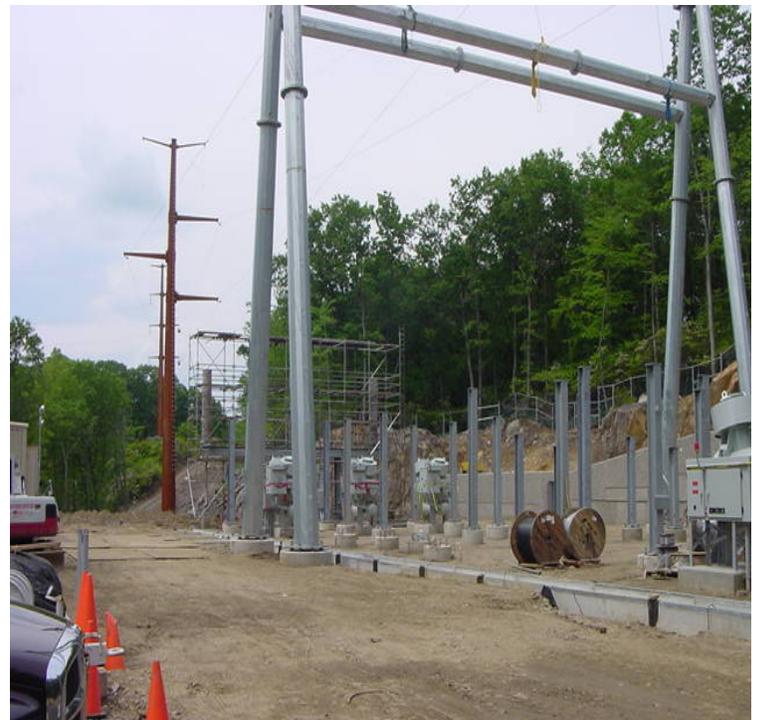
Archers Lane: Both photos show an overall view of the foundation and structure work occurring in the station yard. 6/14/06.

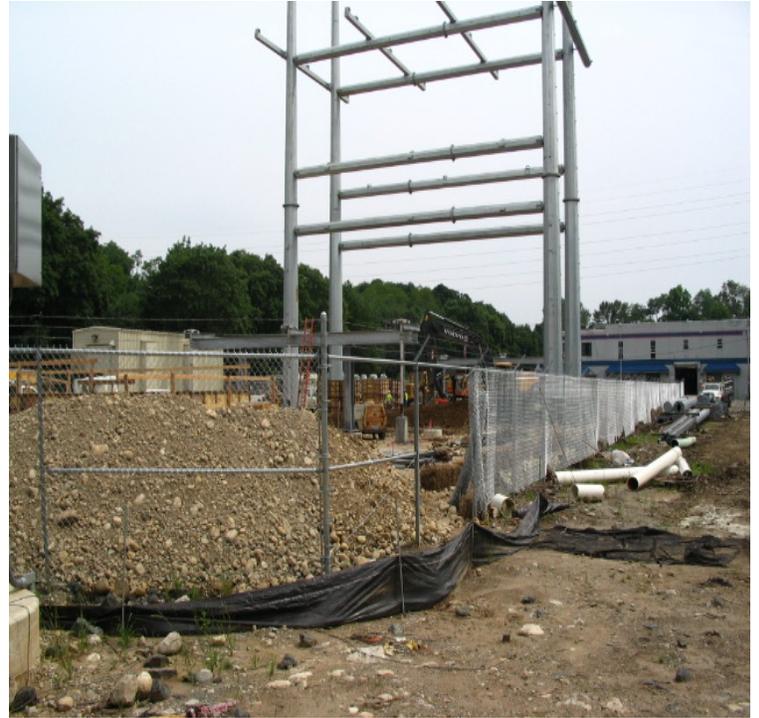
- Crews repaired silt fence along the access road and it is holding back turbid run-off from the wetland. 6/14/06	- Continue to monitor and repair as soon as necessary. 6/14/06	-Silt fence was repaired
	-Slopes remain disturbed along the access road where 345kV trenching occurred. 4/26-6/14/06	-The area should be restored after vault access and work here is complete. 5/4-6/14/06	- Needs attention when work is complete

Archers Lane: Photo on the left shows the repaired silt fence at the wetland crossing. Turbid water is being held back and filtered but this fence will have to continue to be monitored. (Norwalk Junction): Photo on the right shows an overview of the yard here. 6/14/06.
