Docket No. 217 – Development and Management Plan Inspection

Northeast Utilities Service Company Certificate of Environmental Compatibility and Public Need for the construction of a 345-kV electric transmission line and reconstruction of an existing 115-kV electric transmission line between Connecticut Light and Power Company's Plumtree Substation in Bethel, through the towns of Redding, Weston, and Wilton, and to the Norwalk Substation in Norwalk, Connecticut.

Date: July 12, 2006

Location: Transition Stations: Hoyts Hill, Archers Lane, Norwalk Junction

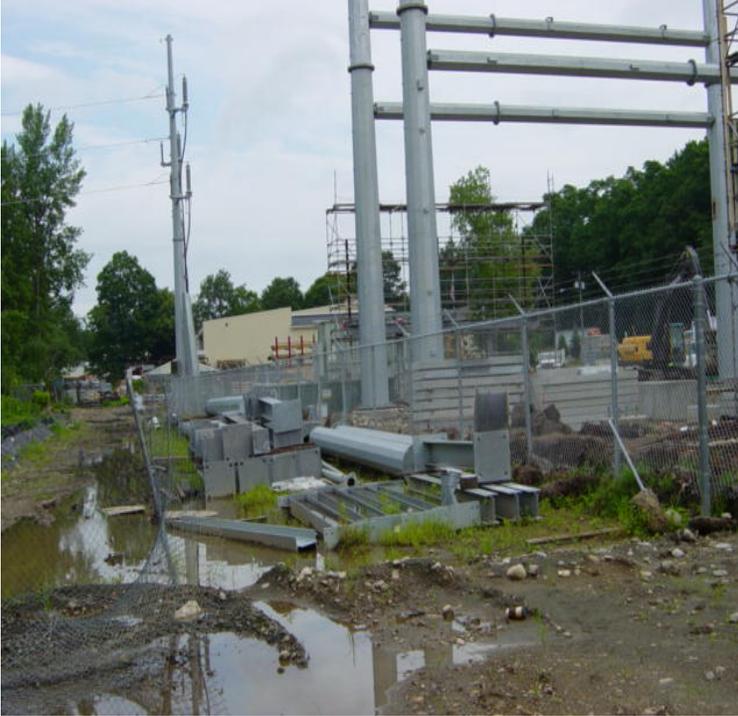
Norwalk Junction: Photo on the left shows an overview of the site work and scaffolding. Photo on the right shows the old haybale line along the fence. These could be replaced as an additional control but are not necessary if the silt fence along the river remains well maintained. 7/12/06.
