Docket No. 217 – Development and Management Plan Inspection

Northeast Utilities Service Company Certificate of Environmental Compatibility and Public Need for the construction of a 345-kV electric transmission line and reconstruction of an existing 115-kV electric transmission line between Connecticut Light and Power Company's Plumtree Substation in Bethel, through the towns of Redding, Weston, and Wilton, and to the Norwalk Substation in Norwalk, Connecticut.

Date: October 4, 2006

Location: Transition Stations: Hoyts Hill, Archers Lane, Norwalk Junction

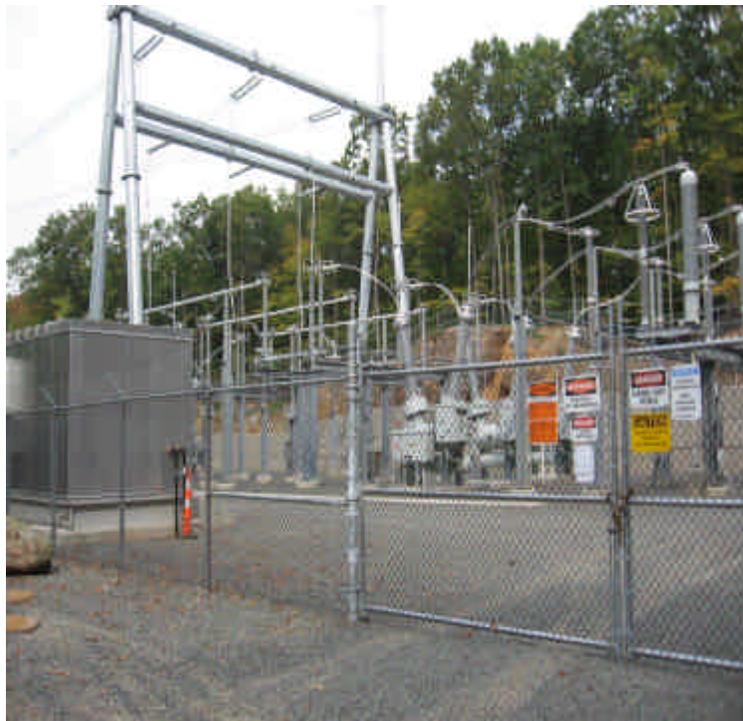
Archers Lane: Photo on the left shows some remaining stockpiles along the access drive. These areas should be restored/vegetated to the extent feasible. Photo on the right shows an overview of the yard. The line and stations will be energized soon. 10/04/06

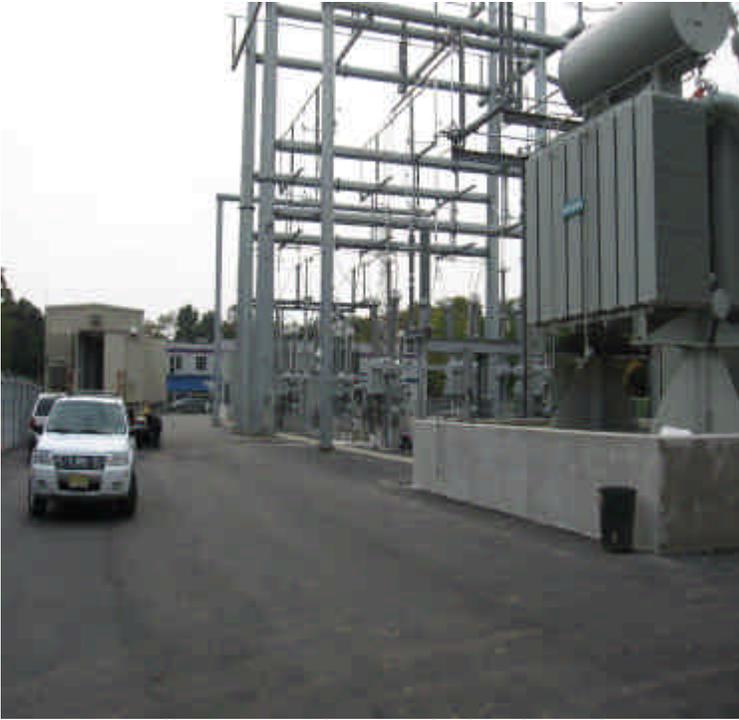
Norwalk Junction: Photo on the left shows the view of the paved station yard. No active work was occurring here during the inspection. Photo on the right shows the paved area adjacent to the yard. The disturbed soil surface should be vegetated to the extent feasible. The non-project related berm is degrading. 10/04/06.
