Docket No. 272 – Development and Management Plan Inspection

Segment 3 Underground Line

Date: March 20, 2008

Location: East Devon Substation to the Housatonic River Crossing

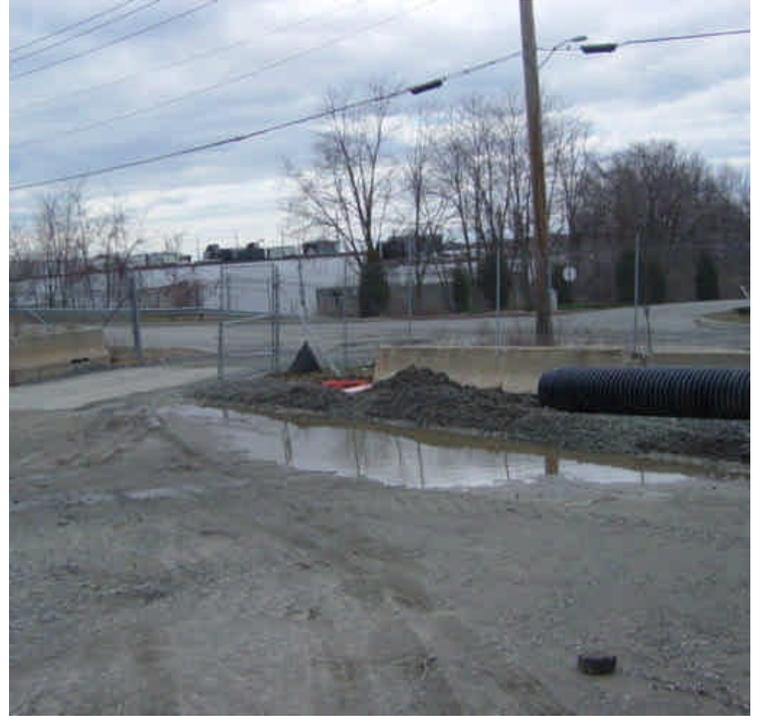
Sediment has accumulated behind the stone berm near the entrance to the Shelland Street lay down yard. A minor amount has migrated beyond the berm. The catch basin remains protected.
