**Docket No. 272 – Development and Management Plan Inspection**

**The Connecticut Light and Power Company Certificate of Environmental Compatibility and Public Need for the construction of a new 345-kV electric transmission line and associated facilities between Scovill Rock Switching Station in Middletown and Norwalk Substation in Norwalk, Connecticut, including reconstruction of portions of existing 115-kV and 345-kV electric transmission line, the construction of Beseck Switching Station in Wallingford, East Devon Substation in Milford, (and Singer Substation in Bridgeport), modifications at Scovill Rock Switching Station and Norwalk Substation, and the reconfiguration of certain interconnections.**

**Segment 4a Underground Line**

**Date:** April 10, 2008

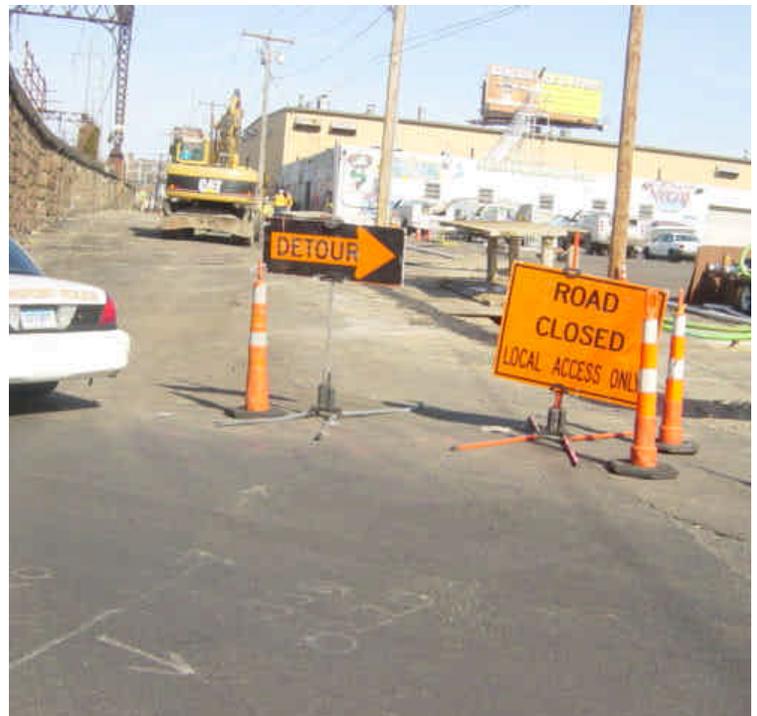
**Trenching and backfilling work continue near sta. #719-720 along Railroad Ave. Accumulated sediment was observed near the stone wall but may not be related to the construction activities. Sweep as needed.**
