**Docket No. 272 – Development and Management Plan Inspection**

**Segment 4a Underground Line**

**Date:** June 20, 2008

**Location:** Singer Substation to Fairfield/Westport Town Line

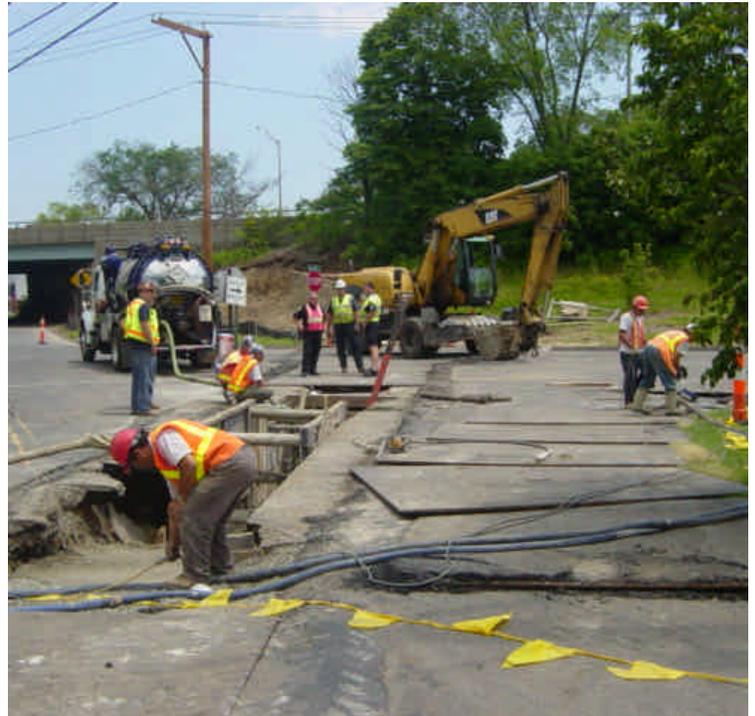
<b>Areas of Inspection</b>	<b>Observation</b>	<b>Recommended Action</b>	<b>Corrected Action</b>
	<p><b>observed in the storage yards. 6/20/08</b></p> <p><b>A well contained concrete washout area was noted near station #463. 6/20/08</b></p>	<p><b>vehicle during active construction 6/20/08</b></p> <p><b>Continue to proactively establish areas for concrete washout. 6/20/08</b></p>	<p><b>Washout area was established proactively.</b></p>
<b>Additional Observations</b>	<b>None. 6/20/08</b>	<b>None. 6/20/08</b>	<b>NA</b>

Trenching continues near sta. #463. Dewatering was ongoing at the time of the inspection. A well contained concrete washout area was also observed.
