Docket No. 272 – Development and Management Plan Inspection

Segment 4b Underground Line

Date: February 7, 2008

Location: Westport Avenue to the Norwalk Substation in the City of Norwalk

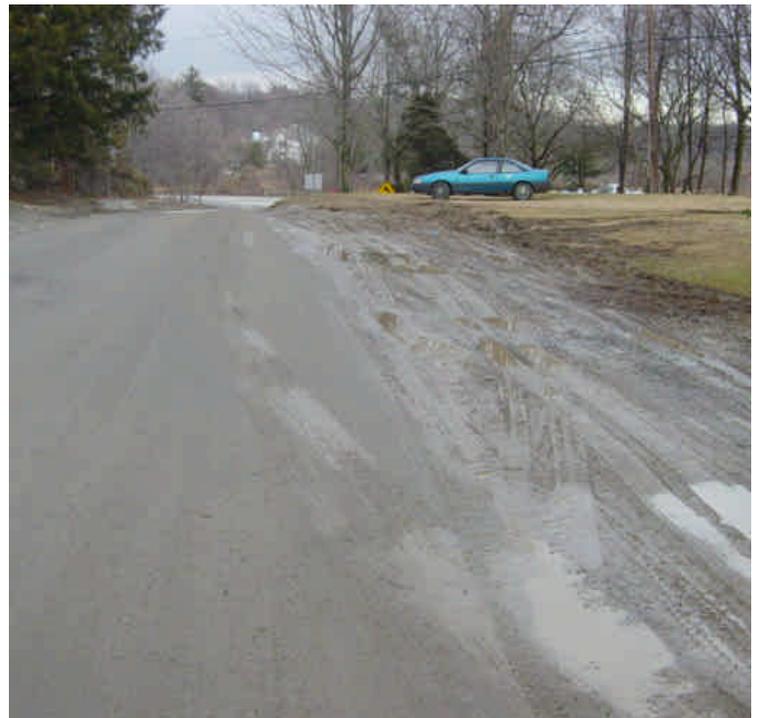
The Sherwood Island lay-down yard was very muddy due to the recent rain event. Heavy sediment tracking was observed along the access road to the yard and along Sherwood Island Connector. The areas along the shoulders of the access road remain heavily rutted and muddy.
