**Docket No. 272 – Development and Management Plan Inspection**

**Segment 4b Underground Line**

**Date:** June 12, 2008

**Location:** Westport Avenue to the Norwalk Substation in the City of Norwalk

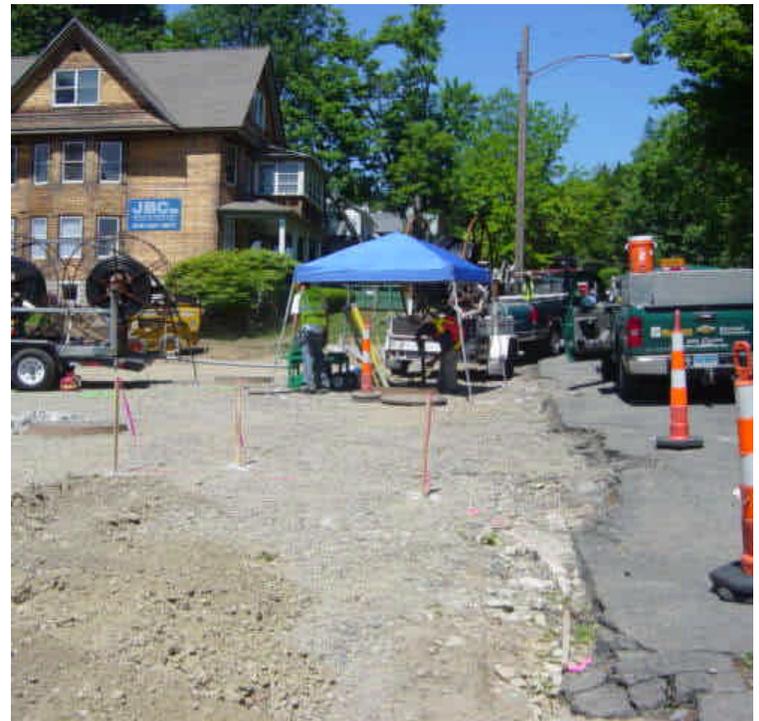
**Crews were setting stone curbing near sta. #234 and the electrical contractor was on-site pulling wire. Adjacent residential structure was being re-sided by other contractors.**
