Docket No. 272 – Development and Management Plan Inspection

Segment 4c Underground Line

Date: August 29, 2008

Location: Westport Avenue to the Norwalk Substation in the City of Norwalk

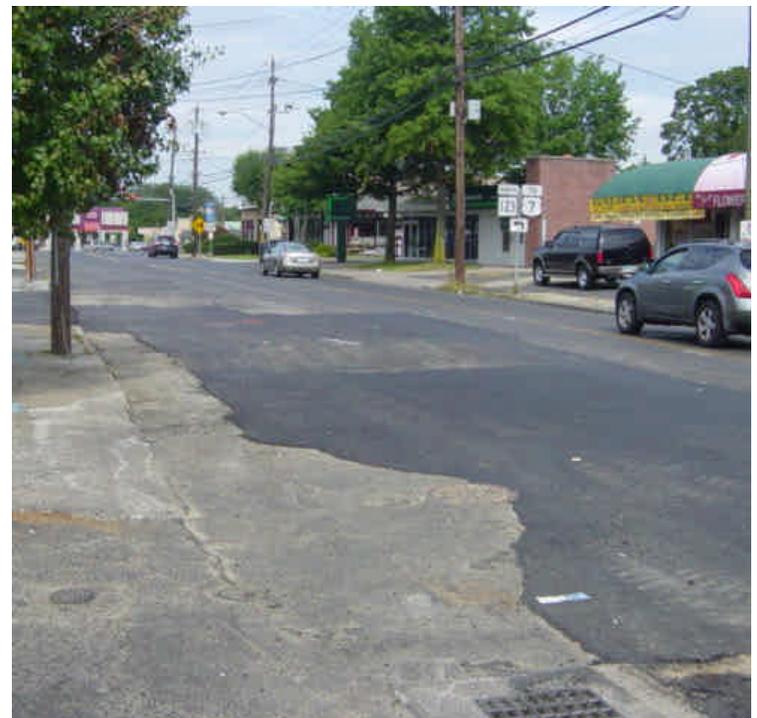
Trenching work has been completed in some locations between sta. #31-40 and the areas have been backfilled and temporarily paved. A minor amount of cold mix/ granular material remains along the edge of the roadway. Sweep where needed.
