**Docket No. 272 – Development and Management Plan Inspection**

**Underground Line Watercourse and Railroad Crossings**

**Date:** June 6, 2008

**Location:** Crossings of Watercourses and Railroads in Segments 3, 4a and 4b

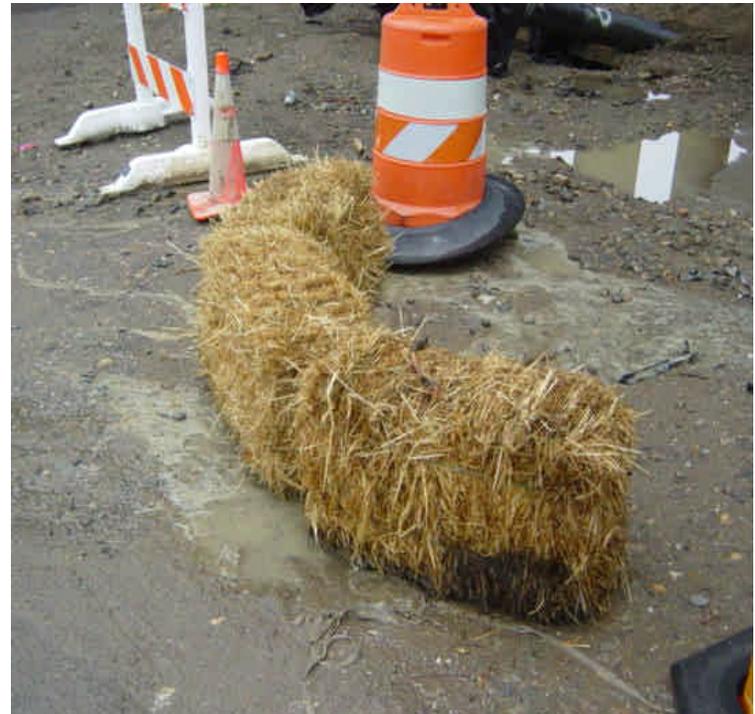
**The drilling pit on the south side has been partially backfilled and stabilized and all drilling equipment has been removed from the area. Hay bales remain in place in one location to contain any potential residual material. A minor amount of drilling slurry has seeped under the hay bale barrier.**
