Docket No. 272 – Development and Management Plan Inspection

Underground Line Watercourse and Railroad Crossings

Date: June 20, 2008

Location: Crossings of Watercourses and Railroads in Segments 3, 4a and 4b

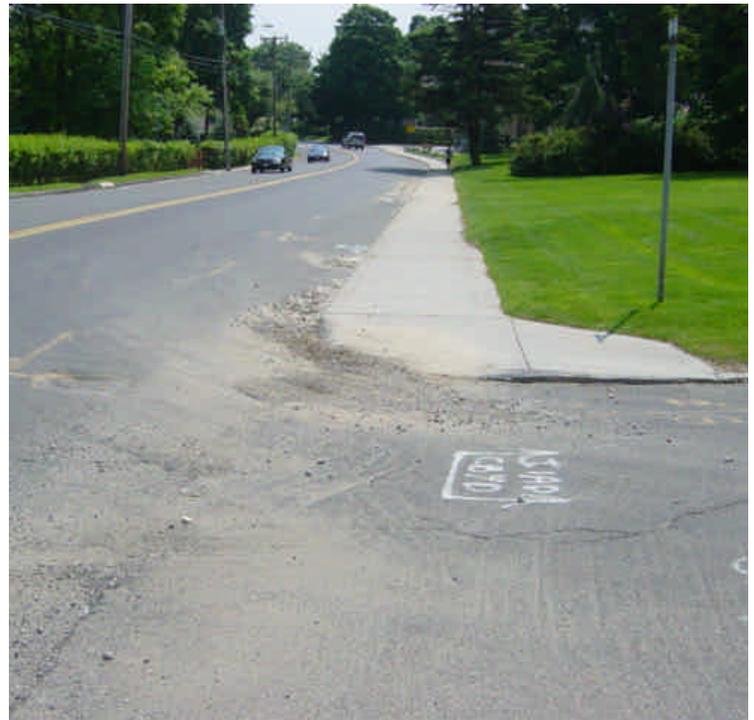
Stone curbing has been set near sta. #234. The adjacent areas have been partially re-graded and some of the material had eroded and accumulated at the intersection of Lincoln St. and Riverside Ave. Sweep this area as needed.
