**Docket No. 272 – Development and Management Plan Inspection**

**The Connecticut Light and Power Company Certificate of Environmental Compatibility and Public Need for the construction of a new 345-kV electric transmission line and associated facilities between Scovill Rock Switching Station in Middletown and Norwalk Substation in Norwalk, Connecticut, including reconstruction of portions of existing 115-kV and 345-kV electric transmission line, the construction of Beseck Switching Station in Wallingford, East Devon Substation in Milford, (and Singer Substation in Bridgeport), modifications at Scovill Rock Switching Station and Norwalk Substation, and the reconfiguration of certain interconnections.**

**Underground Line Watercourse and Railroad Crossings**

**Date:** August 14, 2008

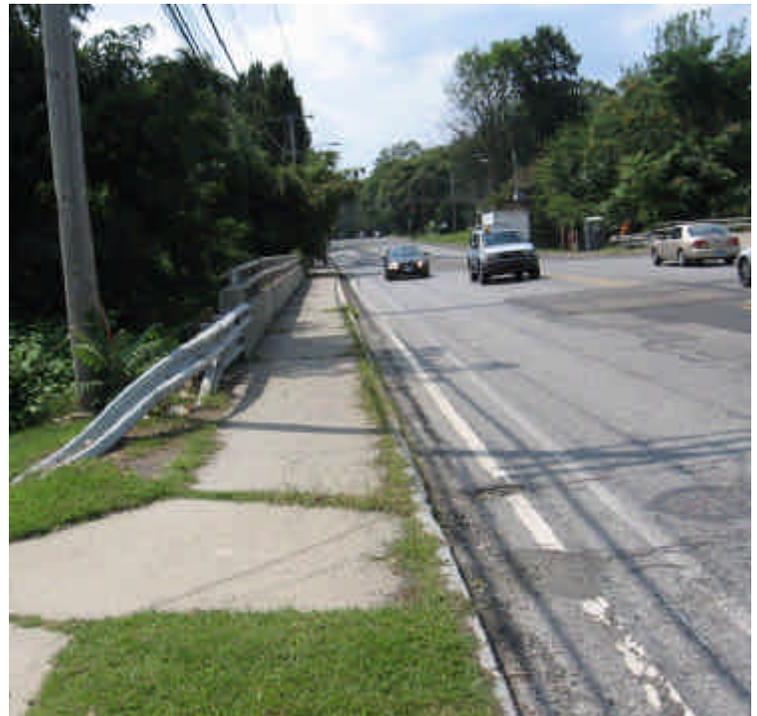
**Tie-in work appears to be complete on the bridge over Sasco Creek near sta. #434. Final stabilization is still required near the tie-in locations.**
