Smith-Curtiss House Complex
Osbornedale State Park
411 Hawthorne Avenue
Derby, CT 06418

Conditions Assessment **for the** **Smith-Curtiss House and Property**

September 2010

Prepared by:
Faesy-Smith Architects PC
523 Danbury Road
Wilton, CT 06897

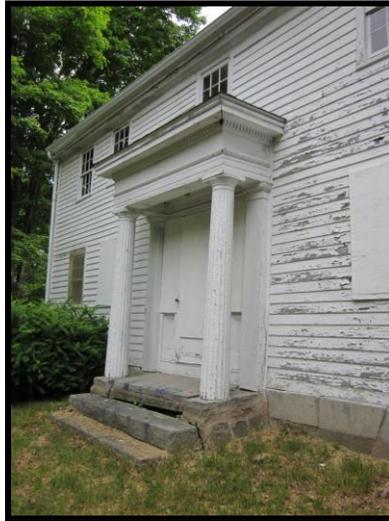
The Greek Revival portico has been damaged by moisture and animal intrusion. The fluted columns sit directly on the stone landing and have been wicking moisture which has caused the individual 'flutes' to swell and the seams to open up thus inviting in even more moisture.

Portions of the fascias and soffits show signs of rot.

Figure 22: Portico

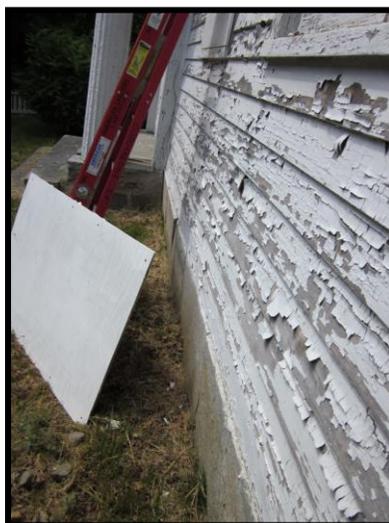
Figure 24: Clapboard siding on the west side of the House

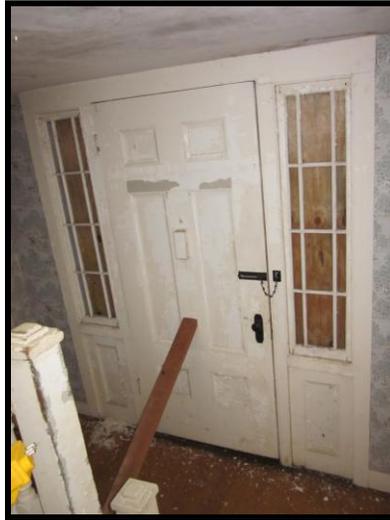
The doors are all wood and vary in style and age from batten doors, to 4 and 6 panel, to half light French doors. Most of the doors are restorable. The batten doors could be original to the House. The entrance door and sidelights look to be of similar vintage to the portico, early to mid 19th century. Most of the hardware looks to be original. There are two sets of bypass doors that go to closets in the north parlor and in bedroom #2 that look to be a relatively recent addition and not worthy of preservation.

Figure 25: Entrance door and sidelights

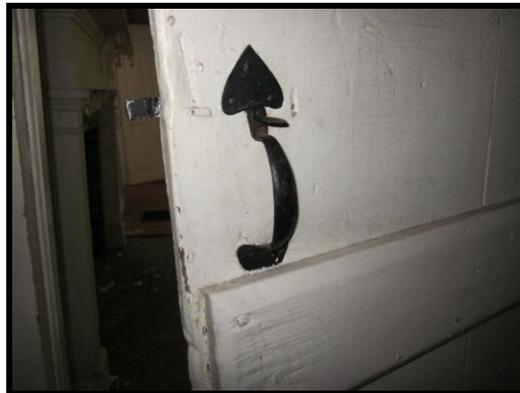
Figure 26: Detail of handle on batten door

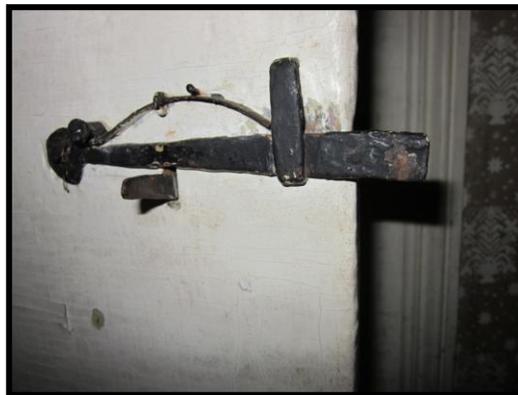
Figure 27: Detail of spring activated latch side of door

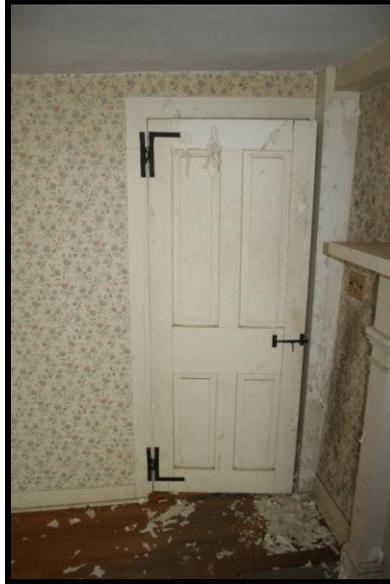
Figure 28: Panel door in the north parlor

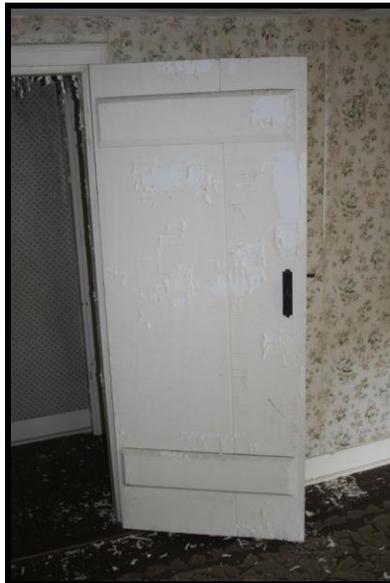
Figure 29: Batten door in bedroom #1

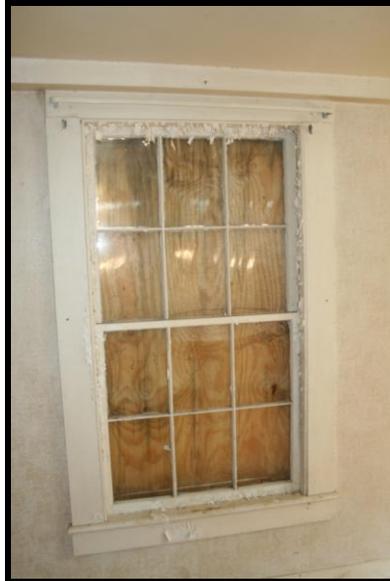
Figure 30: Double-hung window in south parlor

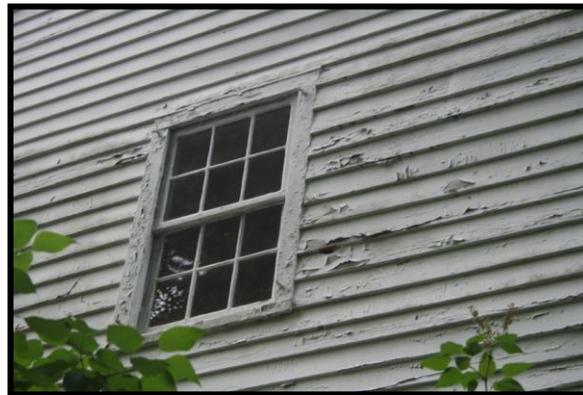
Figure 31: Double-hung window

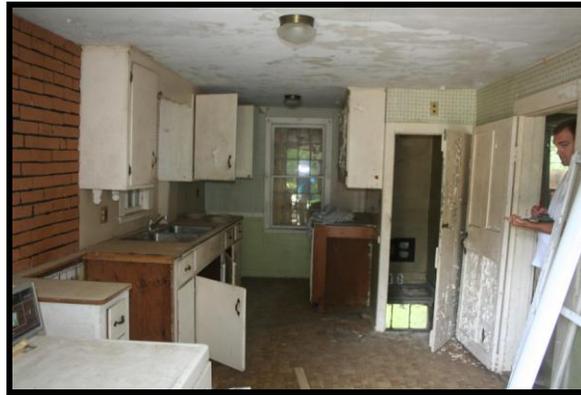
Kitchen: With the exception of a clothes dryer, there are no appliances remaining in existing kitchen. There is a plumbing rough where the washing machine once was installed on the west wall. There is a double bowl stainless steel sink on the east wall. The cabinets were clearly 'site built' probably in the 1930's or 1940's and are in poor condition. The counters are Formica over plywood with aluminum edging.

Figure 33: Kitchen

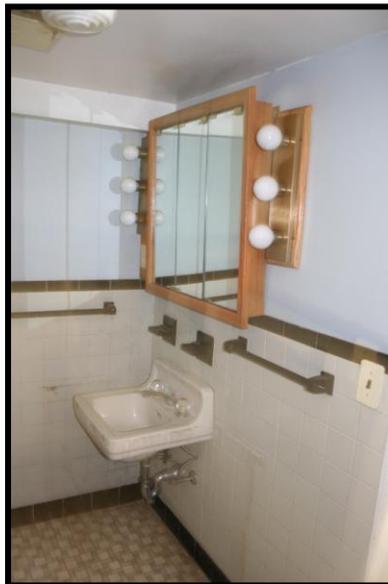
Bathroom: The fixtures in the bathroom include a small sink, toilet, and bathtub with glass sliding doors. The plumbing fixtures in the existing bath appear to be serviceable, but are of low quality.

Figure 34: Bathroom sink

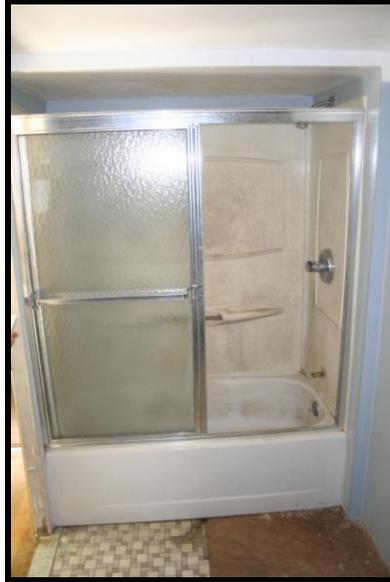
Figure 35: Bathroom bathtub

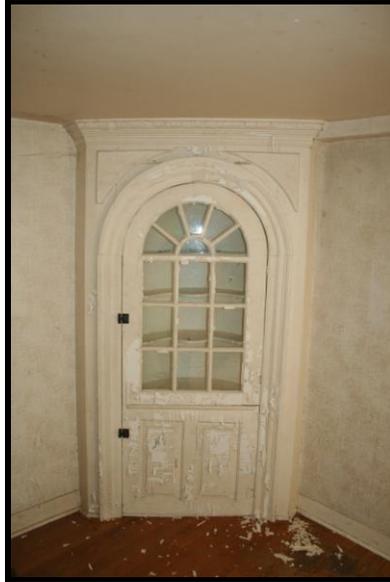
Built-Ins: In the southeast corner of the south parlor, there is a cupboard that is one of the more quintessential features found in the majority of Connecticut's original central chimney houses. It is in excellent condition and was quite possibly installed soon after this portion of the House was constructed.

Figure 36: Cupboard in south parlor

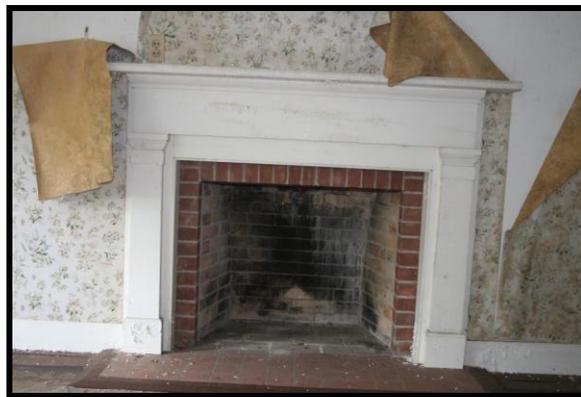
Mantels: The mantels that surround the fireplaces of the House, with exception of the mantel in the keeping room are rather simple pilaster and lintel configurations. They are not original to the House, as ‘bolection’ type molding surrounds were more commonly applied around fireplaces when the House was built in the 1700s. Pilaster and lintel mantels did not come into fashion until the early 19th century.

Figure 37: Mantel in bedroom #1

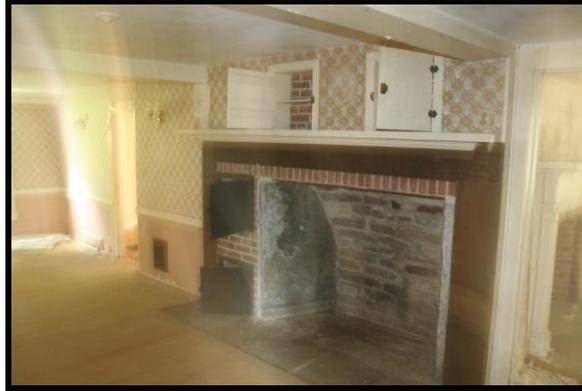
The fireplace in the keeping room has a natural finished beaded 1x wood surround with a mantel shelf above. It looks to have been recently restored.

Figure 38: Fireplace in keeping room

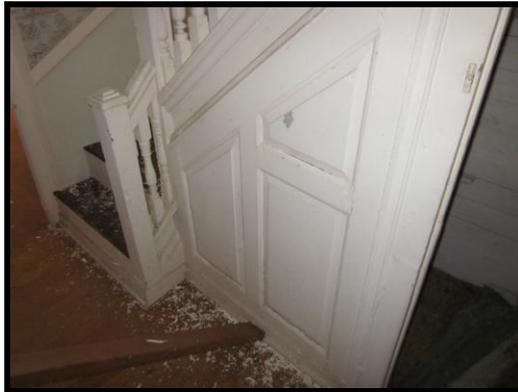
Paneling: The only place in the House where raised paneling is found is in the front hall. The paneling is part of the wall beneath the stair.

Figure 39: Raised paneling in the front hall

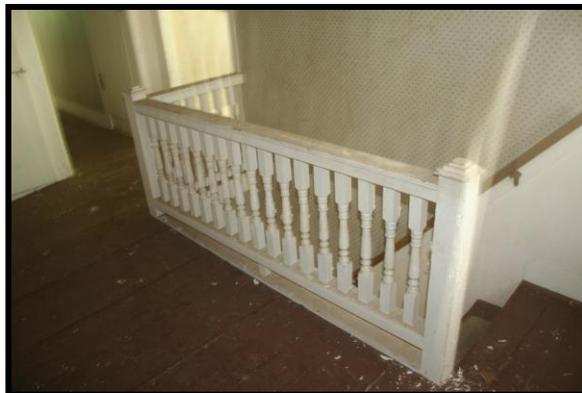
Balusters: Both the front and rear stairs have turned balusters that are in good condition and look to be original.

Figure 40: Rear stair railings

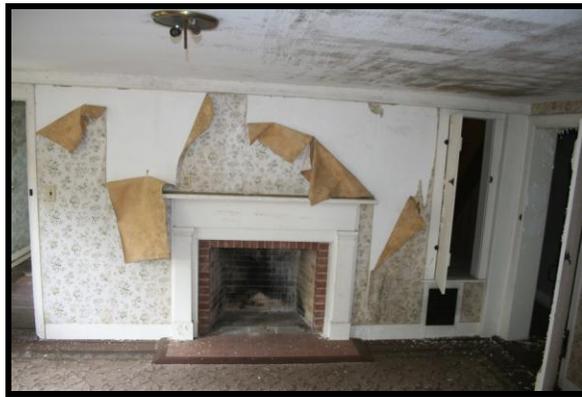
Figure 42: North wall of bedroom #1

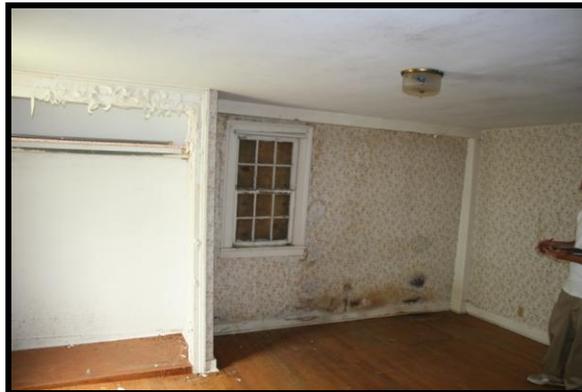
Figure 43: North wall of north parlor

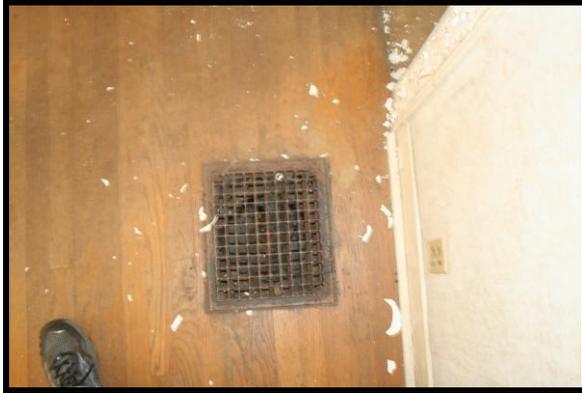
South Parlor, Front Hall, and North Parlor: Floors in these rooms are oak strip and also not original. The oak strip has been installed above another layer of hardwood, which is over a subfloor that is visible from the cellar below.

Figure 45: Oak strip floor in south parlor

The layer of wood flooring below the current top layer of strip oak floor may be wide hardwood boards, and if so, the strip oak should be removed and the older floor repaired and refinished. There is visible rot in the floor on the north side of the north parlor.

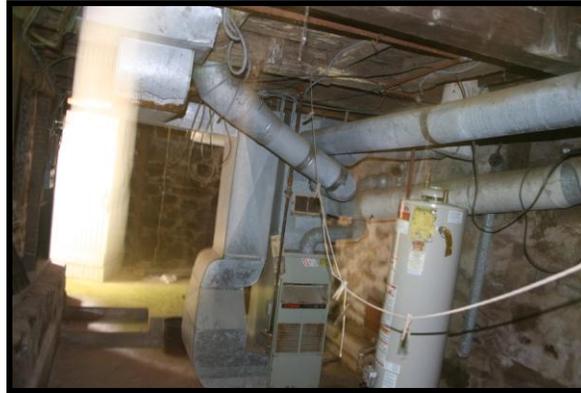
The House is heated by gas fired furnace (Trane XE70) located in the cellar and a distribution system of metal ducts. Gas is supplied from the street.

There is a gas-fired hot water heater (A.O. Smith) also located in the cellar.

Figure 47: Mechanical System in cellar

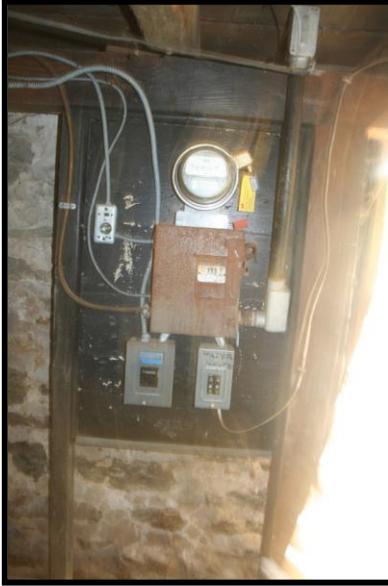
Figure 48: Electrical Panel

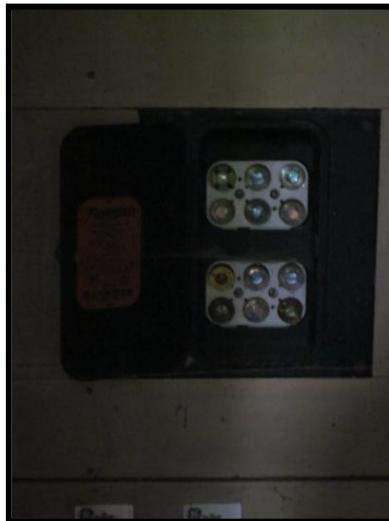
Figure 49: Fuse Box

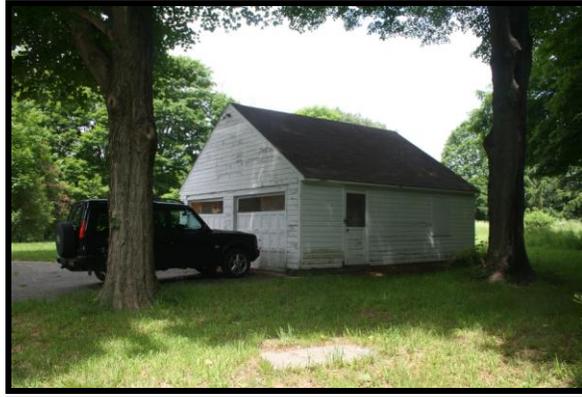
Figure 51: Garage

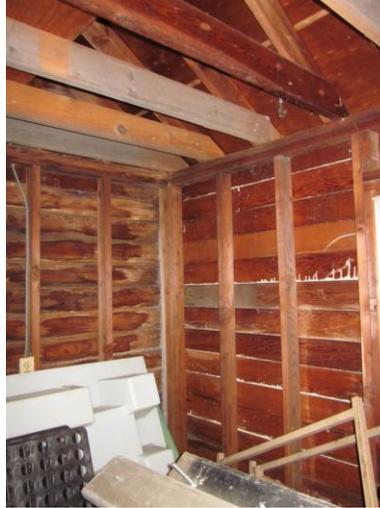
The ceiling consists of 2"x6" joists spaced 16" on center.

The walls are framed with 2"x4" studs at 16" on center.

Figure 52: Interior of Garage (southeast corner)

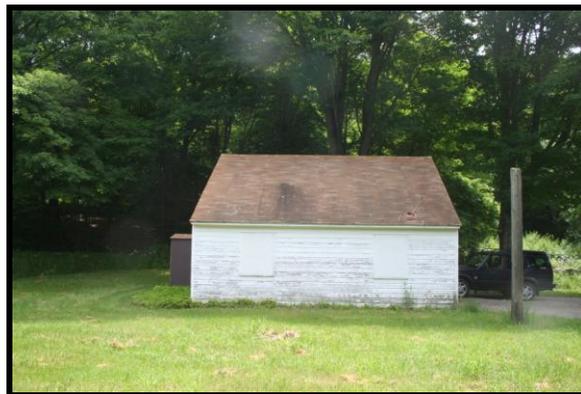
The existing roof is 3-tab asphalt shingles over plywood sheathing. It is in poor condition.

The Garage has no gutters.

Figure 53: North side of Garage
