CAPOZZO RESIDENCE

Limited Hazardous Materials Building Inspection Report

60 Cosey Beach Avenue
East Haven, CT

Connecticut Department of Housing Application No. 1129
Lothrop Associates Project No. 1524-23

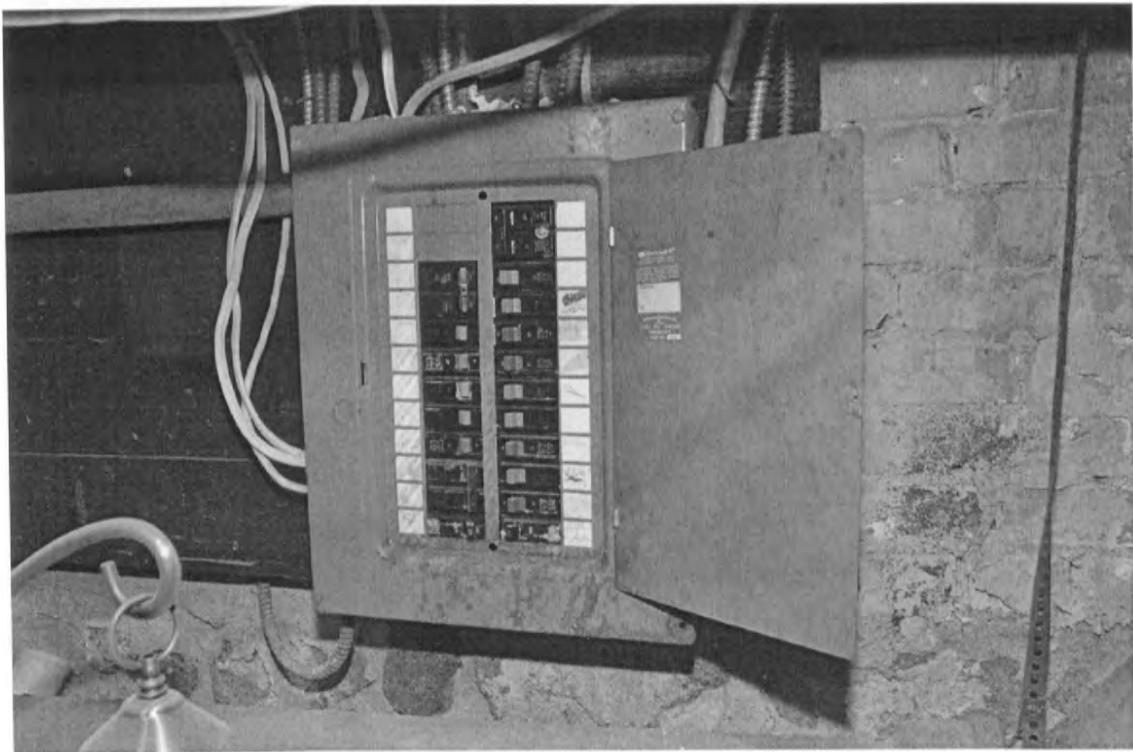
Figure 3

<p>Electric service panel: The owner states the service panel was under water. The owner states the panel was allowed to dry out and no further action was taken.</p>	<p>The service panel is currently in use. The panel is rusted and has some sediment on the exterior. See figure 3</p> <p><i>Recommendation: Continued use of this service panel should be considered hazardous. It potentially could be a fire and electrical shock hazard. Replace the panel and all its components together with the service cable. Replace any circuit wiring that shows any sign of damage complete to the next existing junction that has not been exposed to water. Any wiring that may remain should have the conductors cleaned at the connection interface with panel fixtures.</i></p>	<p>\$4,500</p>	<p>\$4,500</p>
<p>Masonry basement foundation wall degrading: The owner expressed concern over the stability of the foundation wall and demonstrated portions falling away by removing a small piece of parging or mortar patch by hand.</p>	<p>The basement exist under only a small portion of the house, it appears to be the oldest portion. The foundation wall is mortared stone and red brick. Most of the mortar appears to consist mostly of beach sand and is loose and crumbly. It looks to have had mortar patched several times over the decades, some of this is lose and cracked. The foundation wall seems to be relatively solid, at least as solid as it ever was. It seems that when new, it wasn't the best quality construction and does not meet current codes or modern use. It cannot be determined if the mortar was degraded by exposure to salt water or if it is just old. It appears some of the thin poorly applied mortar patches are falling away but these don't seem to present a structural issue. Newer parging on the exterior above grade seems to be sound. See figures 4 & 5</p> <p><i>Recommendation: If the foundation wall is to remain in use, continue ongoing maintenance required for an old structure. No immediate work required under the CDBG-DR program.</i></p>	<p>NA</p>	<p>NA</p>
