# STRUCTURE NO. 01748

MAYFLOWER STREET

INTERSTATE-84

*Indepth & Special Inspection*

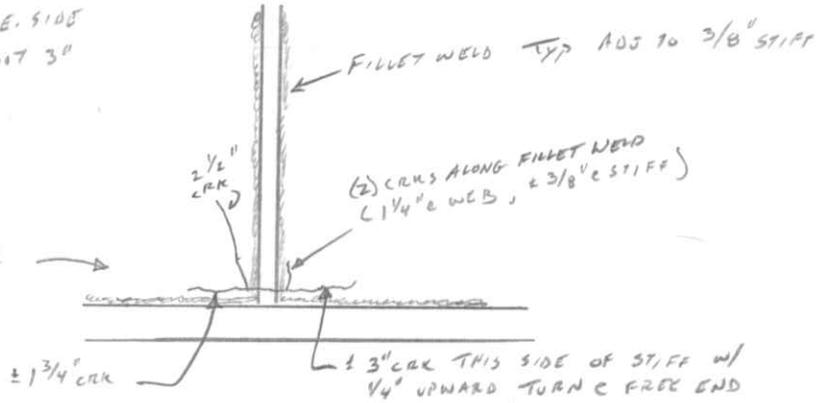
SP #1, GIRDER I C 3<sup>RD</sup> INT DIAPH, W. ELEV  
 (LOWER J-BY E/B CENTER LN)

<p>Along the base of the vertical stiffener fillet weld at this location, there is a 1.25" crack along the web and a 3/8" crack along the stiffener (no stop holes) (An advanced priority C BMM was sent to CDOT on 12/7/11). Stiffeners in this area have bends. Girders 1-3 are tilted up to 1/2" over 9" in these areas (worst at girder 1). Bottom flanges have random gouges that have been ground smooth, while new gouges up to 1" high x 3/4" wide x 1/4" average depth are not ground smooth. BS&amp;E was notified about new cracks along the superstructure via email on 9/22/2011 and 11/10/2011.</p> <p>Overall rating could be lowered to a "3" per CT BIM Section 10.5 (cracks in primary members). However, rating only lowered to a "4" since crack is at fascia girder with sidewalk above.</p> <p>See sheets 22-32 and photos 23 &amp; 31-42.</p>
FLOOR BEAMS:	N	-
TRUSSES-GENERAL:	N	-
TRUSSES-PORTALS:	N	-
TRUSSES-BRACING:	N	-

- BOT PORTION OF WEB BULGED  $\pm 5/8"$
- DIAPH "PUSHED THRU" WEB
- DIAPH LOWN B & E. SIDES
- W/ MINOR BEND & BIT 3"

$$CRK = 1\frac{3}{4} + \frac{3}{8} + 3 = \underline{\underline{5\frac{1}{8}''}}$$

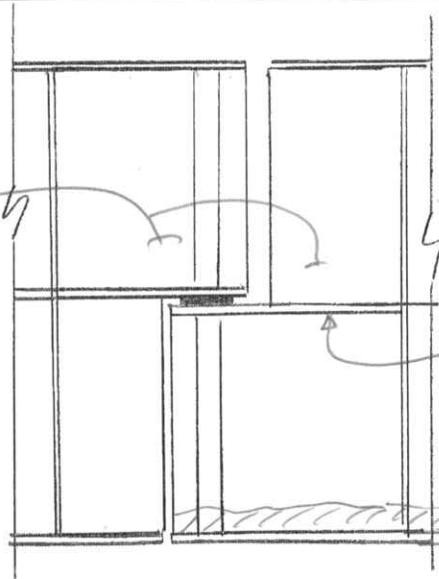
HVY SURF RUST  
SPOTTY LR  
w/ NEG LOSS

LR e t w/ 1/2" REM (1 1/2" ORIG)

Bot 6" OF WEB STIFFS w/  
LR = 8" w/ 1/16" - 1/8" SL;  
MOJ DF w/ 1 9/16" MIN  
REM (1 5/8" ORIG)

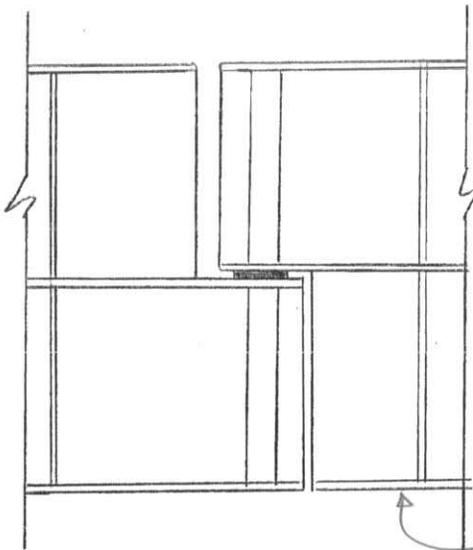
Span 1, Girder 1, East Elevation.

HVY SURF RUSTY w/  
SPOTTY LR +  
NEG LOSS CRIT  
ZONES

3/4" DF ∴  
NO LOSS

1 3/4" LEG w/ LR  
± 1 3/16" REM,  
1 5/16" STIFF w/  
± 5/32" SL (MAX) e  
Bot 6"

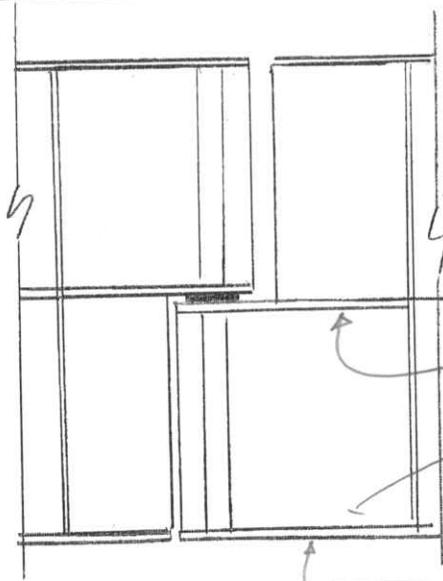
Span 1, Girder 3, East Elevation.

1 7/16" MIN  
REM E FLG  
(1 1/2" ORIG)

BF w/ LR GL  
AREA B/W STIFFS w/  
1 7/16" MIN AVE REM,  
AREA PAST w/ 1 1/16" REM  
(1 3/4" ORIG)

3" H x 1 3/16"  
REM w/ HUY  
RUST (7/8" ORIG)

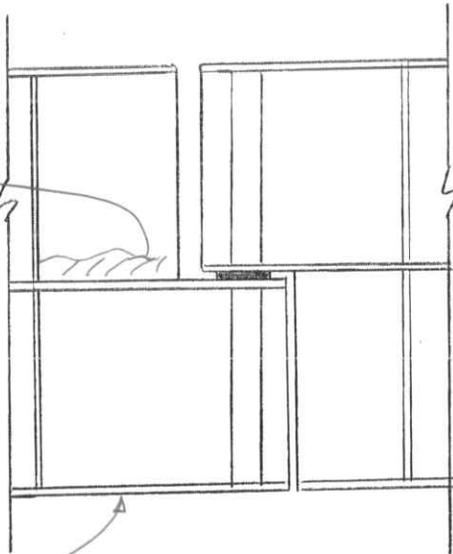
Span 1, Girder 3, West Elevation

BF B/W STIFFS  
w/ LR + 1 7/16" MIN  
REM; NEG LOSS PAST  
THIS AREA (1 3/4" REM)

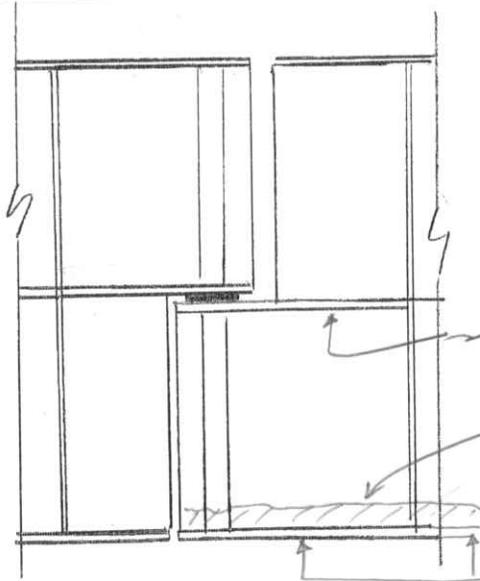
Span 1, Girder 4, East Elevation.

1 5/16" AUC  
REM E FLG

DOT 3" OF WEBS +  
STIFFS W/ LR  
+ ± 1/16" SC (7/8" ORIG)

BF W/ 3L + 1 1/2" AUC  
REM W/ UP TO 1/4"  
LOSS OF WIDTH

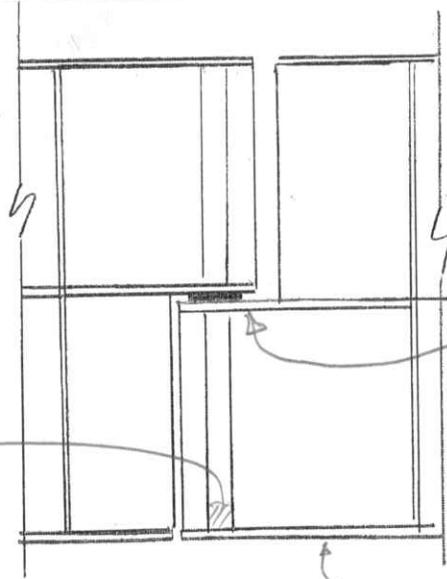
Span 1, Girder 5, East Elevation.

LR B/W STIFFS  
4" H w/ 1/16" ESP SL  
LR DIFFICULT TO REMOVE  
DUE TO STIFF'S;  
S. STIFF w/ UP TO  
3/16" SL C BOOT 6", LR

E w/ 1/4" MIN  
REM BELOW  
HUNG BF (1 1/2" ORIG)

BF w/ LR SL  
w/ 1/32" MIN REM

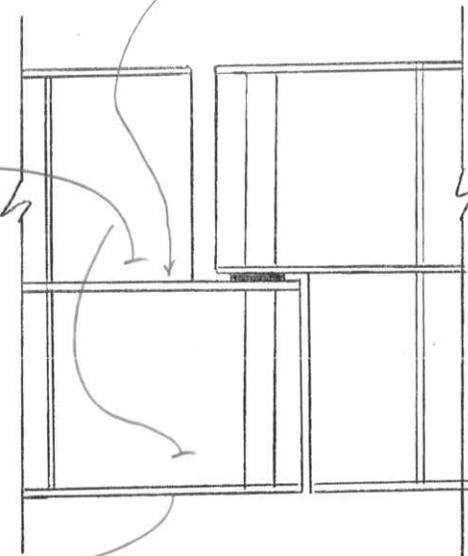
BOOT 6" OF WEBS  
w/ LT LR w/ NET  
LOSS TYP (ISOL 1/16" SPOTTY  
AREAS).

E w/ 1 7/16" MIN REM (1 1/2" ORIG)

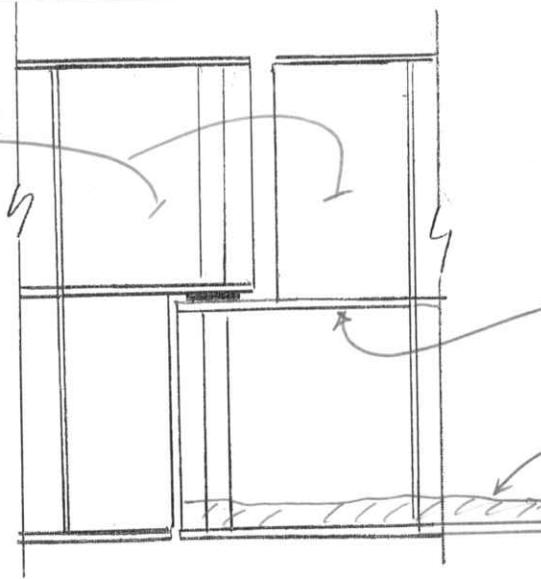
HUY SURF RUST  
TO LT LON RUST  
w/ MINOR LOSS

FE w/ 1 1/16" MIN  
REIN (1 1/2" ORIG)

STIFFS  
WEB w/ LR UP TO 6'H  
+ 9'L w/ UP TO 1/16" - 1/8"  
LOSS. ADJ BF LEG w/  
1 1/2" MIN REIN →  
LOSSES WORST BELOW  
JT + TRANSITION TO  
FULL SECTION ± 4'-9'  
(1 3/4" ORIG).

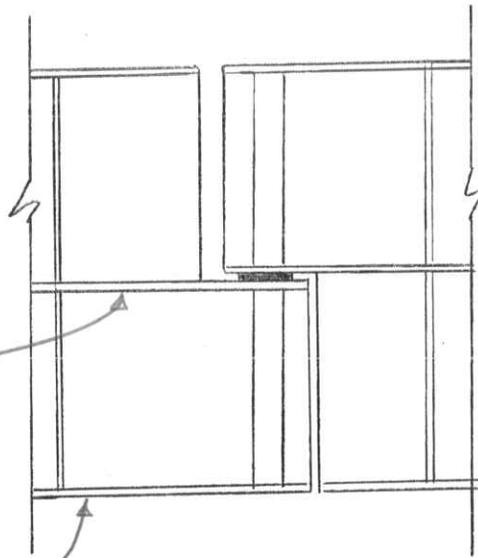
Span 1, Girder 6, West Elevation

FE w/ 1 1/2"  
MIN REIN, LR

LR ± 6'L w/ 1 5/8"  
MIN REIN, LR

NOTE: GIRDER 7 SHIDLAP w/ ONLY  
MINOR LOSSES

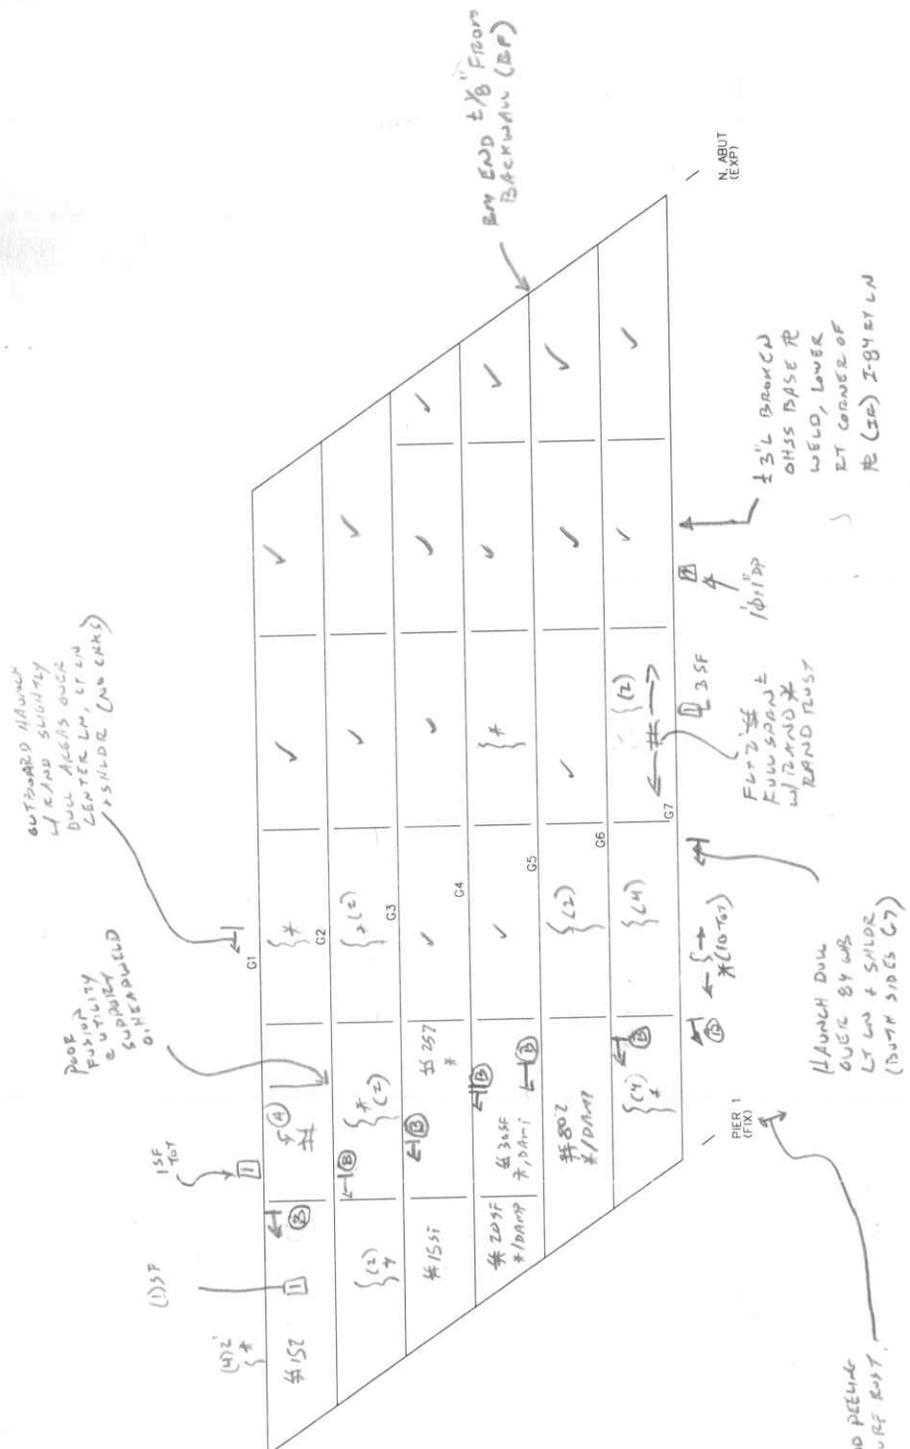
SHEET 31/69

The fixed bearings at the pier have random peeling paint and random light to moderate surface rust. See sheet 31 and photo 29.

## UNDERSIDE OF DECK - SPAN 2

- GEN
- RAND LT HL; EXT REBAR CHAIRS w/ RUST
  - D.H. WELDS MISSING & NUMEROUS DIAPH LOWER SIGTS
  - LT CR THROUGH w/ 1/2" LOSS & 3/8" x 3/8" DIAPHS
  - RAND BY PIGEON DEBRIS

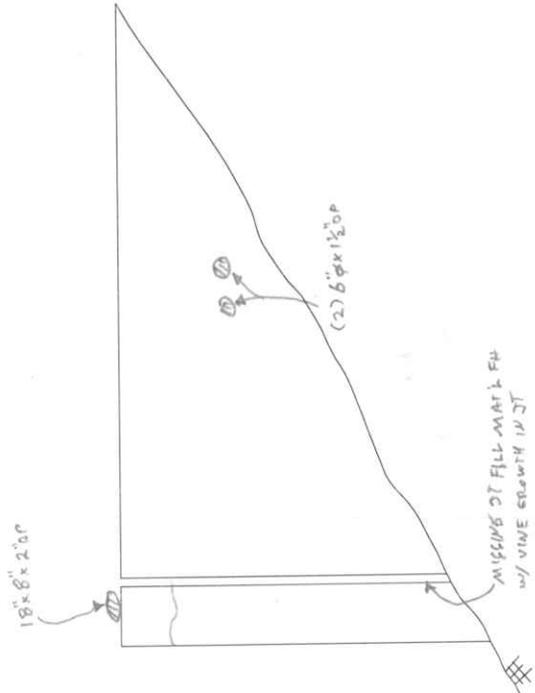
**S.W. WINGWALL**

- MOD - Hvy VINE GROWTH THRU-OUT
- RAPD AREAS OF LT SCALE.

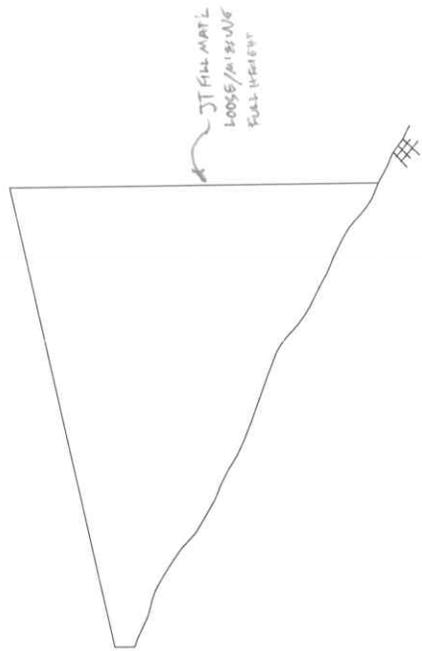
**S.E. WINGWALL**

- PAINTED OVER STAFFITI 7' Hx FL @ 50'

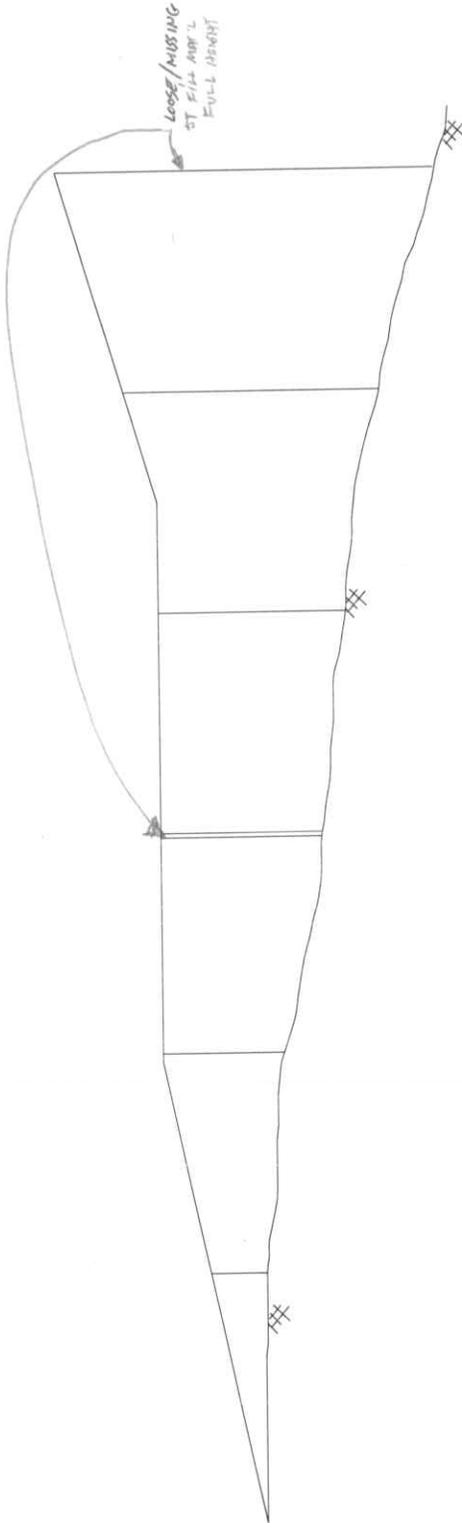
**N.W. WINGWALL**

- MOD - HVY VINE GROWTH IN ALL STS.
- LT - MOD VINE GROWTH THRU-OUT.
- RAMP AREAS OF LT SCALE.

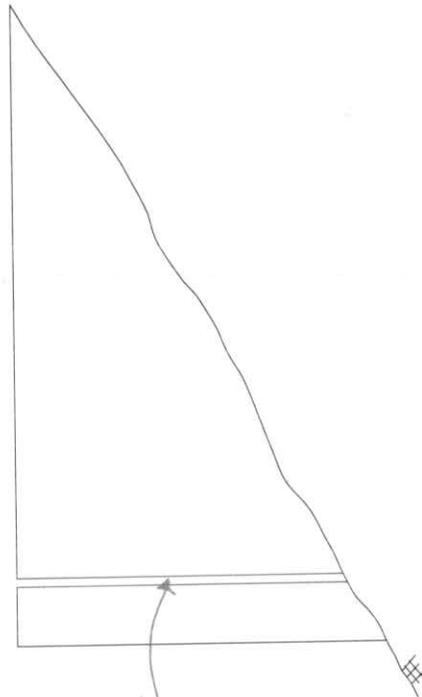
**N.E. WINGWALL**

- HAND AREAS OF LT. SCALE.

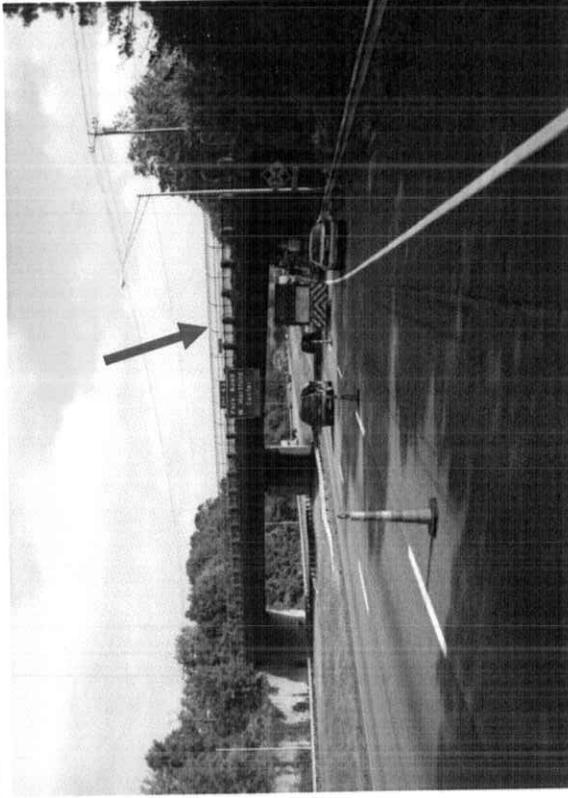
**Photo #2 :**  
West elevation.

Note the vertical clearance posting signs attached to the parapet and behind the guide rail.

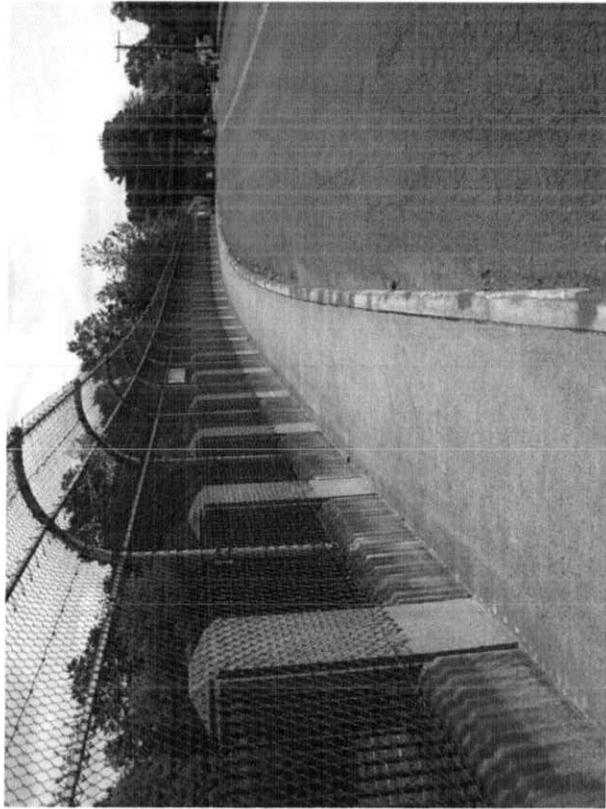
PARAPET:	7	<p>The concrete parapets have light scaling and rust stains from the steel picket fence above. The southwest approach parapet has a 2' x 6" x 2" deep spall. The east parapet has a full width x 1' high x 1.5" deep spall inside of the parapet joint at the ship lap joint. The exterior face of the parapet at the same location has a 2' x 20" x 3" deep spall with exposed rebar. See sheets 16, 17 &amp; 22 and photos 18 &amp; 19.</p>
RAILING:	6	<p>Steel picket railing on top of the parapet has heavy surface rust throughout and areas of laminated rust. The paint system is 100% failed. See sheet 16 and photo 19.</p>
PAINT:	1	<p>Paint system on the picket railing is 100% deteriorated. See photo 19.</p>
FENCE:	6	<p>Galvanized chainlink fence with curved return (9'-2" to sidewalk) in front of the picket railing: Fence has random blush to light rust. The chainlink has random minor damage, and the bottom of the fence has areas where it has been bent and protrudes up to 6.5" into the sidewalk area. The previous hole at the northwest corner of the bridge (over dirt) has been repaired with coated wires. There is one disconnected upper horizontal rail at the southwest approach. BS&amp;E was notified about the protruding fence areas via email on 09/22/2011. See sheets 16 &amp; 17 and photos 19-21.</p>

**Photo #19 :**  
Typical sidewalk, parapet, railing, and fence.

5. The parapets have random spalls, up to 3" deep with exposed rebar. Repair the parapets (<1/4 cubic yard).
6. Steel picket railing has heavy surface rust throughout, areas of laminated rust, and its paint system is 100% failed. The chainlink fences have random minor damage, and the bottom of the fence has areas where it has been bent and protrudes up to 6.5" into the sidewalk area. The previous hole at the northwest corner of the bridge has been repaired with coated wires. There is one disconnected upper horizontal rail at the southwest approach. BS&E was notified about the protruding fence areas via email on 09/22/2011. Paint the steel picket railing (520 linear feet) and repair damaged areas in the fences (50 linear feet).

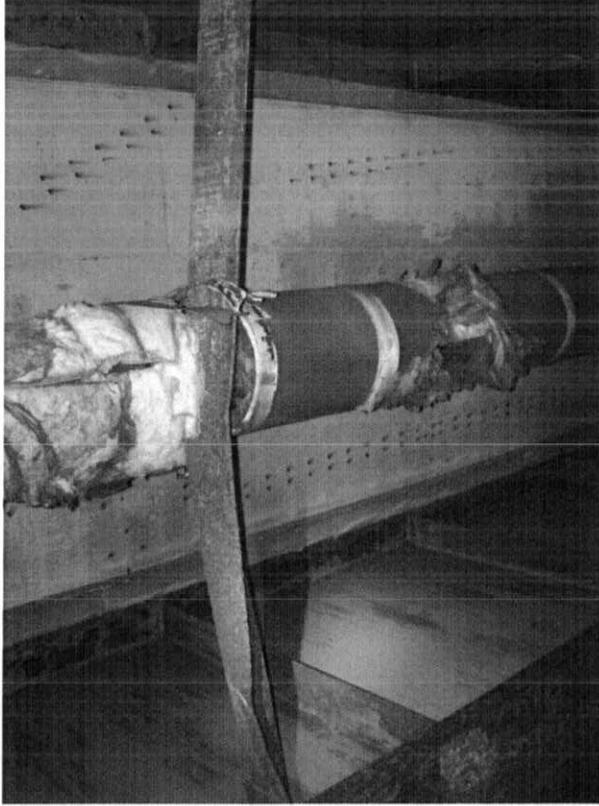
**Photo #23 :**  
Span 1, bay 1: Bent utility support member. Also note the torn insulation.

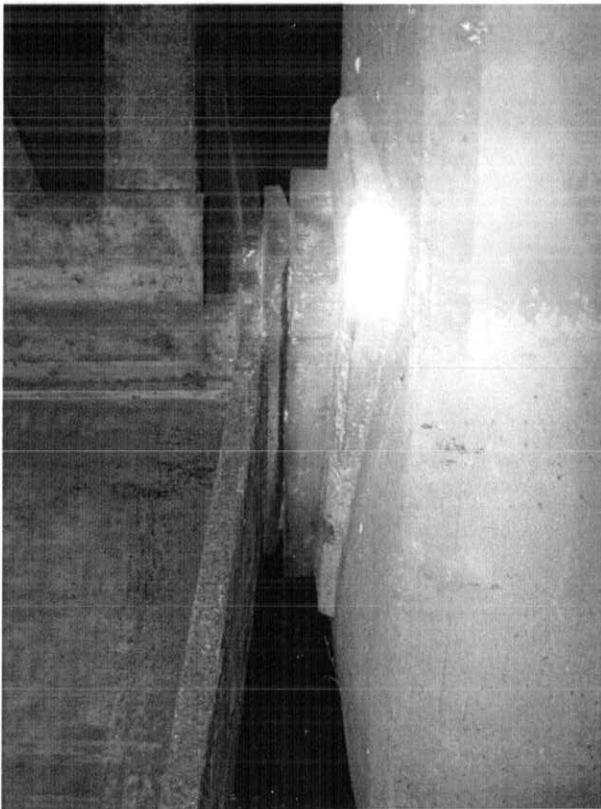
**Photo #29 :**  
Girder 7 fixed bearing at the pier, typical.

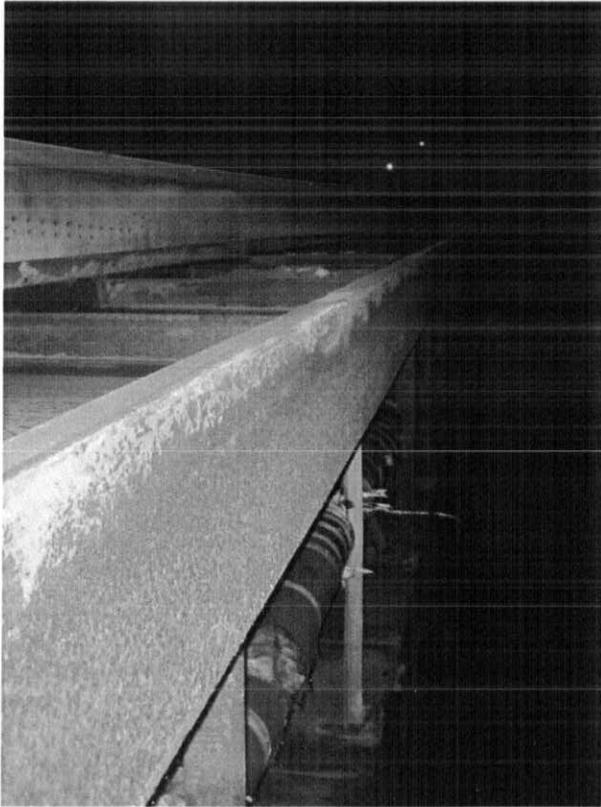
**Photo #41 :**  
Span 1, girder 1: Gouges not ground smooth along the edge of the bottom flange.  
*BMM ISSUED THIS INSPECTION 20 12-11-12*

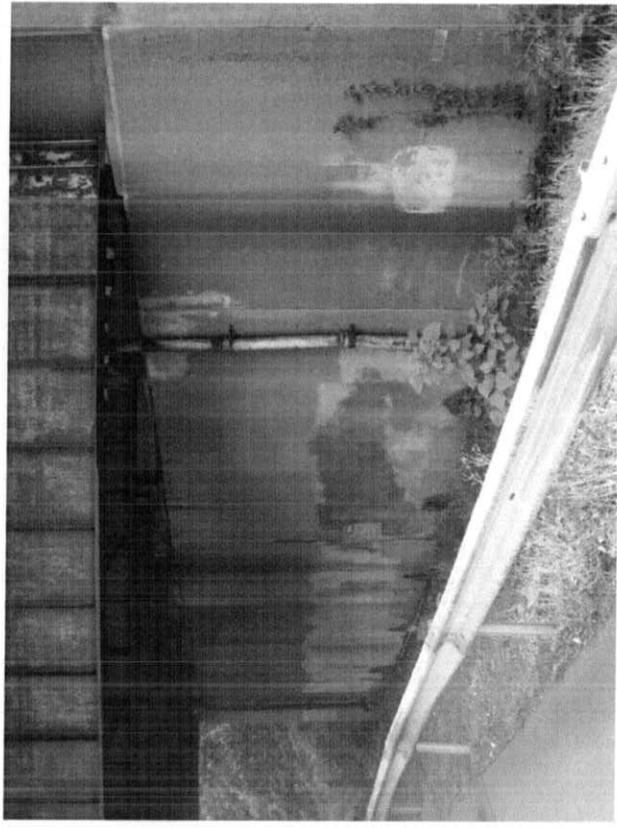
**Photo #45 :**  
Span 2, girder 5 at the north abutment: Only 1/8" gap between the bottom flange end and the backwall.

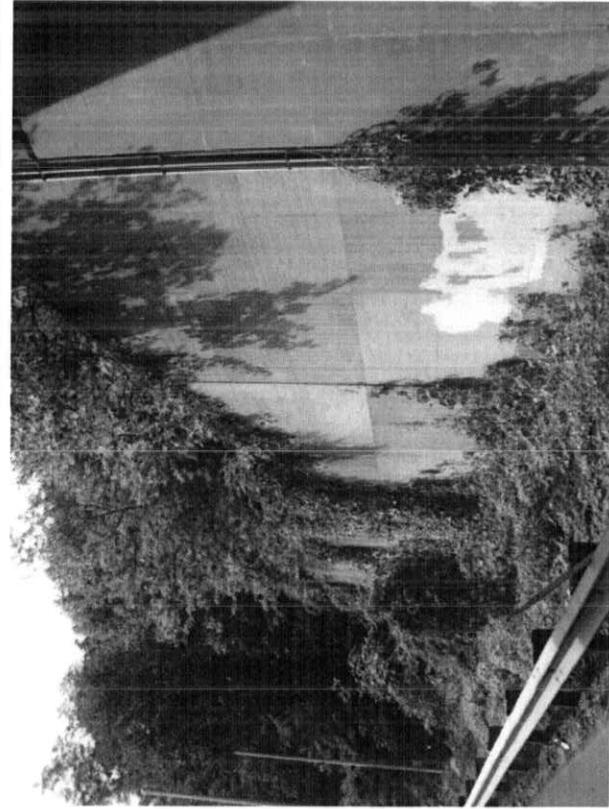
**Photo #49 :**  
Northwest wingwall, typical.

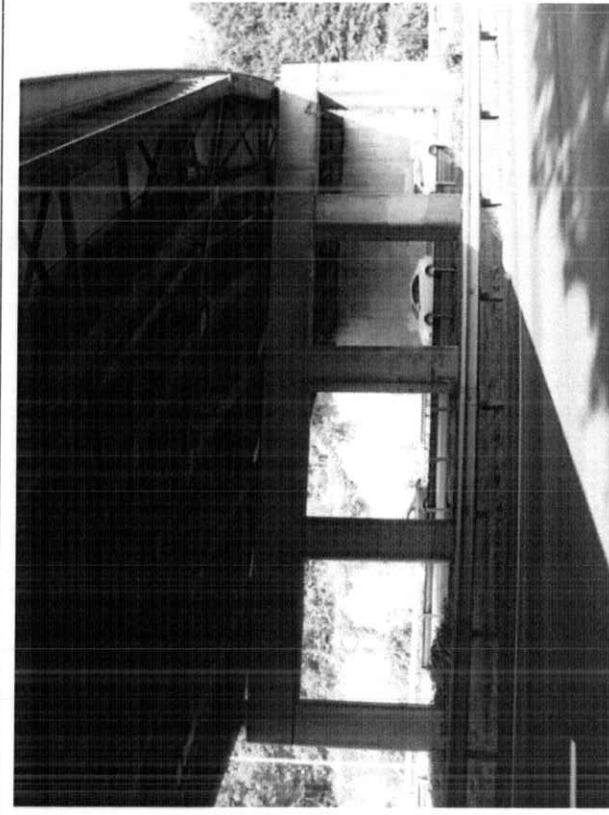
**Photo #50 :**  
South elevation of pier, typical.

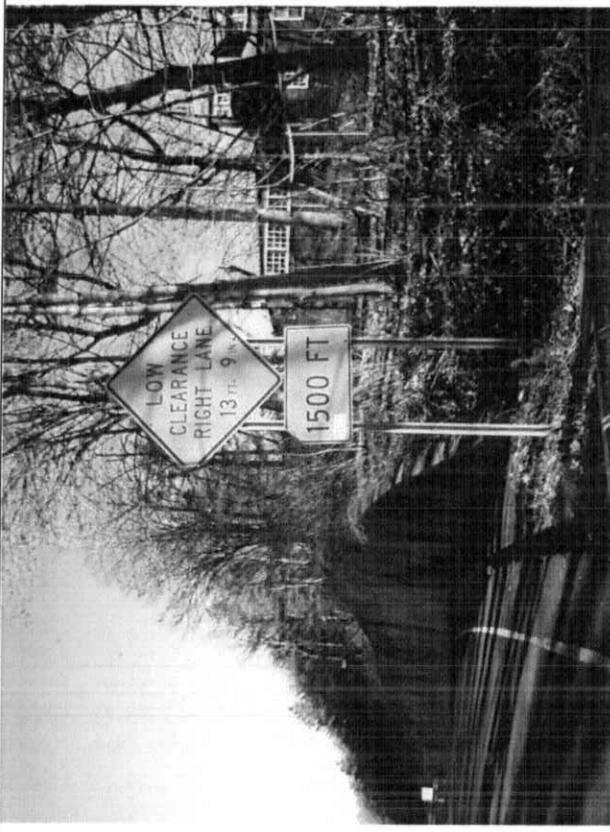
**Photo #54 :**  
Advance warning vertical clearance posting sign at the I-84 Eastbound exit 41 on-ramp (South Main Street). There is a similar sign on I-84 Eastbound between exits 40 & 41, prior to the bridge.

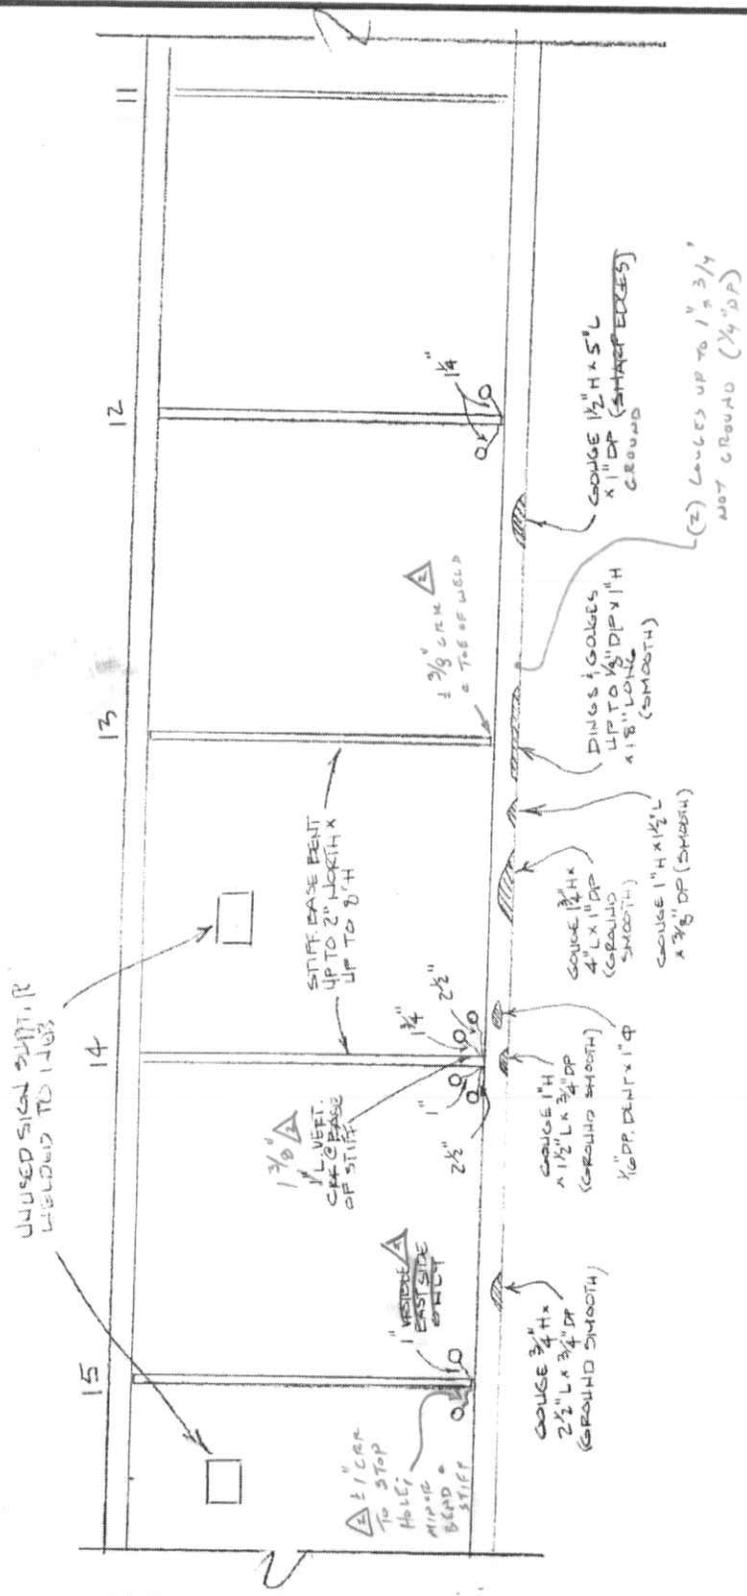
W. ELEV. GIRDER 1, SPAN 1 OVER PGT. W. I 84 EB

- STIFFENERS NUMBERED FROM 1<sup>st</sup> INTERMEDIATE STIFF. FROM SOUTH ABUT. (SEE SHIT 23)
- STOP HOLES = 1" Ø
- ALL CRK'S VISIBLE ON OPP. SIDE WEB EXCEPT STIFF 15
- NO CRK. PROPAGATION BEYOND STOP HOLES
- SMALL DINGS & SCRAFES < 1/16" DP (SMOOTH) LOWER EDGE BF. RANDOM LOGS. BTLH STIFFS 12 & 15

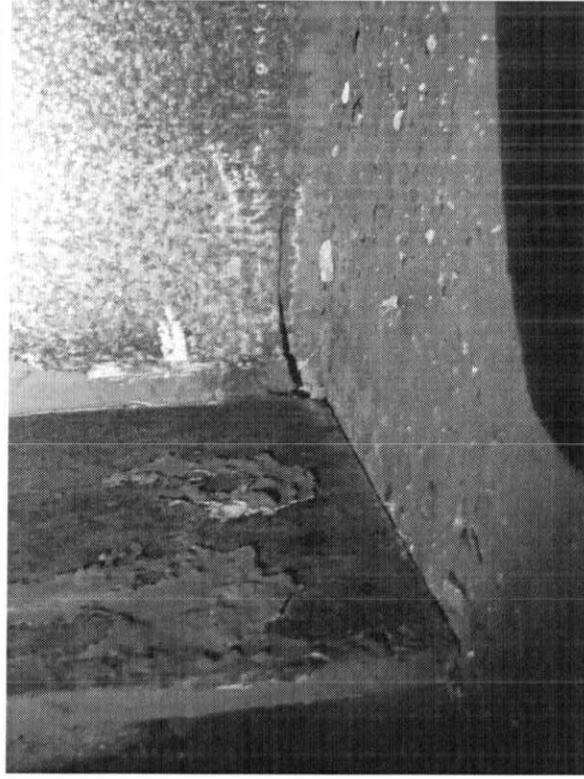
1. The girder 1 and girder 7 deck haunches are dull over the center lane, left lane and left shoulder of Interstate 84 Eastbound and Westbound. See attached photo 1.
2. The base of the span 1 girder 1 web has a 5-1/8 inch long horizontal crack just above the bottom flange fillet weld at the third intermediate diaphragm from the south abutment. There is a 2.5 inch long diagonal crack in the girder 1 web which extends from this horizontal crack at the north side of stiffener. Also, along the base of the vertical stiffener fillet weld at this location, there is a 1.25 inch crack along the web and a 3/8 inch crack along the stiffener. There are currently no stop holes at these crack locations. See the attached field sheets and photos 2 and 3.

**Photo #3 :**  
Same as photo 2, but looking from right side of the stiffener.

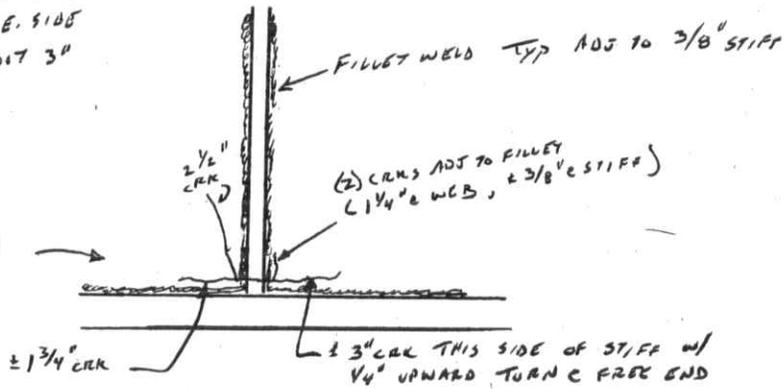
SP #1, GIRDER I @ 3<sup>RD</sup> INT DIAPH, W. ELEV  
(LOWER J-84 E/B CENTER LN)

- BOT PORTION OF WEB BULGED ± 5/8"
- DIAPH "PUSHED THRU" WEB
- DIAPH LOWN R & E. SIDE W/ MINOR BEND & HIT 3"

CRK =  $1\frac{3}{4} + \frac{3}{8} + 3 = \underline{\underline{5\frac{1}{8} \pm}}$
