STRUCTURE NO. 01428D

I-91 TR 840
over
I-91 NB,US44 EB,RR,CT RV
HARTFORD

Routine Inspection
on
3/22/2007

Bridge No. 01428D carries Interstate 91 TR840 over Interstate 91 Northbound, US Route 44 Eastbound, Railroad and the Connecticut River in Hartford. The bridge consists of a 5 span, steel multi-girder superstructure with a reinforced concrete deck. The bridge is supported by concrete piers, one of which has a steel pier cap. The bridge is abutted by adjacent structures at each end (Bridges 00980A & 01428A). The bridge has an overall length of 408 feet and a curb-to-curb measurement of 25 feet. The bridge was constructed in 1961 and rehabilitated in 1990. According to information on file at ConnDOT, the bridge has an inventory load rating capacity of 51 tons for an AASHTO HS Loading. Note that this load rating did not include a steel pier cap analysis. Section losses found on the steel pier cap may warrant re-analysis of this structure. The bridge was found to be in fair condition during this routine inspection completed in April 2007.

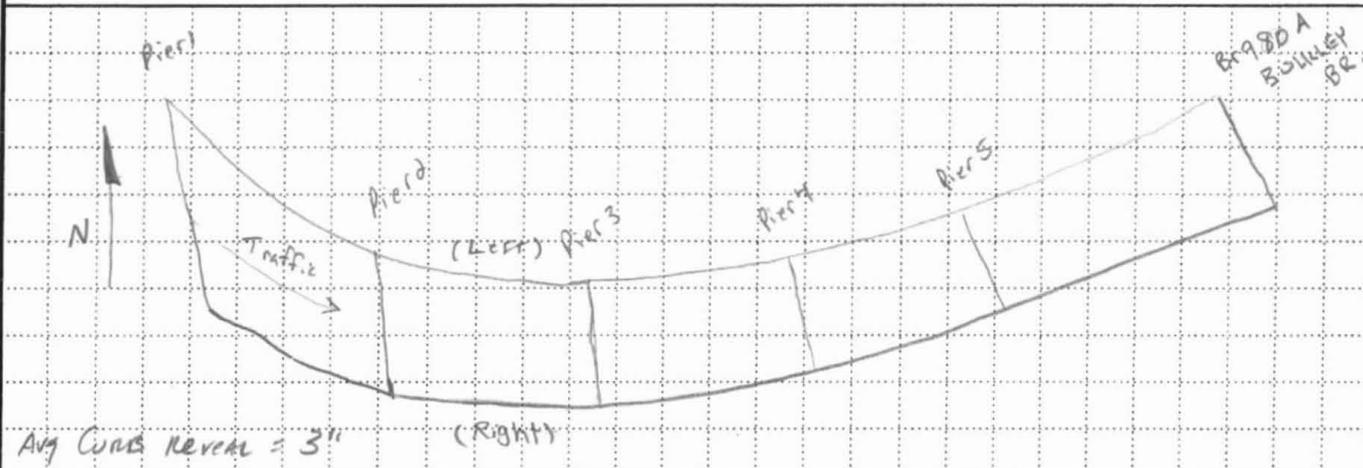
DESCRIPTION: PARAPET JOINT MEASUREMENTS

LOCATION	MEASUREMENT < 50° F				MEASUREMENT > 50° F				JOINT TYPE
	LEFT	RIGHT	TEMP	DATE	LEFT	RIGHT	TEMP	DATE	
Pier 1	1 1/16	1 5/16	48°	3/31/07					Comp. Seal
Pier 2	1 2/16	1 7/16	48°	3/31/07					Comp. Seal
Pier 3	1 4/16	1 7/16	48°	3/31/07					Comp. Seal
Pier 4	1 6/16	1 14/16	48°	3/31/07					Comp. Seal
Pier 5	2 7/16	2 3/16	48°	3/31/07					Strip Seal
End	**	1 0/16	48°	3/31/07					Saw and Seal

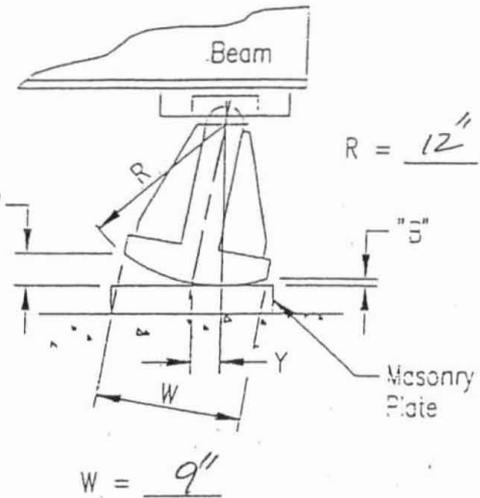
Beam	"F"	"B"	Y	Cont. or Exp.	Comments
1	1 1/8"	1 1/8"	7/16"	E	A Bolt nuts exhibit up to 90% S. Loss. Drop bolt nuts, up to 95% S. Loss (painted over)
3	1 3/16"	3/4"	9/16"		
4	1 1/16"	5/8"	9/16"	E	severe S. Loss & A. Bolt nuts up to 100%.
3	1 3/16"	7/16"	1/2"		
6	5/8"	1 3/16"	3/4"	C	Lt. to mod imp. rust @ bottom rocker
3	7/8"	1 1/8"	5/16"

- Mod to HVY spotty Pigeon debris on Brgs, mainly @ the S. end.
- Mod. imp. rust @ rocker bottom up to 1/8".

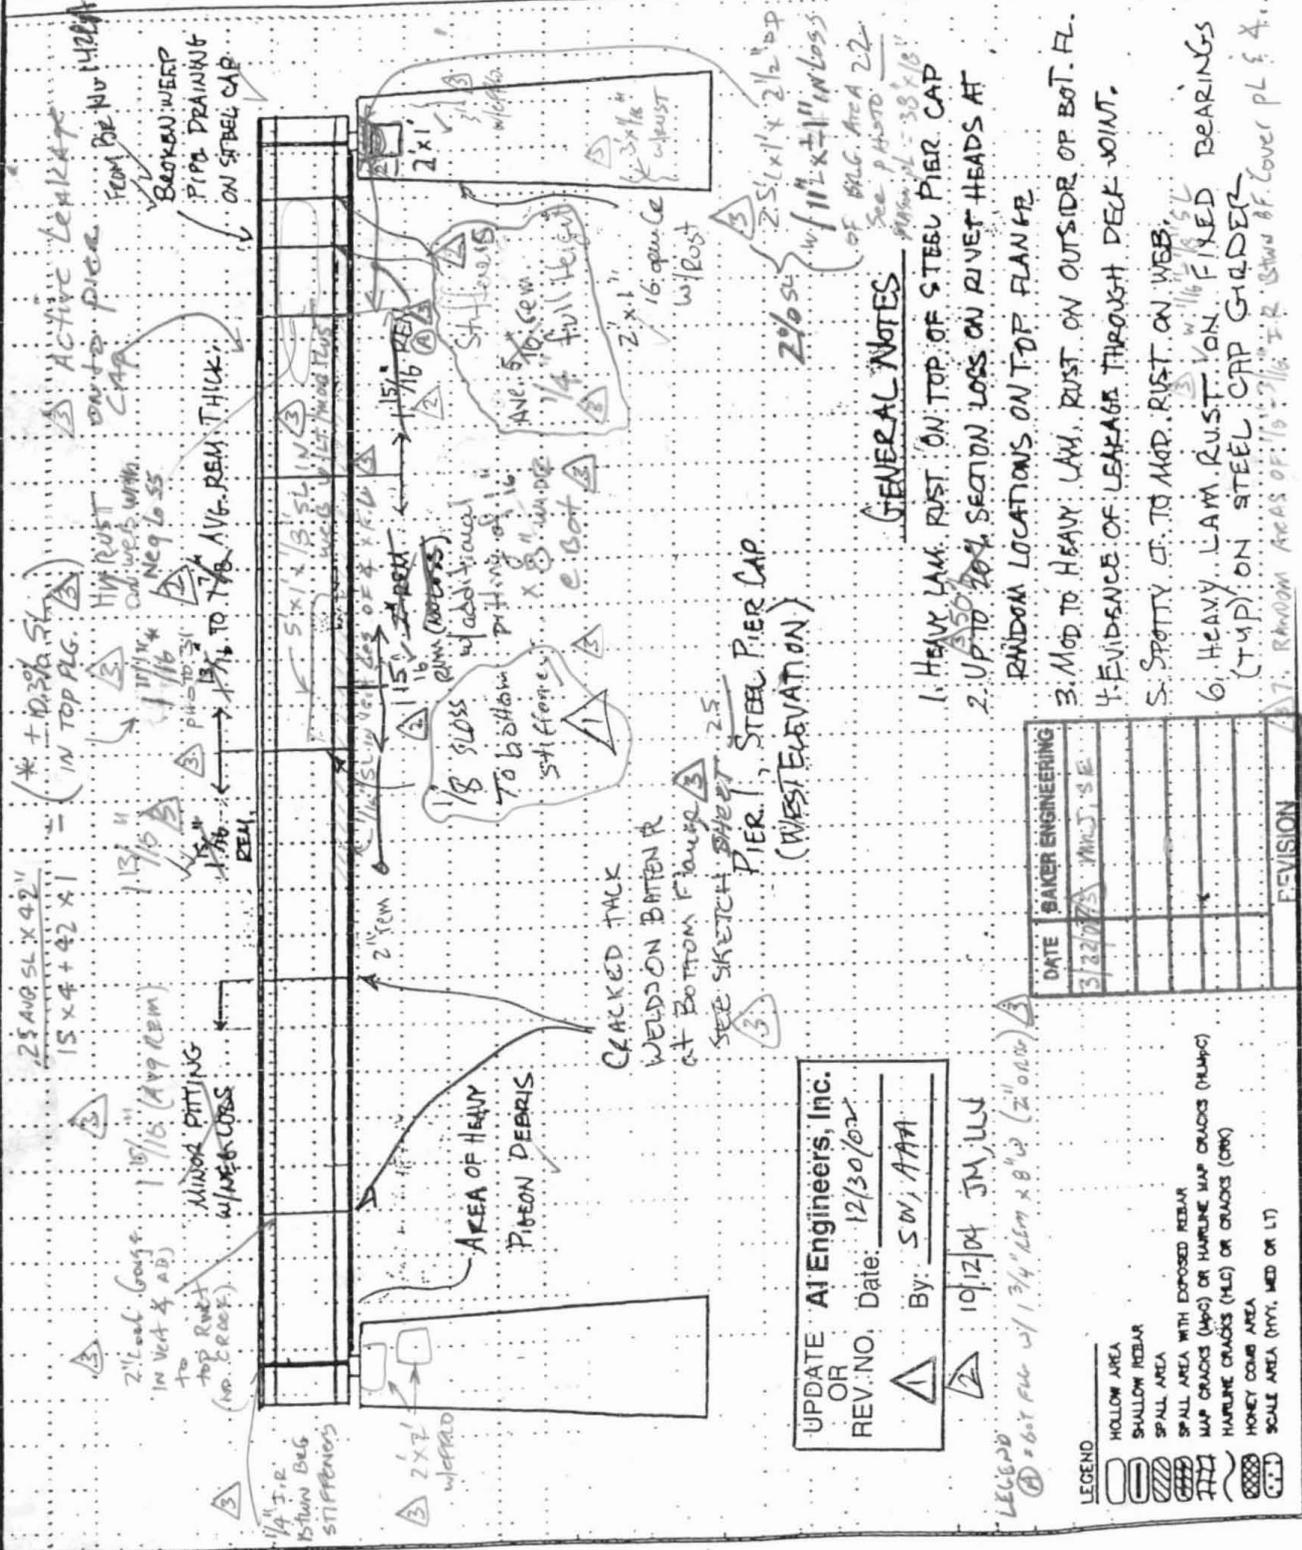
<h1 style="margin: 0;">SUPPLEMENTAL SHEET</h1> <p style="margin: 0;">□ FIELD ORIGINAL ■ TRANSCRIBED BY: JJA</p>	JOB NO. 170-1965	BRIDGE NO. 014281
	DATE: 1/2/01	SHEET 23 OF 51
DESCRIPTION: SUBSTRUCTURE FIELD NOTES	CREW: JJA, MARJ	REVISED 5/16/01

1. HEAVY LAM. RUST ON TOP OF STEEL PIER CAP
2. UP TO 20% SECTION LOSS ON RIVET HEADS AT RANDOM LOCATIONS ON TOP FLANGE
3. MOD TO HEAVY LAM. RUST ON OUTSIDE OF BOT. FL.
4. EVIDENCE OF LEAKAGE THROUGH DECK JOINT.
5. SPOTTY C. TO MOD. RUST ON WEB
6. HEAVY LAM. RUST ON FIXED BEARINGS (TYP) ON STEEL CAP GIRDER
7. RANDOM AREAS OF 1/8\"/>

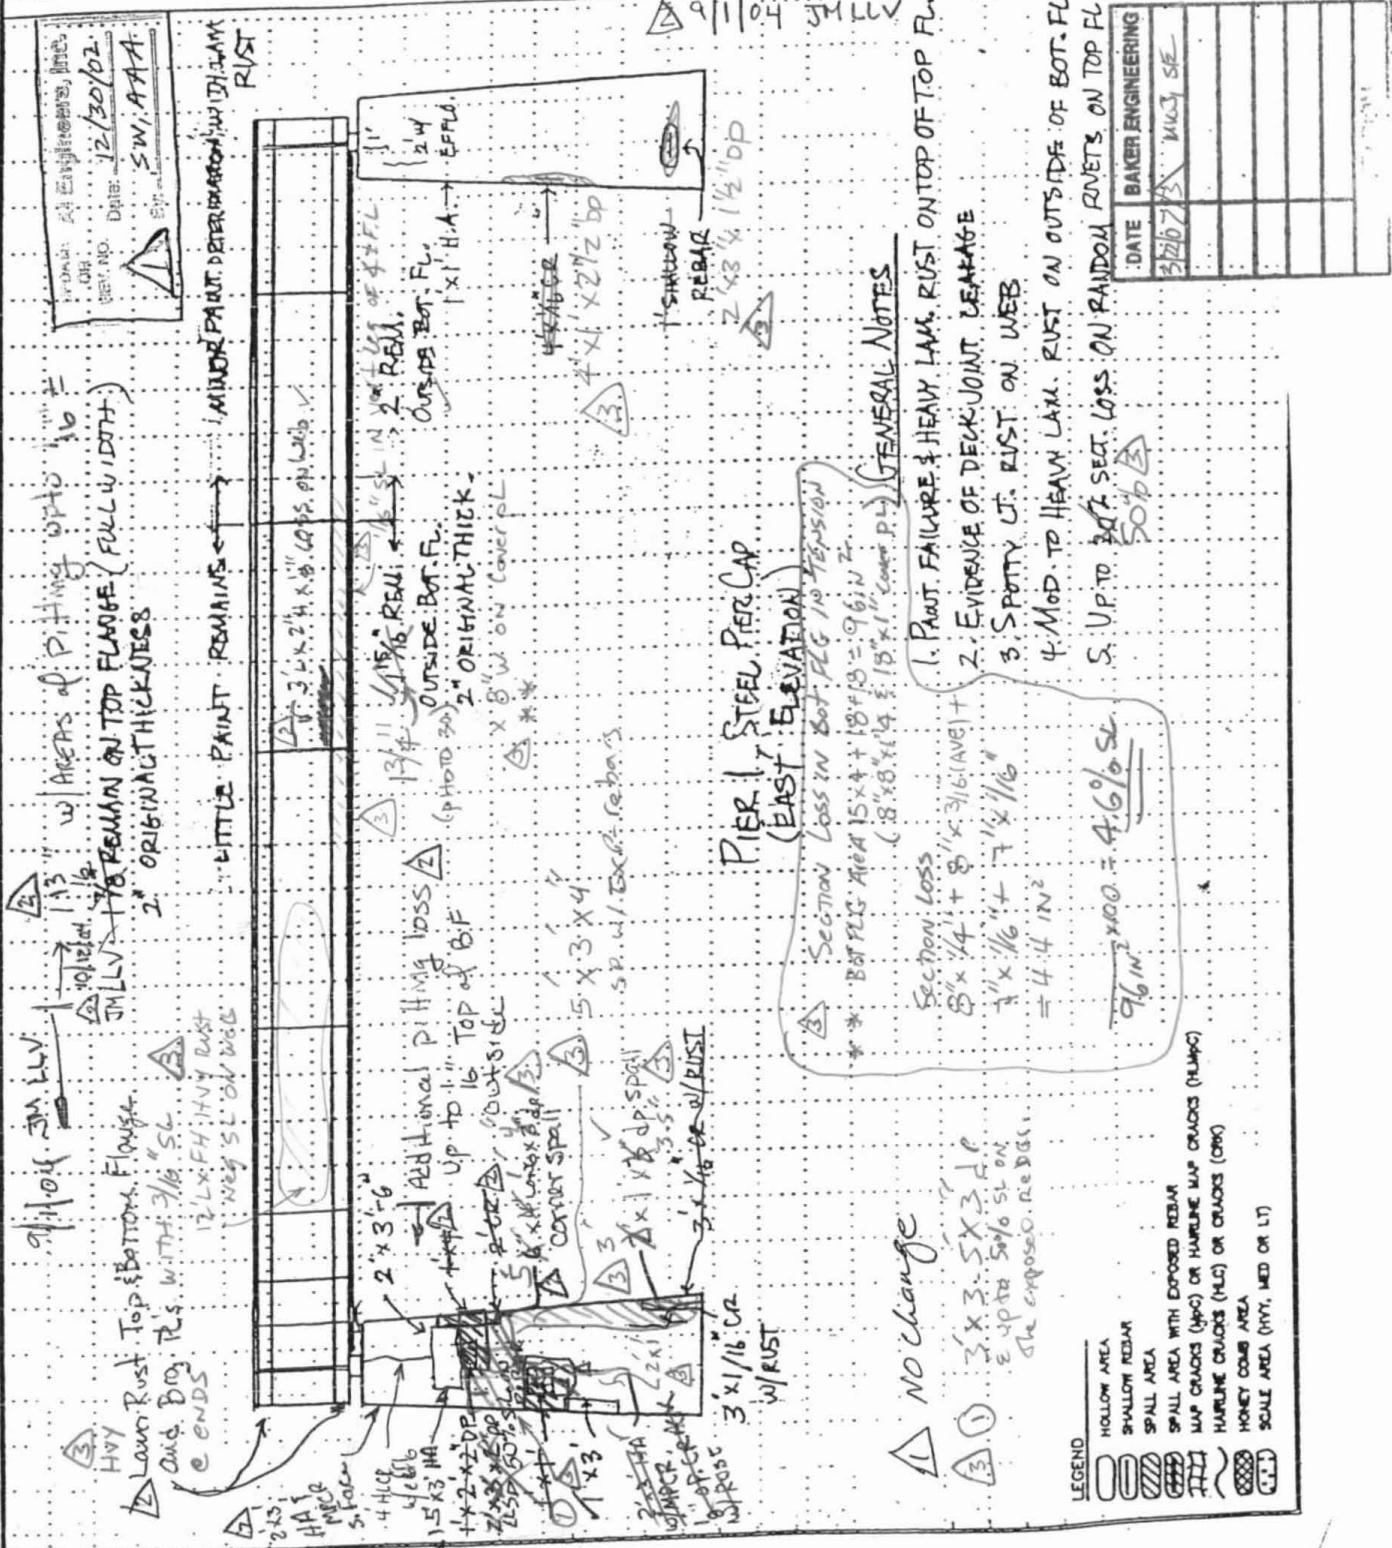
<h2>SUPPLEMENTAL SHEET</h2> <p>FIELD ORIGINAL TRANSCRIBED BY: <u>JJA</u></p>	JOB NO. 170-1965	BRIDGE NO. 014281
	DATE: 1/2/01	SHEET 24 OF 51
DESCRIPTION: SUBSTRUCTURE FIELD NOTES	CREW: JJA, MRJ	REVISED 5/14/01

PIER 1 STEEL PIER CAP (EAST ELEVATION)

Section Loss in Bot. Flg. No Tension
 BOT FLG. AREA 15' x 4' + 18' x 3' = 96 in²
 (.8' x 8' x 1/4" + 18' x 1" cover p.l.)

- GENERAL NOTES
1. PAINT FAILURE & HEAVY LAM. RUST ON TOP OF TOP FL.
 2. EVIDENCE OF DECK JOINT LEAKAGE
 3. SPOTTY UT. RUST ON WEB
 4. MOD. TO HEAVY LAM. RUST ON OUTSIDE OF BOT. FL.
 5. UP TO 30% SECT. LOSS ON RANDOM POINTS ON TOP FL.

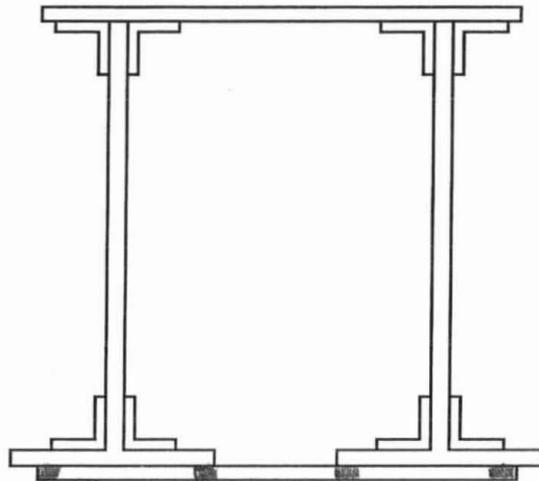
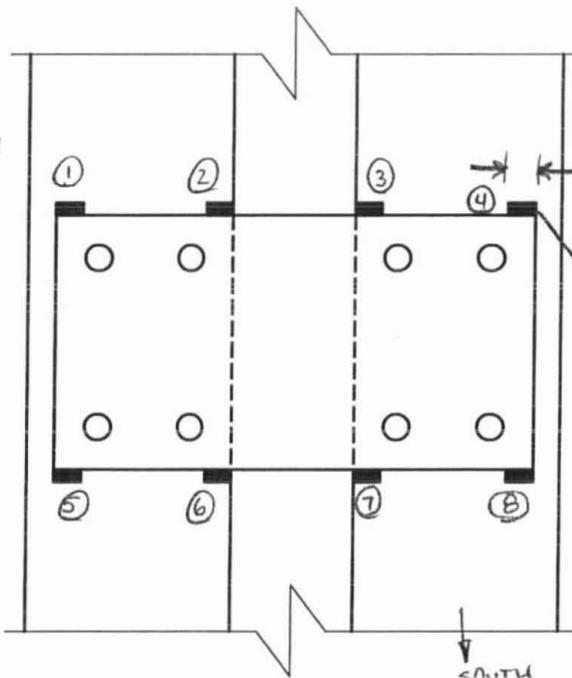
CAP GIRDER AT PIER 1

TYP. TACK WELD

1. Clean and paint the steel cap girder at pier 1 (700 Square Feet). *Rehab*
2. Remove the cracked tack welds along the cap girder batten plates (± 6 Linear Feet).
3. Repair areas of deteriorated concrete along the piers (± 2 Cubic Yards). *Repair / Rehab*

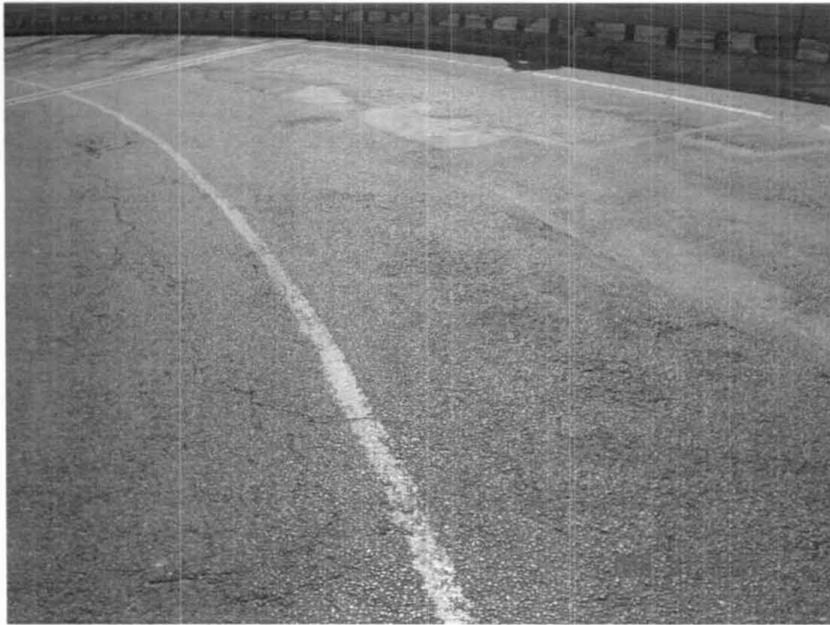
RATING	
OVERLAY	6	The bituminous overlay exhibits cracks up to 1.5" wide, random potholes up to 2' x 6" x 1" deep, areas of raveling, and random settled/depressed areas up to 1/2" deep. See sheets 13-15 and photos 9-12 .
DECK STR. CONDITION	7	The stay-in-place forms have small areas of light rust around PVC drains. The bare concrete deck overhangs have transverse hairline cracks at random locations. Note that since there are stay-in-place forms, a BRI-10 was not generated. The total deck deterioration is less than 1%. See sheets 18-22 and photo 8.
CURBS	7	Sloped Granite. Random scrape marks and a few random spalls up to 9" x 4" x 2" deep with isolated exposed rebar at the joints where the curbs are concrete. The average curb reveal is 3". See the "Expansion Joint" item below for the loose curb plate. See sheets 13-15 and photo 14.
MEDIAN	N	
SIDEWALKS	6	North side only in Spans 4 and 5. The sidewalk exhibits a few random transverse hairline cracks, minor light debris and an accumulation of sand. There is up to 1-1/2" of settlement/vertical misalignment at the end of the sidewalk over pier 4. See sheets 13-15 and photo 13.

Photo # 9: Typical top of deck.

1. Repair potholes and depressed areas in the overlay (<1/2 Ton).
2. Repair the settlement of the approach sidewalk at pier 4 (<1/4 Cubic Yard).
3. Repair short and/or missing weeps that drain onto bridge elements below (± 25 Linear Feet).
4. Repair areas of active leakage along the piers 1 and 5 deck joints (± 25 Linear Feet).

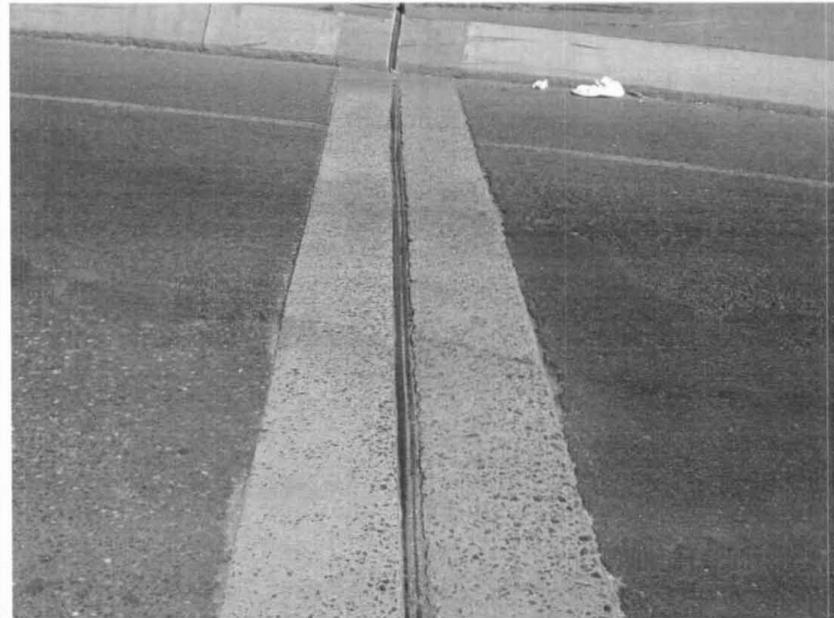
UTILITIES TYPE/SIZE	N	
CONSTRUCTION JOINTS	N	
EXPANSION JOINTS	5	Compression seal with concrete headers at Piers 1-4 and strip seal with concrete headers at Pier 5. There is sand, typical in the joints, and the concrete headers have random longitudinal hairline cracks, minor edge spalling, and light scaling throughout. The joint plate at the north curb over pier 5 is disconnected. The bituminous patch at the joint at the east end of the bridge (junction with Bridge 00980A) is depressed up to 2' wide x 1" deep throughout. There is evidence of active leakage at random locations throughout. Only piers 1 and 5 joint exhibited

58. DECK **OVERALL RATING** 7
active leakage at the time of inspection. See sheets 13-15 & 18-22 and photos 16, 17 and 24.

Photo # 16: Typical compression seal joint.

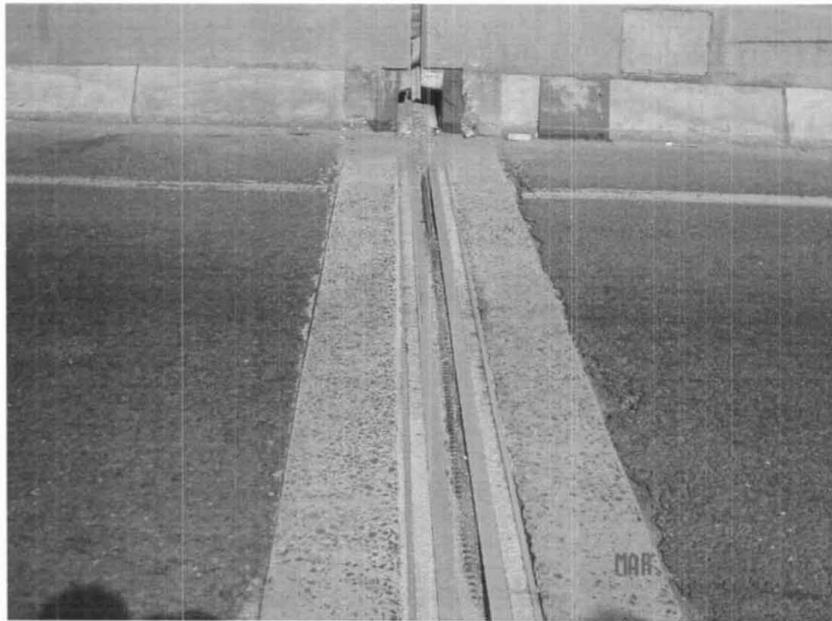
Photo # 17: Typical strip seal joint over pier 5.

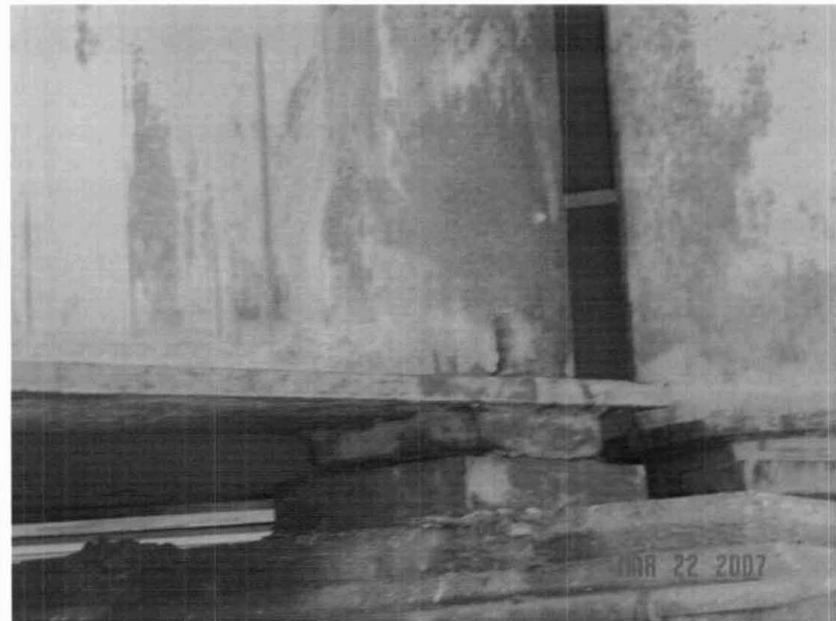
RATING	
BEARING DEVICES	5	<p>The fixed and elastomeric bearings exhibit moderate to heavy laminated rust to the steel plates with up to 1/8" deep section losses. Fixed bearings have up to 1/4" impacted rust between sole and masonry plates. There are random tilted anchor bolts, random missing anchor bolt nuts and random anchor bolt nuts with up to 100% section loss. See sheets 18-22 and photos 18-21.</p> <p>Rocker bearings at pier 5: Rocker bearings exhibit light to moderate rust, up to 100% loss of anchor bolt nuts, and up to 1/8" impacted rust below the rockers. Bearings exhibit evidence of movement, based on comparison with previous measurements. See sheet 17.</p> <p>Cap girder bearings at pier 1: The curved sole plate bearings for the steel cap girder exhibit heavy laminated rust with up to 1/16" deep section loss to the plates. The cap girder bearing at column 2 is undermined 11" x 1" (approximately 2%) due to a spall below. See sheets 23 & 24 and photo 22.</p>

Photo # 18: Typical fixed bearing.

1. Repair the spall that undermines the cap girder bearing at pier 1, column 2 (<1/4 Cubic Yard).
2. Clean and paint the girder ends and bearings (1500 Square Feet). *Rehab*
3. Continue to monitor span 1, girder 2 copes near pier 2 for cracking.
4. Repair the cracked diaphragm weld at the south elevation of girder 3, span 1 at the second intermediate diaphragm lower strut (0.5 Linear Feet).

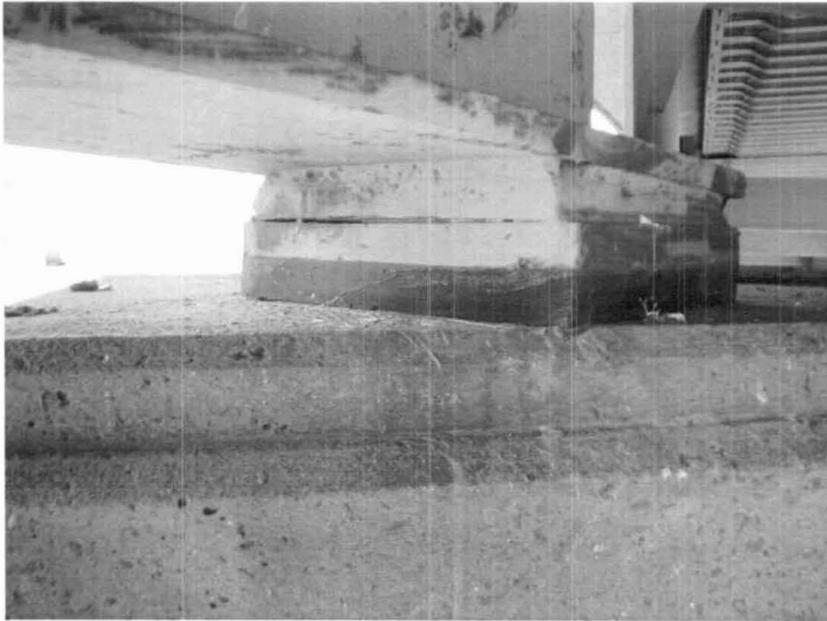
Photo # 19: Typical expansion (elastomeric) bearing.

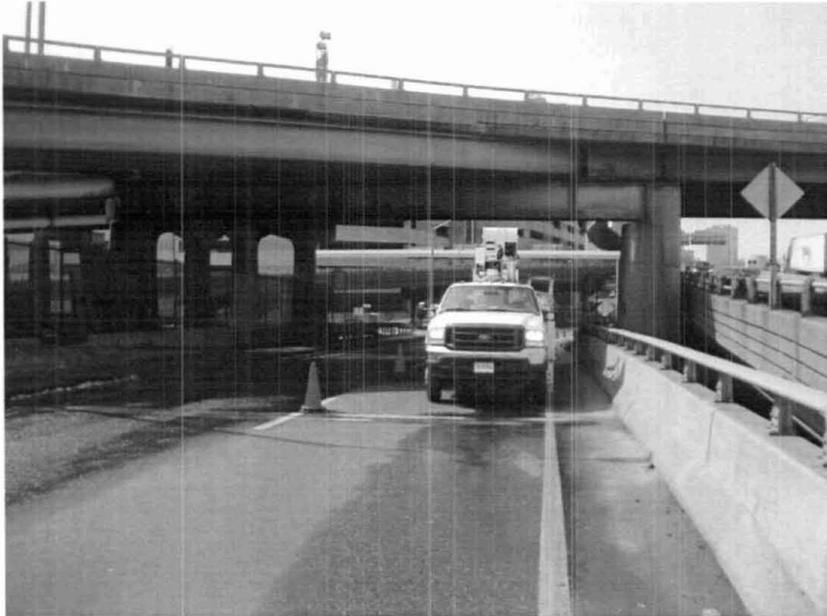
60. SUBSTRUCTURE		OVERALL RATING 4
	<small>RATING</small>	
ABUTMENTS-STEM	N	
ABUTMENTS-BACKWALL	N	
ABUTMENTS-FOOTINGS	N	
ABUT.-SETTLEMENT	N	
ABUTMENTS-WINGWALLS	N	
PIERS/BENTS-CAPS	4	<p>Riveted steel pier cap (Pier 1 only). The steel pier cap at pier 1 exhibits areas of heavy laminated rust and section loss. The top flange (1" thick cover plate and 1" thick angles) has areas of as little as 1-11/16" remaining, resulting in a maximum of <u>10.3%</u> top flange average loss across the entire width. The bottom flanges have areas of section loss, up to 4.6%. The web plates have areas of up to 1/8" deep x 1' high loss at the web bases, resulting in up to 5% web loss. Several tack welds at the batten plates are cracked and/or broken. There is up to 3/16" impacted rust between the cover plates and angles. Random rivet heads have up to 50% section loss. See sheets 23-25 and photos 29-32.</p> <p>Concrete pier caps (piers 2, 3 & 5): Concrete pier caps exhibit hollow areas up to 3' x 3', popouts, spalls up to 1' diameter x 1" deep, isolated spalls with exposed rebar up to 1' x 6" x 1" deep, isolated scaling up to 1" deep, and random cracking, up to 1/16" wide with rust and efflorescence. See sheets 26-33.</p>

PIERS/BENTS-PILE BENT	N	
PIERS/BENTS-COLUMN	5	<p>Concrete pier columns (piers 1, 2, 3, & 5): Concrete pier columns exhibit random shallow rebar, hollow areas up to 3' x 3.5', spalls up to 5' x 3' x 4" deep with exposed rebar with section loss, popouts, isolated hairline map cracking, and cracks up to 1/16" wide with rust and efflorescence. See sheets 23-29 & 32 & 33 and photos 22, 33 & 34.</p> <p>Solid pier stem at pier 4: Pier stem exhibits random popouts, shallow rebars, spalls up to 1' x 7" x 1" deep with exposed rebar, and isolated hairline cracks with efflorescence. See sheets 30 & 31.</p>
PIERS/BENTS-FOOTINGS	N	Not visible.
PIERS/BENTS-SETTLEMENT	8	None noted.
EROSION-SCOUR	8	No deficiencies.
CONCRETE CRACK-SPALL	5	See above items.
STEEL CORROSION	4	See "Piers/Bents Caps" item above.
PAIN	3	More than 50% of the painted surfaces along the steel pier cap at pier 1 exhibit deterioration. See photos 27 and 29.

Photo # 27: Typical elevation of steel pier cap (pier 1).

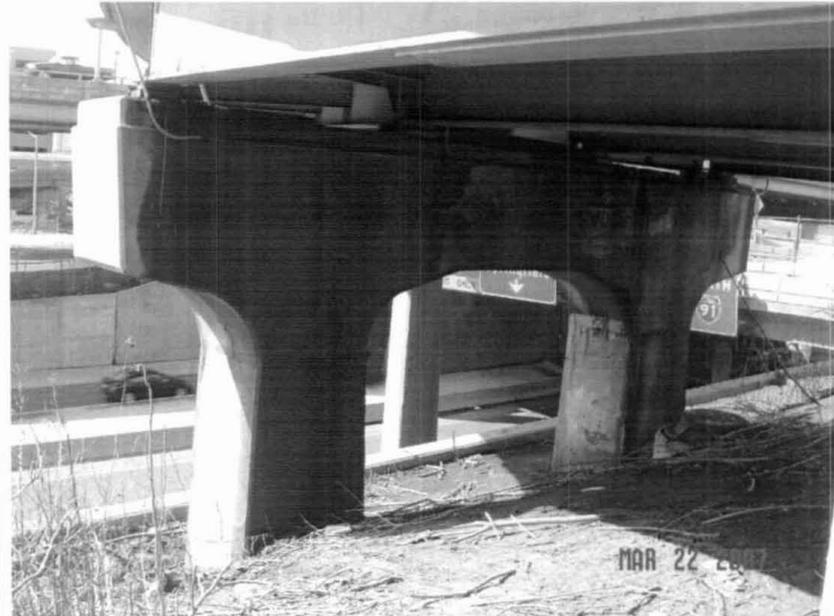
Photo # 28: East elevation of pier 3 (typical).

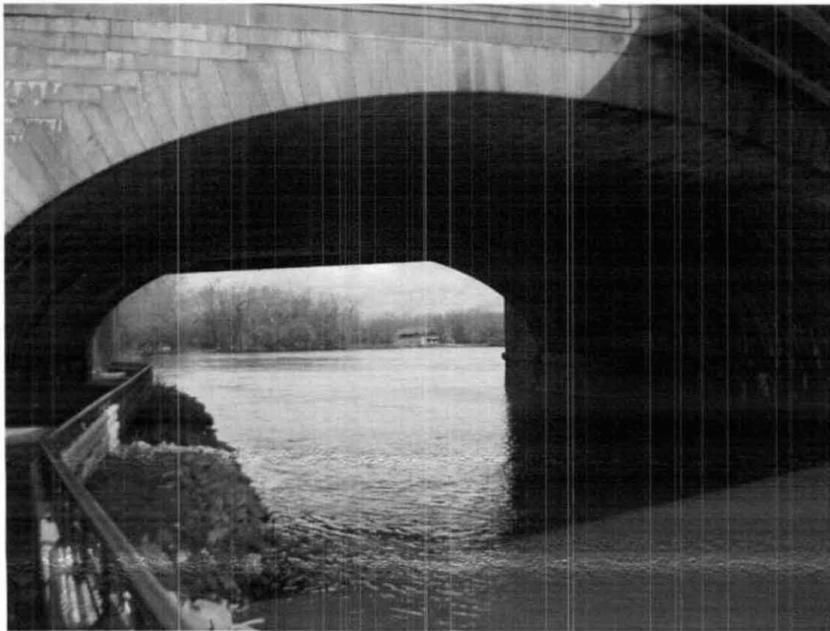
CHANNEL SCOUR	8	Channel under Span 5 only. See photos 35 & 36.
EMBANKMENT EROSION	8	
DEBRIS	8	
VEGETATION	7	Light growth under span 5 only.
CHANNEL CHANGE	8	
FENDER SYSTEM	N	
SPUR DIKES & JETTIES	N	
RIP RAP	8

Photo # 35: Looking upstream from bridge.

Bridge #00980A in photo (1428D is in upper right corner)

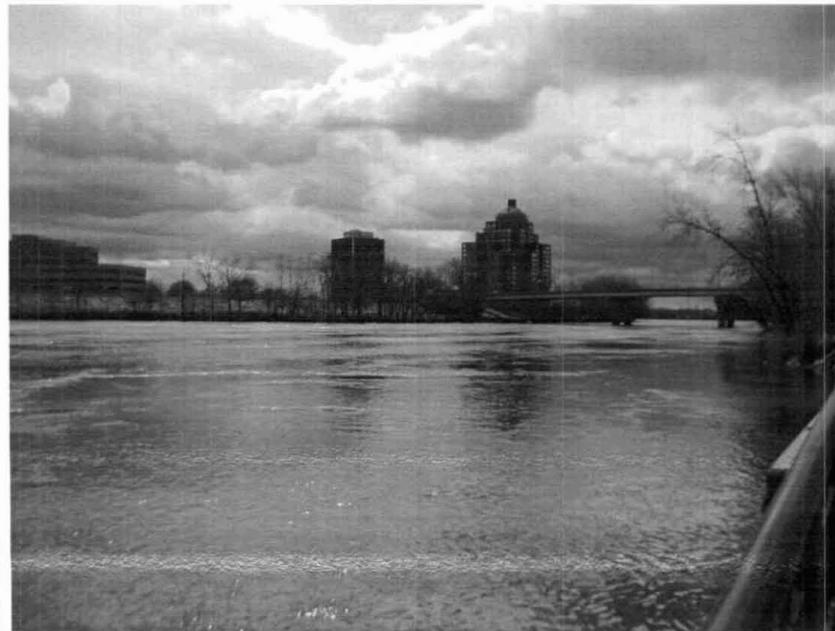
Photo # 36: Looking downstream from bridge.
