Structure No. 03290

Route 9 North Bound

Nedobity Road

Routine Inspection

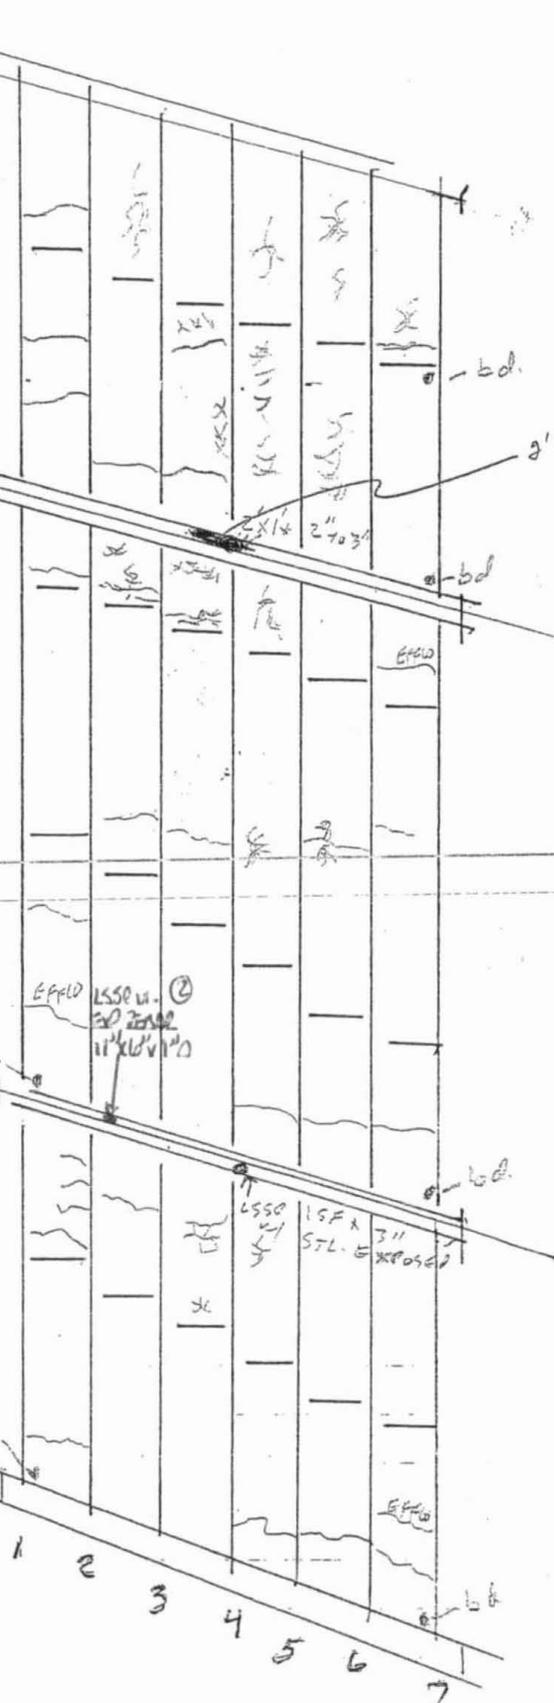
LIGHT RUST  
IN THIS AREA IS  
TYPICAL ON BEAMS

- bd = blind drains
- ~ = TV HLC
- \* = MP HLC
- ⊙ = SPALL
