TASK 210: SURFICIAL SITE INVESTIGATION

**IMPROVEMENTS TO ROUTES 82 AND 85
SALEM AND MONTVILLE**

**ConnDOT Assignment No. 95632
ConnDOT Project No. 0120-0079**

Atlantic Project No. 1178-075-210

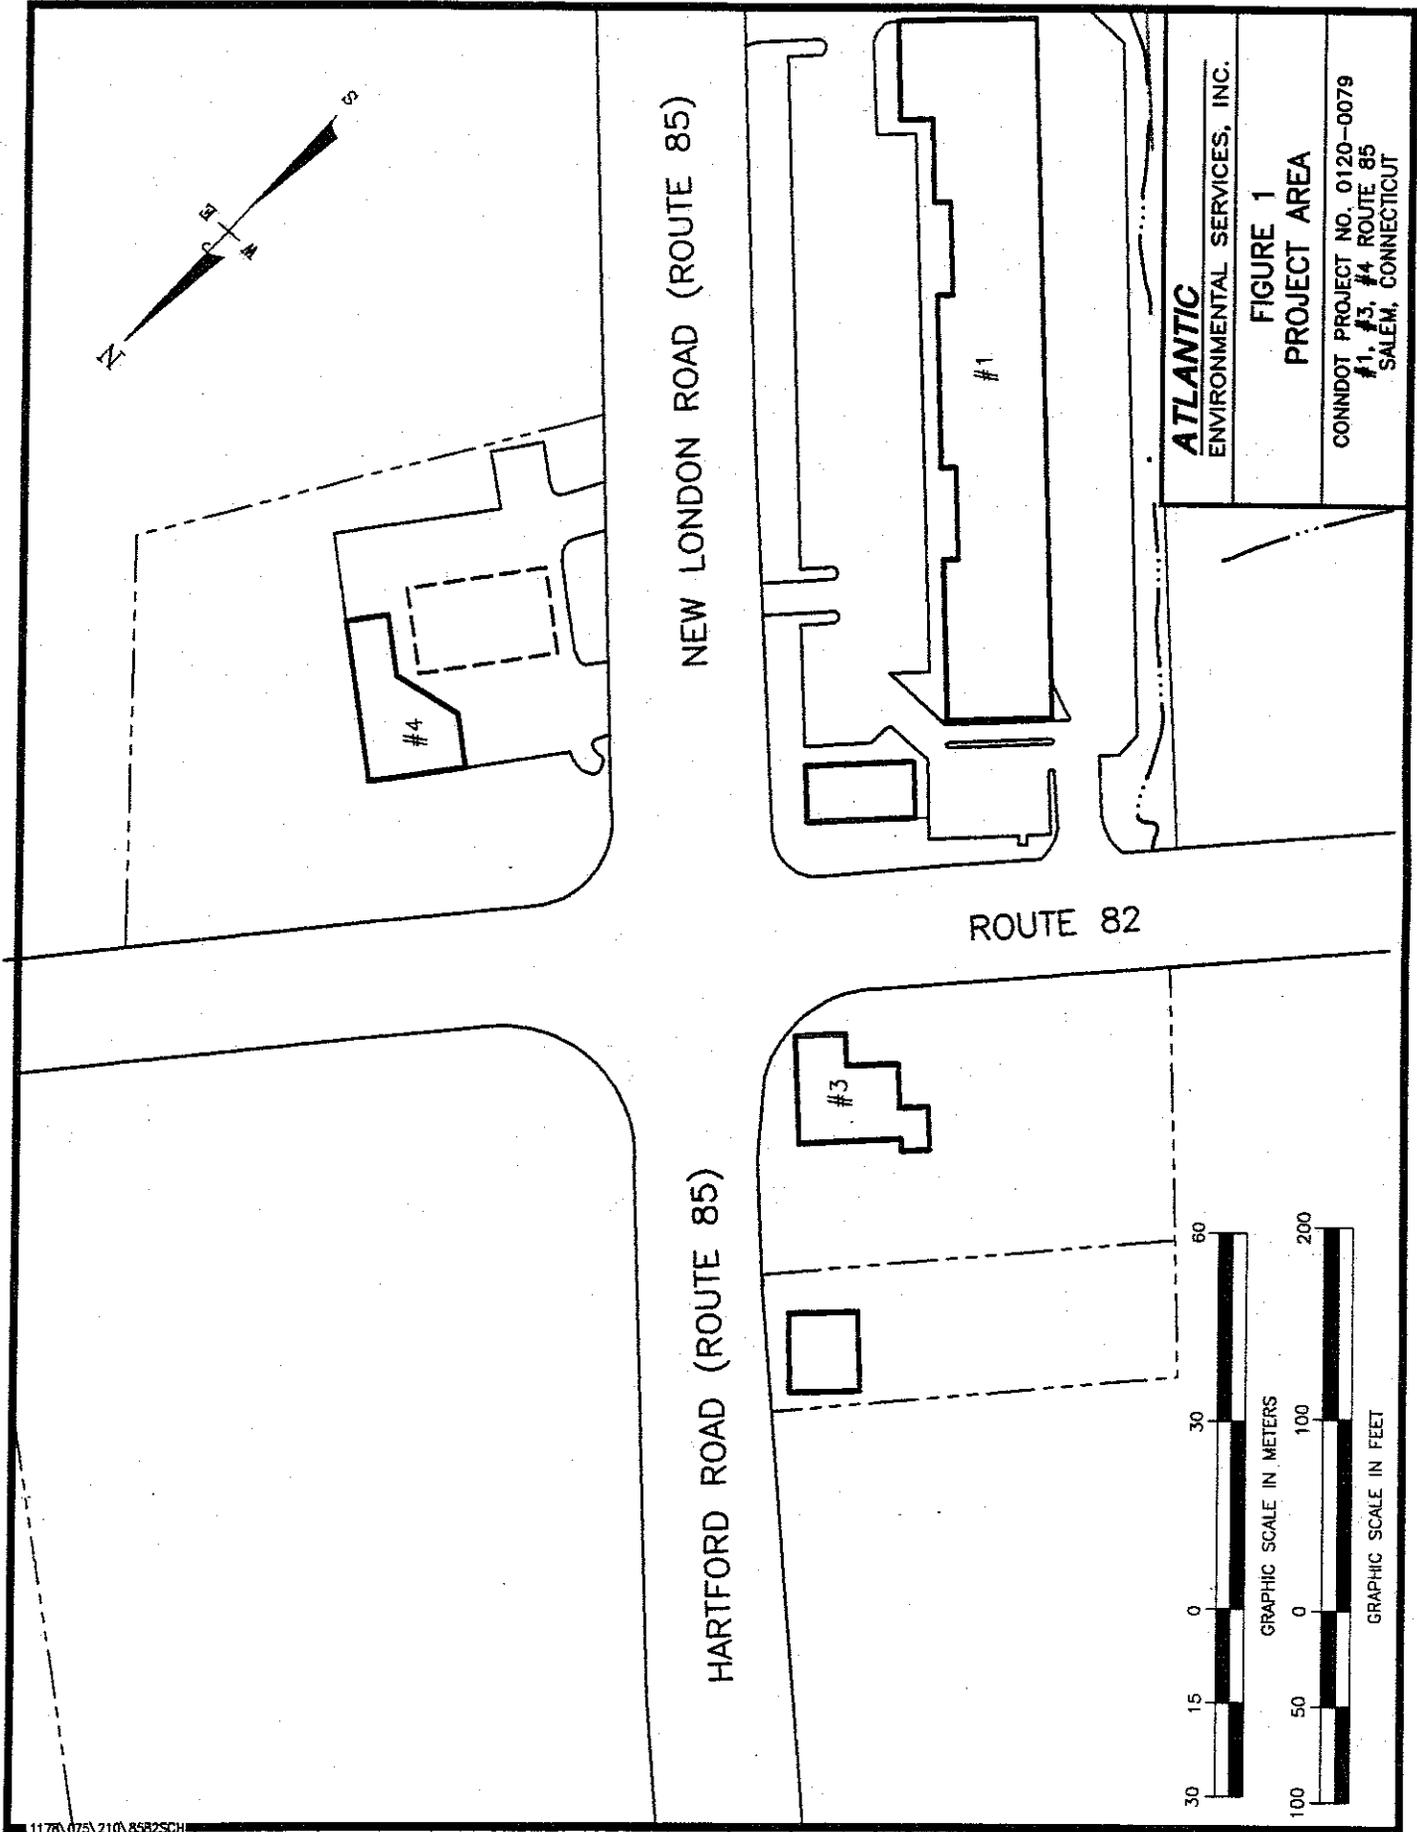
ATLANTIC
 ENVIRONMENTAL SERVICES, INC.
FIGURE 1
PROJECT AREA
 CONNDOT PROJECT NO. 0120-0079
 #1, #3, #4 ROUTE 85
 SALEM, CONNECTICUT

Environmental concerns within the ConnDOT ROW at the intersection of Routes 82 and 85 in Salem, Connecticut include, but are not limited to: former/current gasoline stations and automobile and autobody repair activities; documented releases of gasoline and other petroleum products and impacts to soils and groundwater; current/former underground storage tanks (USTs); documented leaking UST incidents; potential contamination leaching from individual septic systems; hazardous waste generation; and improper waste oil handling practices.
