Individual Station Report

Wilton

Connecticut Department of Transportation

CONDITION INSPECTION
FOR THE
WILTON STATION

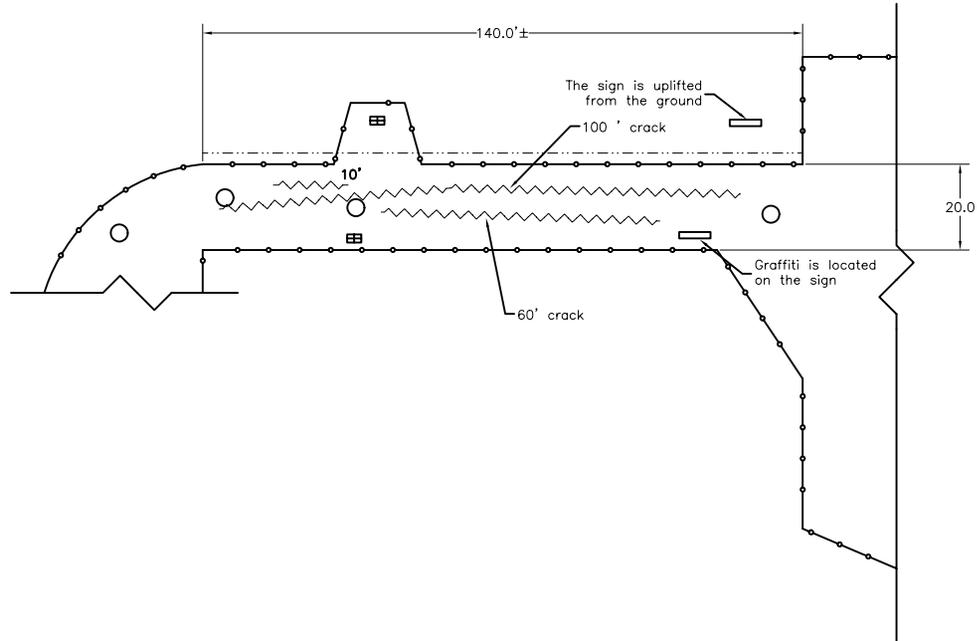
Urbitran Associates, Inc.
Connecticut Dept. of Transportation
Wilton Station Quadrant III Plan
Date: 12-13-01

1. The parking lot appears to be a new lot and the only entrance is blocked by a concrete barrier
