Lessons Learned Catenary Work Items

NEW HAVEN MAIN LINE
CATENARY REPLACEMENT BETWEEN STRUCTURES 236 AND 356A
CATENARY SYSTEM INTERIM CONTACT WIRE LOWERING

Metro-North Railroad Bridges in Greenwich, CT
CDOT Project Nos. 56-248, 301-0042/0044

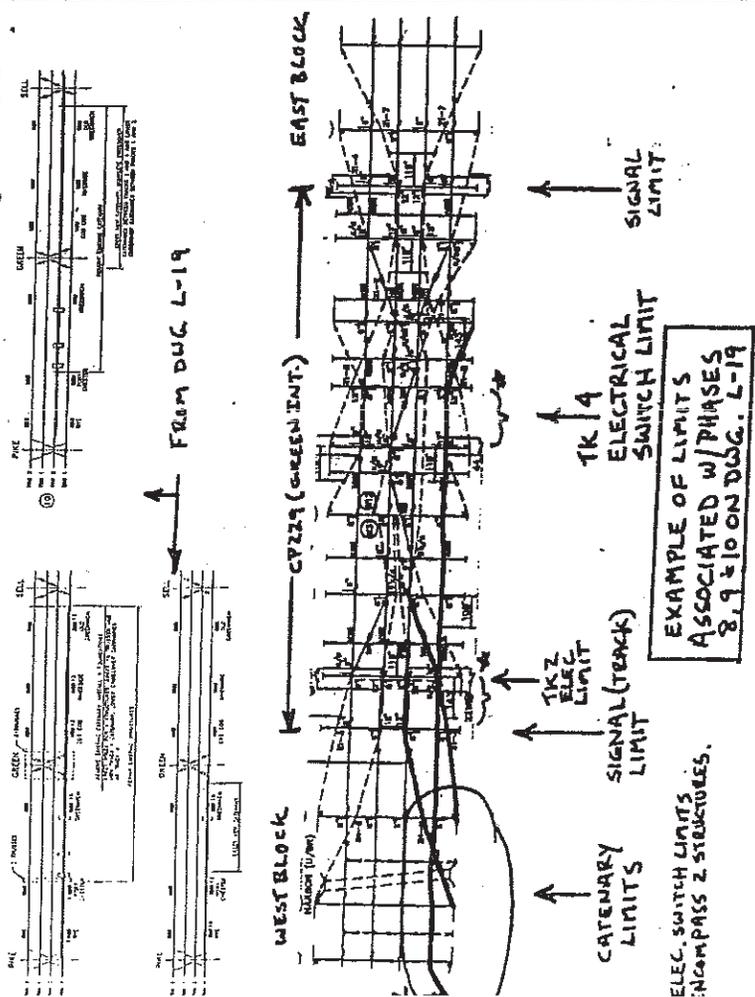
ATTACHMENT "B"

The contract drawings L-18 to L-20 accurately depict the electrical switching limits. They do not clearly indicate the signal (track) limits or the new catenary limits. All of the new catenaries extend beyond the electrical and signal limits as they go out-of-running and terminate.
