**NATIONAL INSTITUTE FOR  
OCCUPATIONAL SAFETY AND HEALTH**

**ENVIRONMENTAL AND MECHANICAL  
SYSTEM ASSESSMENTS**

**25 SIGOURNEY STREET, HARTFORD, CT**

**EH&E Report #11767**  
**May 5, 2004**

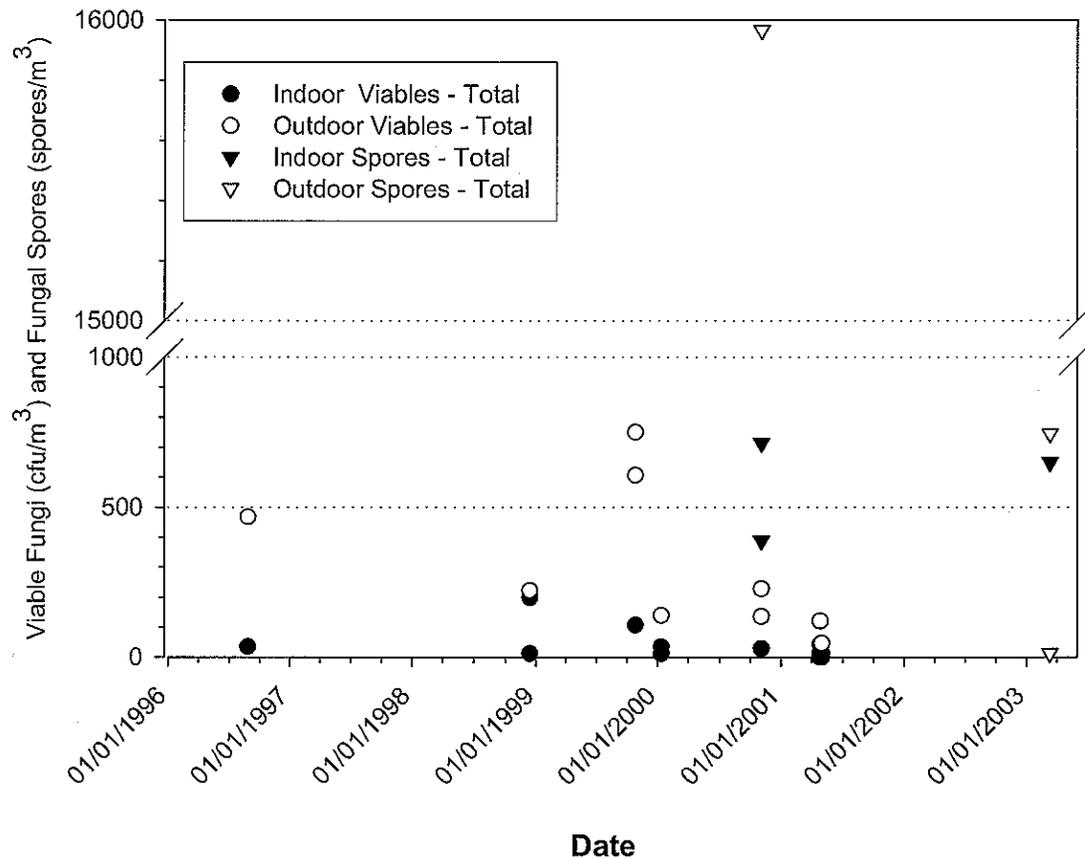
**Figure 2.1** Minimum and Maximum Airborne Fungal Concentrations Measured during Eight Monitoring Periods at 25 Sigourney Street, Hartford, CT

Indoor air concentrations of viable fungi or fungal spores were measured in more than 100 locations distributed over 15 floors of the building between October 1996 and April 2001. On each occasion, at least one corresponding outdoor air sample was also collected. As shown in Figure 2.1, total culturable fungi concentrations in indoor air were less than 200 cfu/m<sup>3</sup> and levels of total fungi indoors were less than those in outdoor air. The types of fungi in the indoor and outdoor air samples were similar, typically *Cladosporium* and basidiospores.

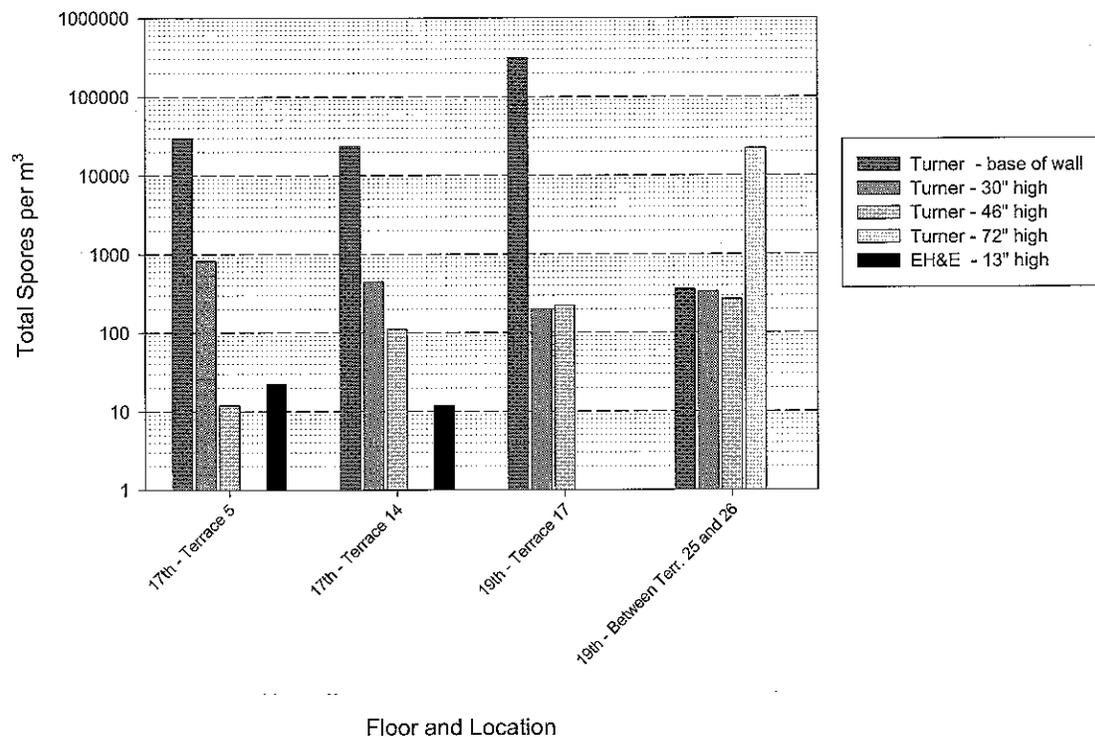
**Figure 3.2** Wall Cavity Samples—March 2000 and July 2002

Figure 3.2 presents a summary of data from WallChek<sup>®</sup> samples collected in March 2003 by EH&E following perturbation of the wall. Data presented by the Turner Group from a wall cavity evaluation completed in 2000 are also shown in the chart.<sup>25</sup> The wall cavity samples from the Turner Group were collected adjacent to areas of visible mold growth and were also collected following wall perturbation. The data in this figure are reported as total spores/m<sup>3</sup> of air and plotted on a logarithmic scale.

The Turner Group collected their samples from a series of heights at each sampling location to evaluate the spatial extent of potential fungal growth inside the wall cavity. The results from the report indicated high levels of spores in the wall cavities at their sampling locations on the 17<sup>th</sup> and 19<sup>th</sup> floors; the highest levels were measured at the base of the wall. The Turner Group concluded that the base of the wallboard on the 17<sup>th</sup> and 19<sup>th</sup> floors was supporting mold growth. Following this report, the wallboard along an entire exterior wall on the 17<sup>th</sup> floor was removed and replaced. This replacement may account for the much lower levels of spores measured on the 17<sup>th</sup> floor by EH&E in March 2003; EH&E did not collect samples on the 19<sup>th</sup> floor at the request of the DPW.
