ETATM
EARTH TO AIR SYSTEMS
ADVANCED GEOTHERMAL HEATING AND COOLING

Re: DX Geothermal Informational Session

Water- and Soil-Side Corrosion of Copper Water Service Lines

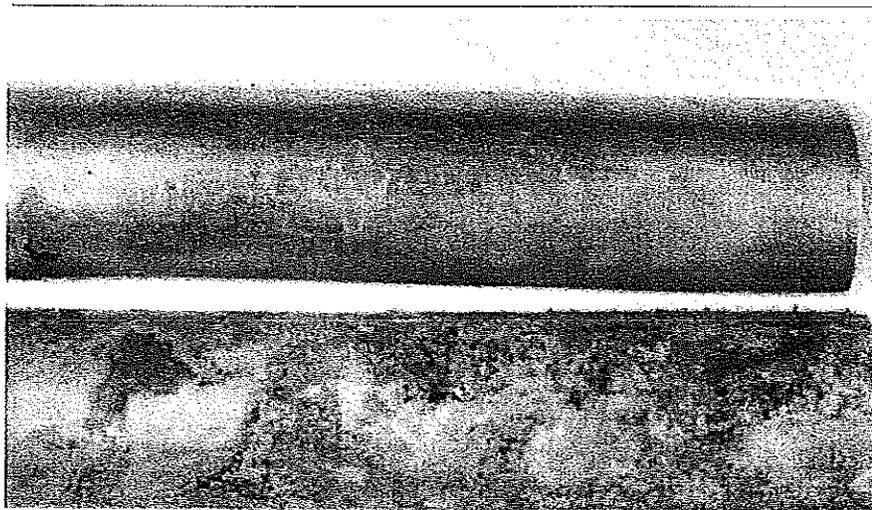
FIGURE 1

Typical outside surface condition of as-excavated tubes after up to 70 years' soil-side exposure.

A total of 110 samples of annealed-temper seamless copper water tube produced to the types K and L wall-thickness schedules of ASTM B 88⁵ from eight locations were visually examined at magnifications up to 40x. Figure 1 shows the surface condition of as-excavated tubes after

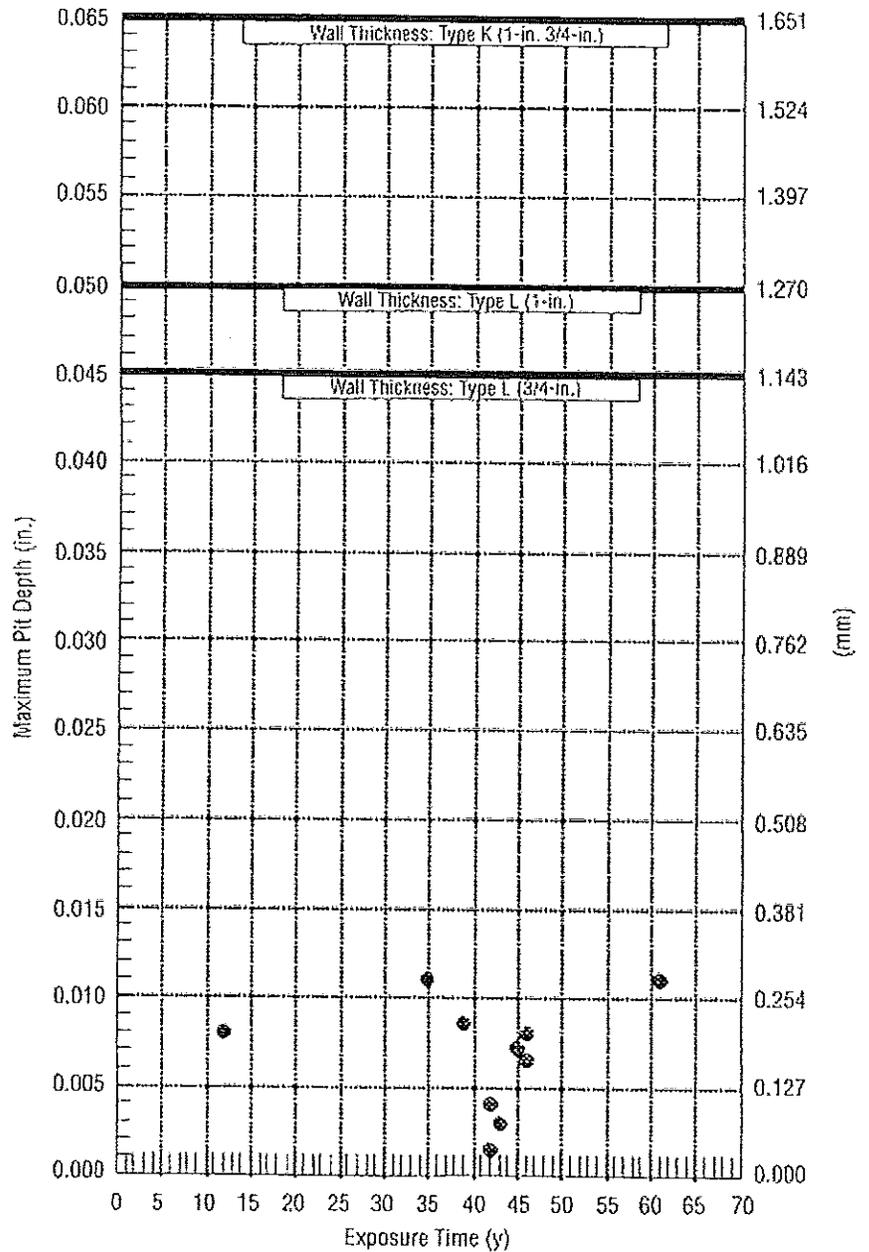
FIGURE 2
Maximum pit depth as a function of exposure time to the various soil conditions (points). Dark horizontal lines represent the original pipe wall thicknesses.

Detailed descriptions of the tubes examined in their as-excavated and cleaned conditions, together with their maximum and average depths of pitting and surface roughness, are described in Table 2. The maximum depths of pitting as a function of exposure time are plotted in Figure 2. The graph shows that even with a maximum soil-side pit depth of 0.011 in. (0.28 mm) after 35 years' exposure, the service life of the underground water lines at these locations would extend into the hundreds of years.

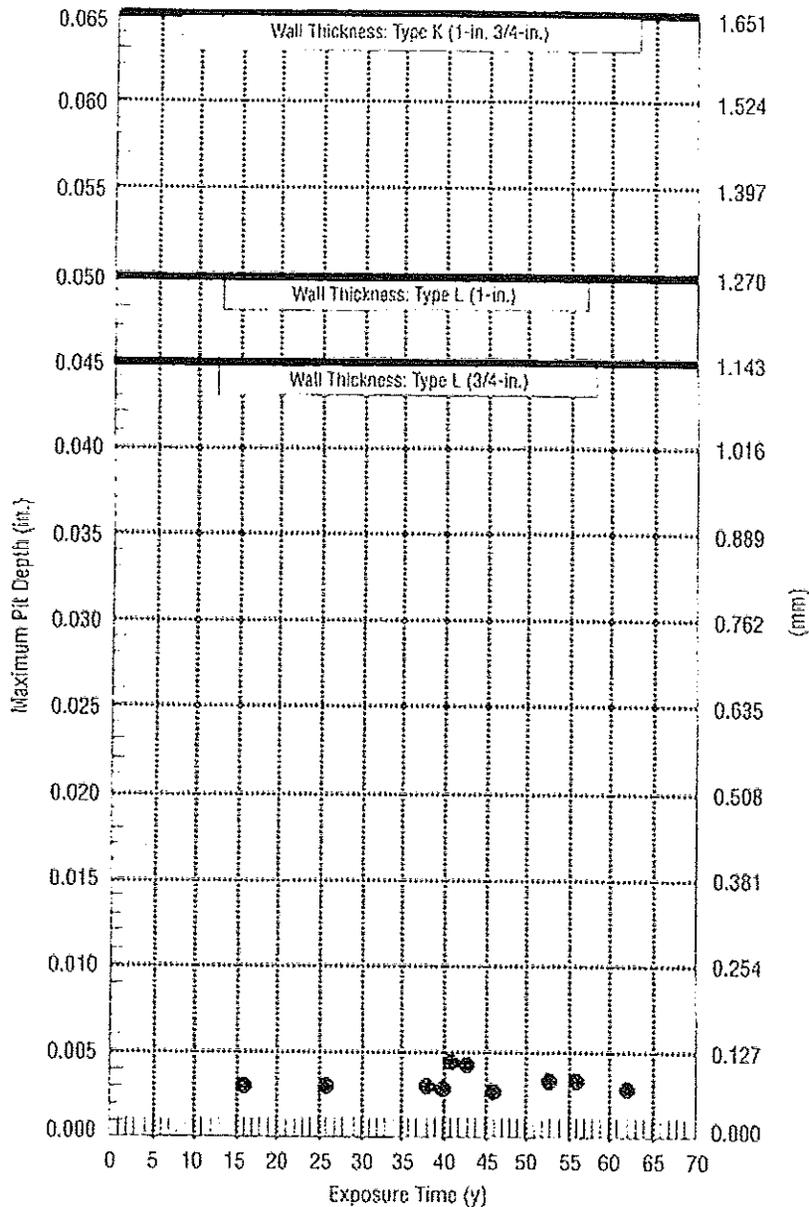
FIGURE 4

Maximum pit depth as a function of exposure time to the municipal water supply (cents). Dark horizontal lines represent the original pipe wall thicknesses.

Irregular penetration of the tube wall also occurred. Corrosion products inside the pits were predominantly cuprous oxide. The maximum depth of the pits is less than 5% of the wall thickness after 29 years' service. As demonstrated by the data plotted in Figure 4, anticipated tube service lives would be many times those of the exposures represented. The figure clearly shows that, even with a maximum water-side pit depth of 0.0044 in. (0.11 mm) after 41 years' exposure, service lives of underground water lines would extend to hundreds of years.
