ENVIRONMENTAL REVIEW REPORT

**Community Development Block Grant – Disaster Recovery
Owner Occupied Rehabilitation and Rebuilding Program**

**7 Melba Street
Milford, Connecticut**

**RE: Limited Hazardous Materials Building Inspection
Storm Sandy Residential Rehabilitation Project
7 Melba Street, Milford, Connecticut**
Fuss & O'Neill EnviroScience Project No. 20140277.D1E
Quisenberry Arcari Project No. 1346-29

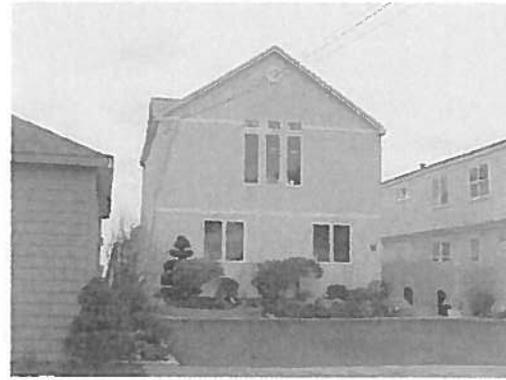
Building Photo

Building Attributes	
Field	Description
Style	Conventional
Model	Residential
Grade:	Good
Stories:	2 Stories

Occupancy	1
Exterior Wall 1	Wood on Sheath
Exterior Wall 2	
Roof Structure:	Gable/Hip
Roof Cover	Asph/F Gls/Cmp
Interior Wall 1	Drywall/Sheet
Interior Wall 2	
Interior Flr 1	Carpet
Interior Flr 2	
Heat Fuel	Gas
Heat Type:	Hot Water
AC Type:	XF Per Sq Ft
Total Bedrooms:	3 Bedrooms
Total Bthrms:	3
Total Half Baths:	0
Total Xtra Fixtrs:	1
Total Rooms:	7 Rooms
Bath Style:	Average
Kitchen Style:	Updated
Bath Desc.	3-Full

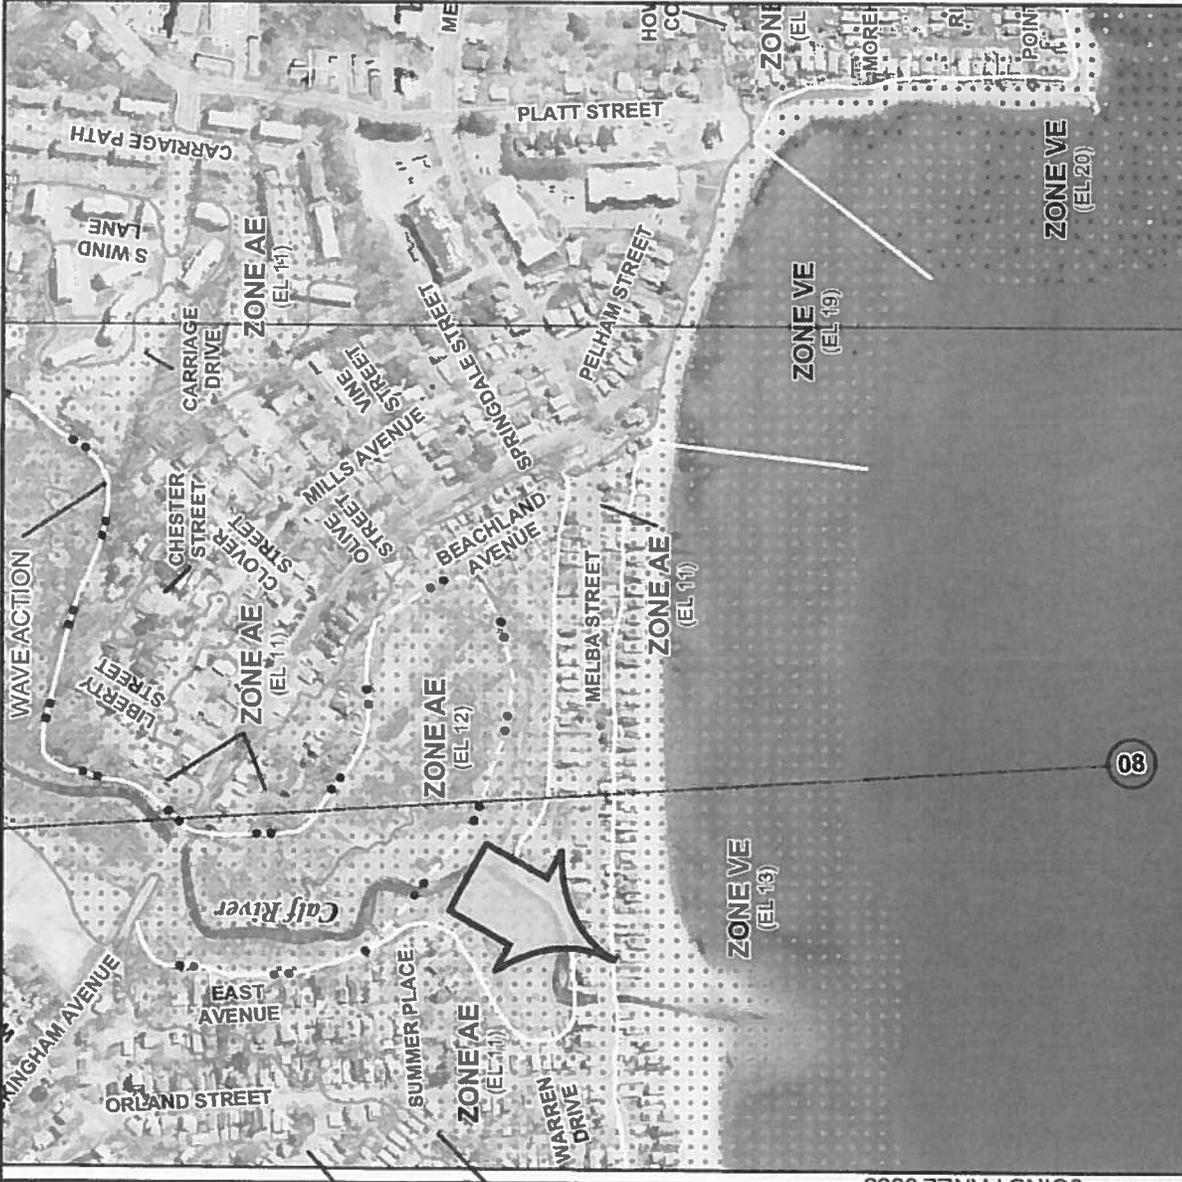
MAP NUMBER
09009C0534J
MAP REVISED
JULY 8, 2013

This is an official copy of a portion of the above referenced flood map. It was extracted using F-MIT On-Line. This map does not reflect changes or amendments which may have been made subsequent to the date on the title block. For the latest product information about National Flood Insurance Program flood maps check the FEMA Flood Map Store at www.msc.fema.gov

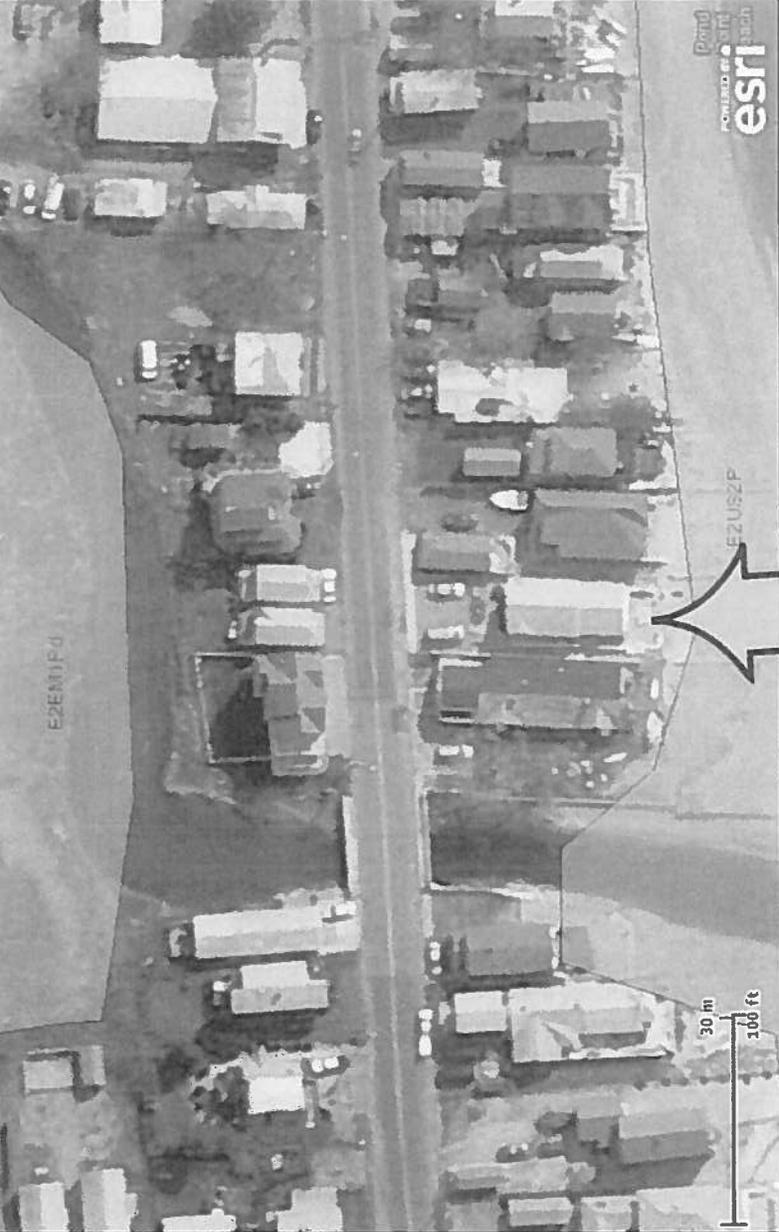
U.S. Fish and Wildlife Service
National Wetlands Inventory

This map is for general reference only. The US Fish and Wildlife Service is not responsible for the accuracy or currentness of the base data shown on this map. All wetlands related data should be used in accordance with the layer metadata found on the Wetlands Mapper web site.

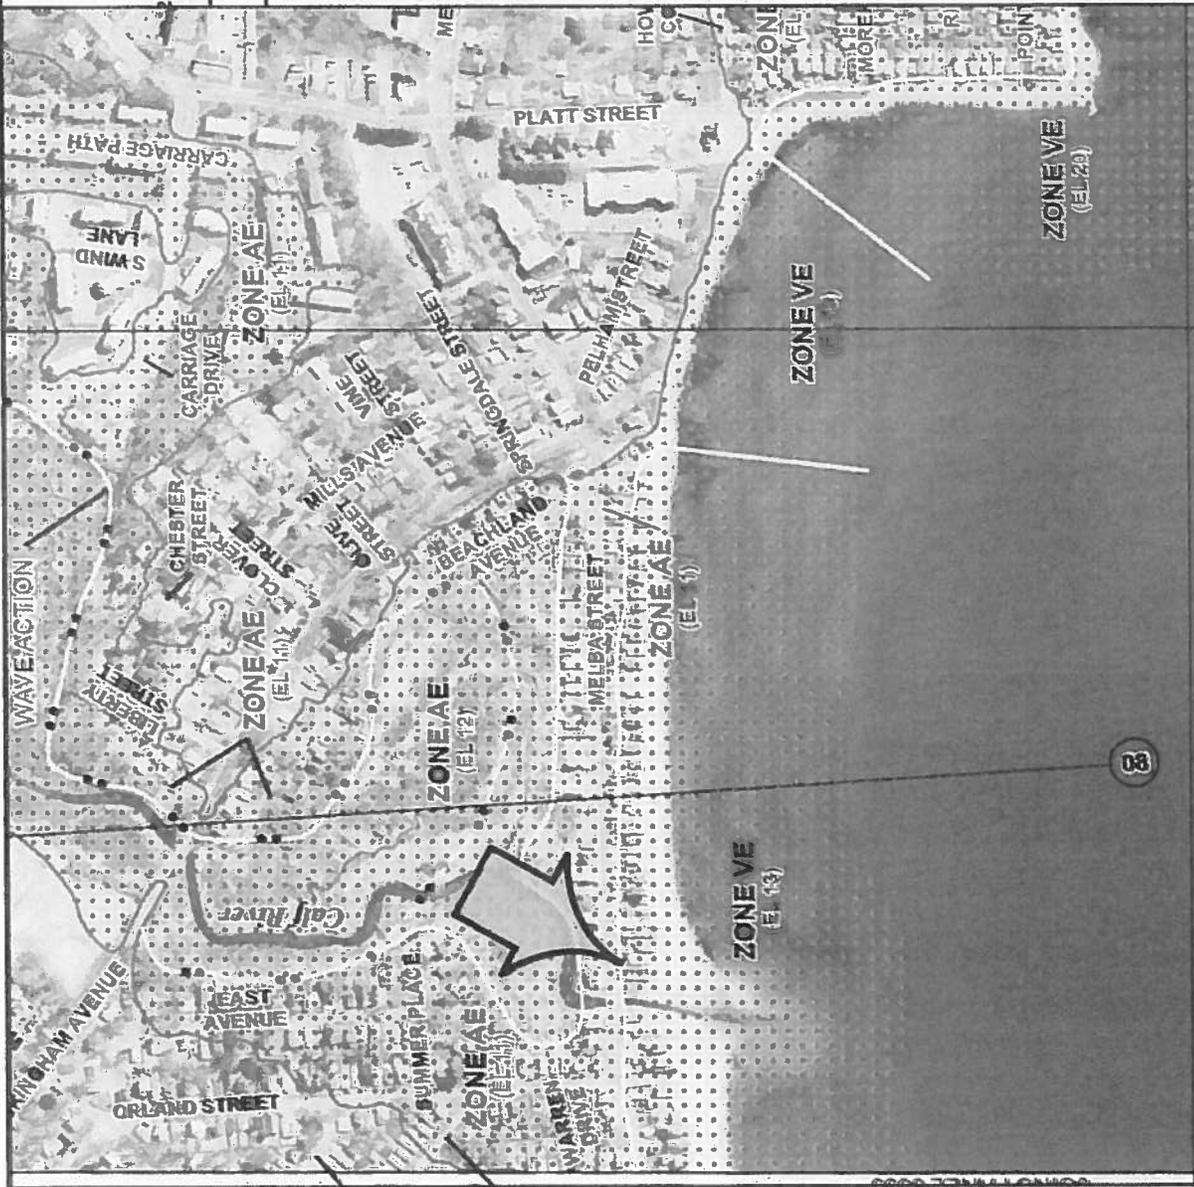
Federal Emergency Management Agency
MAP NUMBER 09009C0534J
MAP REVISED JULY 8, 2013

This is an official copy of a portion of the above referenced flood map. It was extracted using F-MIT On-Line. This map does not reflect changes or amendments which may have been made subsequent to the date on the title block. For the latest product information about National Flood Insurance Program flood maps check the FEMA Flood Map Store at www.fema.gov
