# **ENVIRONMENTAL REVIEW REPORT**

**Community Development Block Grant – Disaster Recovery  
Owner Occupied Rehabilitation and Rebuilding Program**

**Applicant # 1085**

**17 Elaine Road  
Milford, Connecticut**

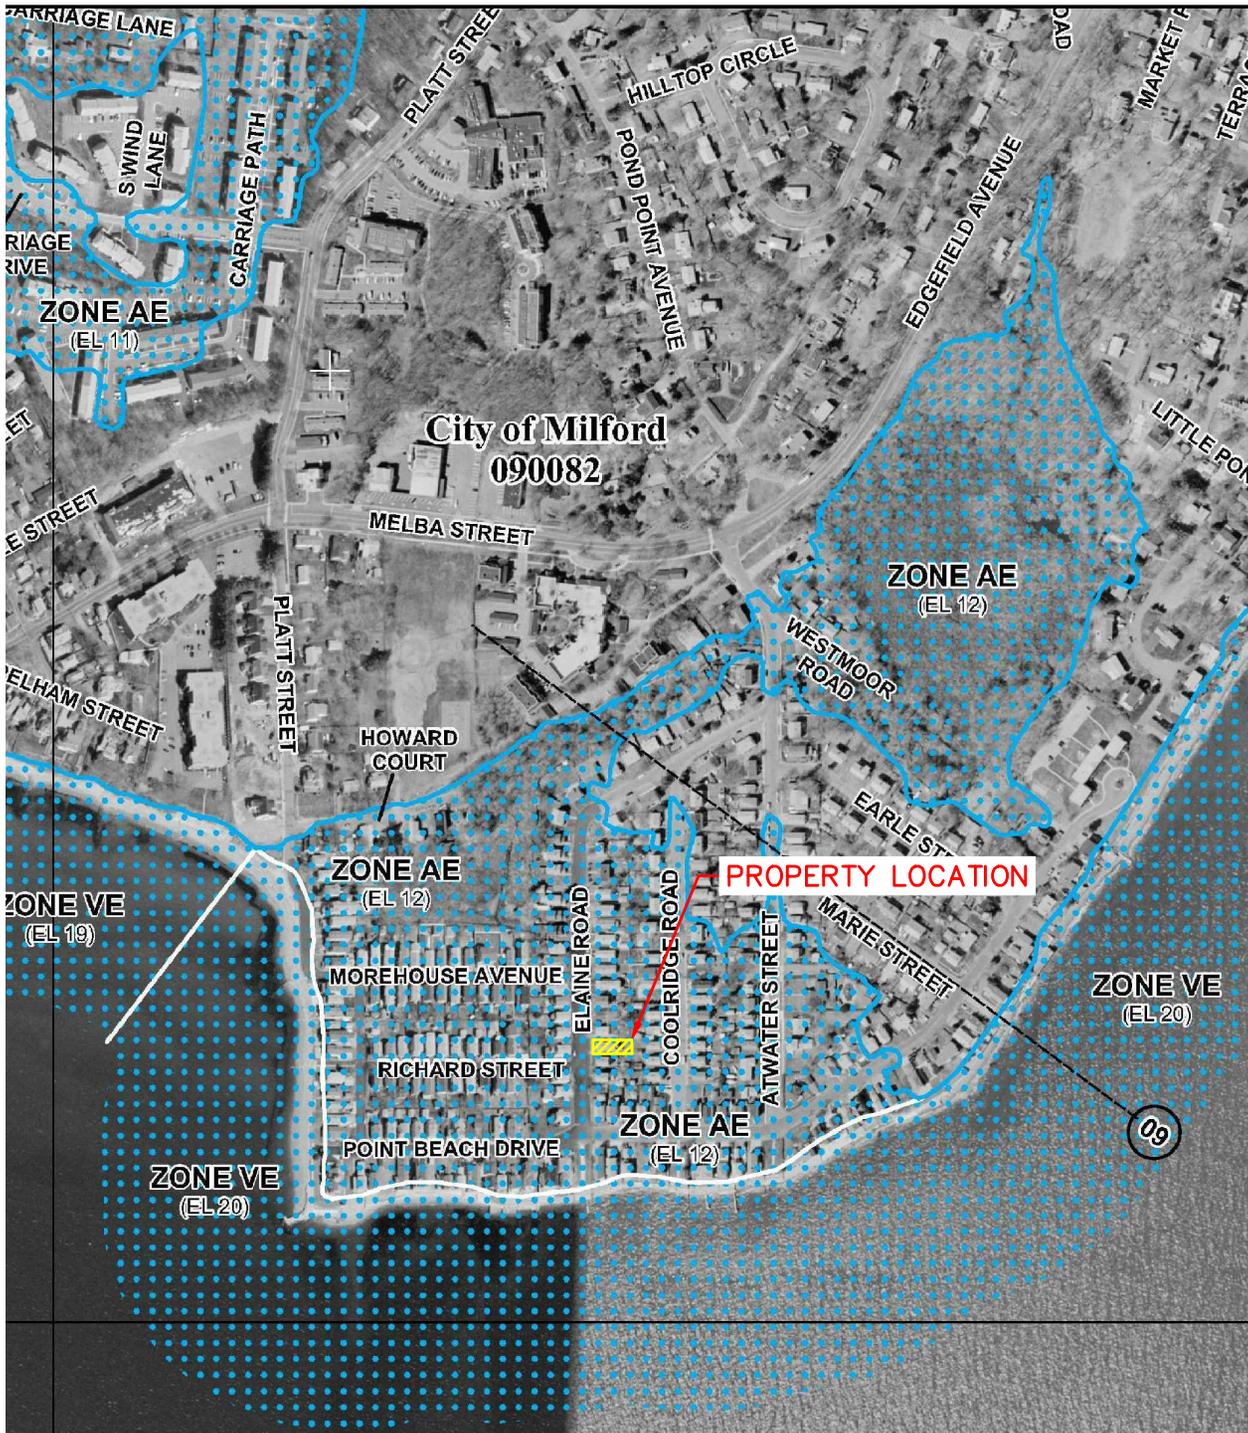
**SPECIAL FLOOD HAZARD AREAS (SFHAs) SUBJECT TO INUNDATION BY THE 1% ANNUAL CHANCE FLOOD**  
 The 1% annual chance flood (100-year flood), also known as the base flood, is the flood that has a 1% chance of being equaled or exceeded in any given year. The Special Flood Hazard Area is the area subject to flooding by the 1% annual chance flood. Areas of Special Flood Hazard include Zones A, AE, AH, AO, AR, A99, V, and VE. The Base Flood Elevation is the water-surface elevation of the 1% annual chance flood.

This is an official copy of a portion of the above referenced flood map. It was extracted using F-MIT On-Line. This map does not reflect changes or amendments which may have been made subsequent to the date on the title block. For the latest product information about National Flood Insurance Program flood maps check the FEMA Flood Map Store at [www.msc.fema.gov](http://www.msc.fema.gov)

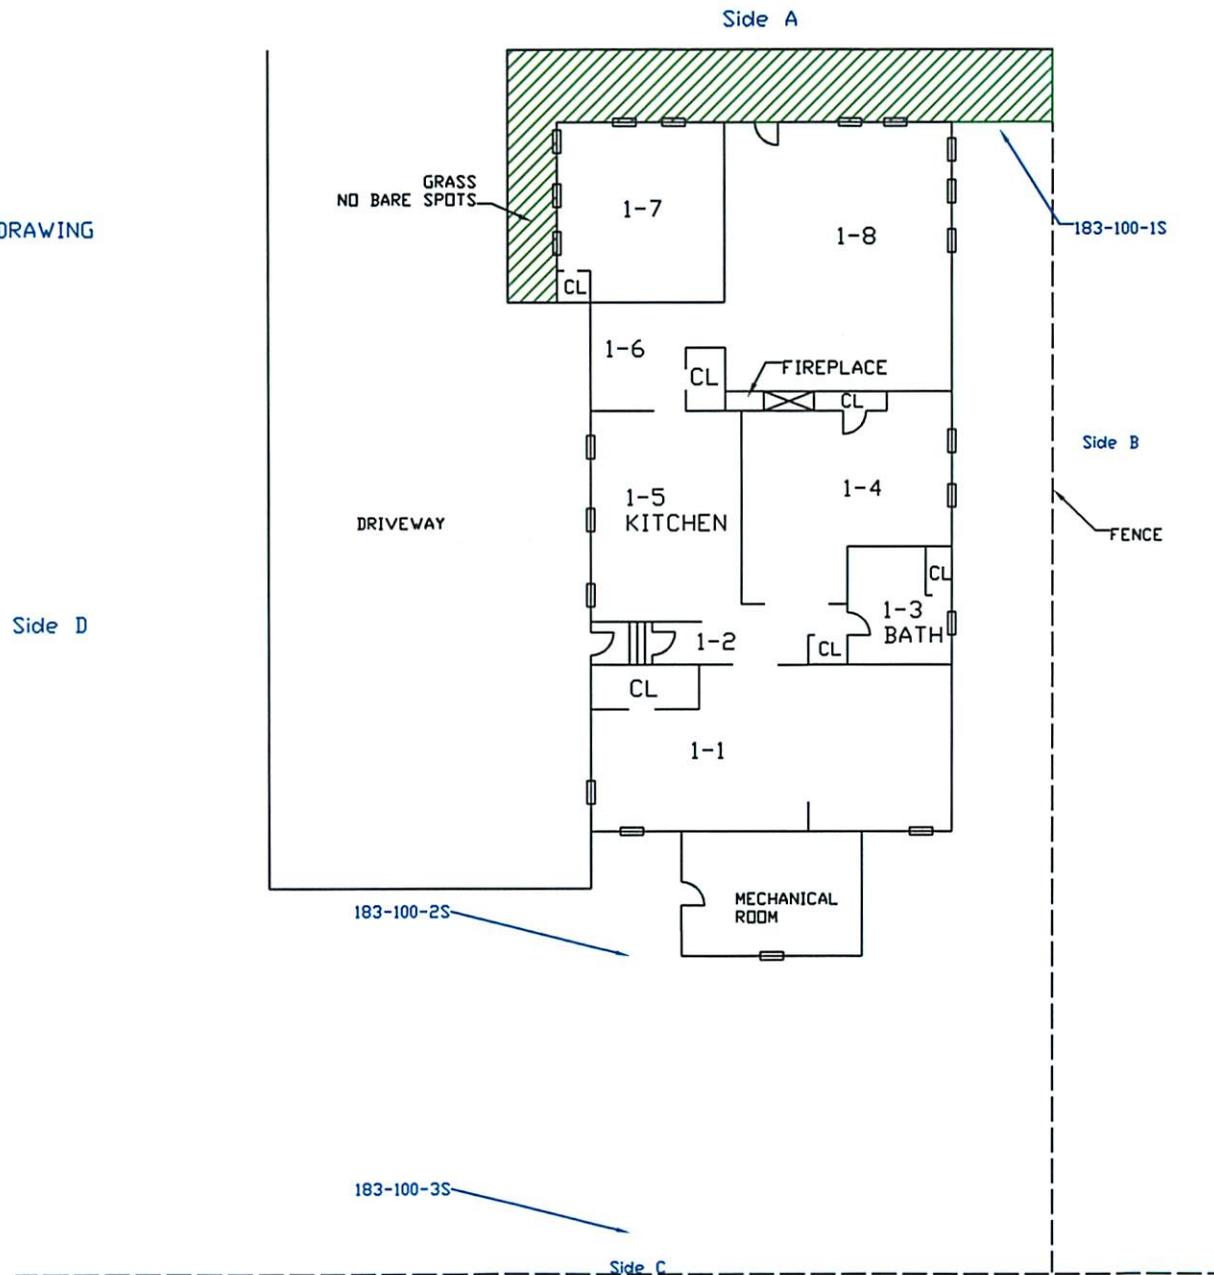
## LEAD IN SOIL SAMPLES LOCATION DRAWING

LEGEND OF SYMBOLS	
1S	LEAD SOIL SAMPLE
	Areas of grass without bare spots

Appendix A: XRF Lead–Based Paint Testing Results with quality evaluation sheet, 5 pages  
Appendix B: Dust Wipe and Soil Sample Analytical Data and Chain of Custody Document, 7 pages  
Appendix C: Sample Location Drawings, 2 pages  
Appendix D: Lead Hazardous Waste Evaluation Worksheet, 1 page(s)  
Appendix E: Copy of Risk Assessor's License/Certification, 2 pages  
Appendix F: Copy of Firm's Lead Activity License/Certification, 3 pages  
Appendix G: Copy of XRF Training Certificate and LPA–1 Performance Characteristics Sheet, 5 pages  
Appendix H: "LEAD SPEAK" – A Brief Glossary, 2 pages  
Appendix I: Additional Lead and Lead Safety Resource Data, 1 page

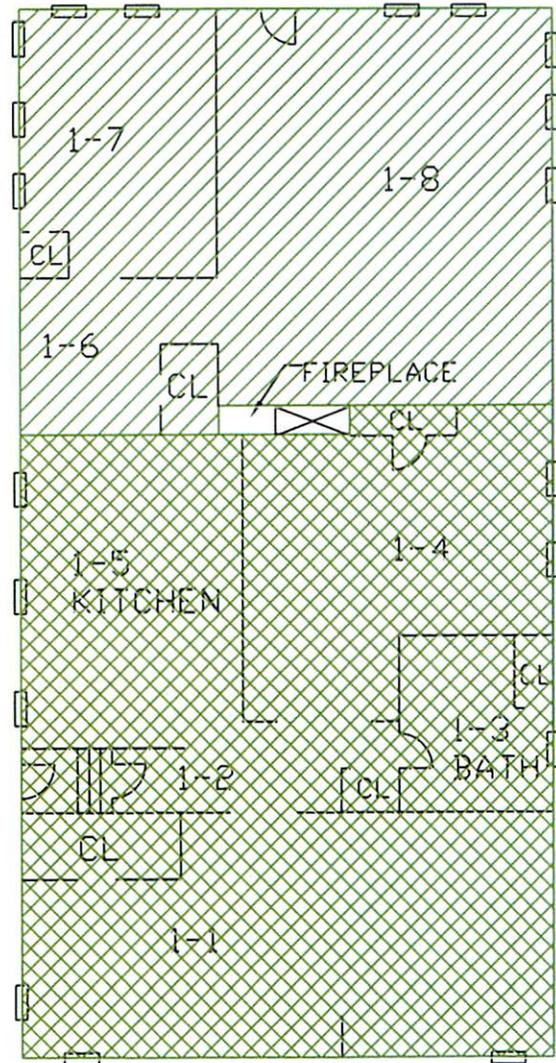
## Scope of Inspection Drawing

Site 011  
 17 Elaine Road, Milford, CT  
 Main Floor  
 CS# 183-100, 4-30-2014

**BACKGROUND:** We understand the subject house suffered damage as a result of hurricane Sandy on October 29-30, 2012 and is scheduled to be renovated and raised. We also understand that the scope of the renovation work would involve disturbance of all flooring (except hardwood), disturbance of select walls, disturbance of select ceilings all on the first floor, and re-insulation of the crawlspace. Please see attached Scope of Inspection Drawing for details.

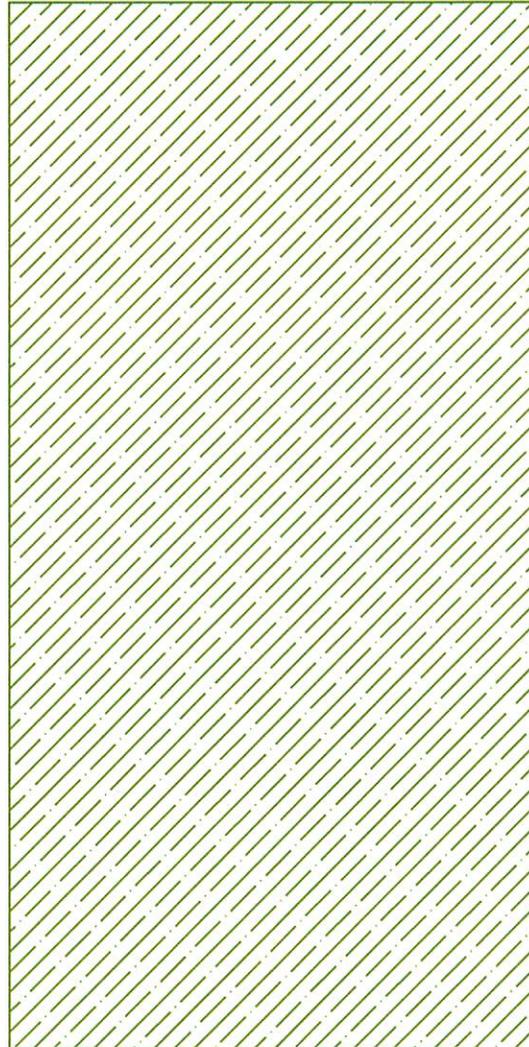
Scope of Inspection Drawing

Location of crawlspace to be re-insulated within scope of inspection

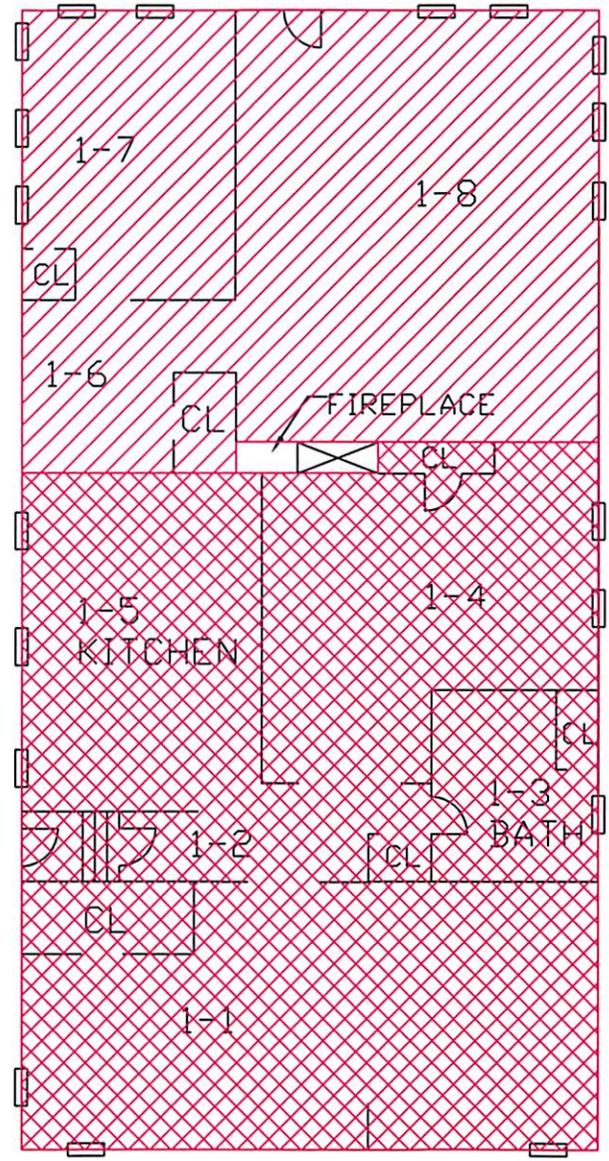
### Scope of Inspection Drawing

Site 011  
 17 Elaine Road, Milford, CT  
 Main Floor  
 CS# 183-100, 4-30-2014
