Figure E-10 Statutory Checklist

**STATUTORY CHECKLIST [§58.35(a) activities]
for Categorical Exclusions and Environmental Assessments**

Project Name and Identification No. DOH 1214, 41 Hillside Avenue, Milford, Connecticut

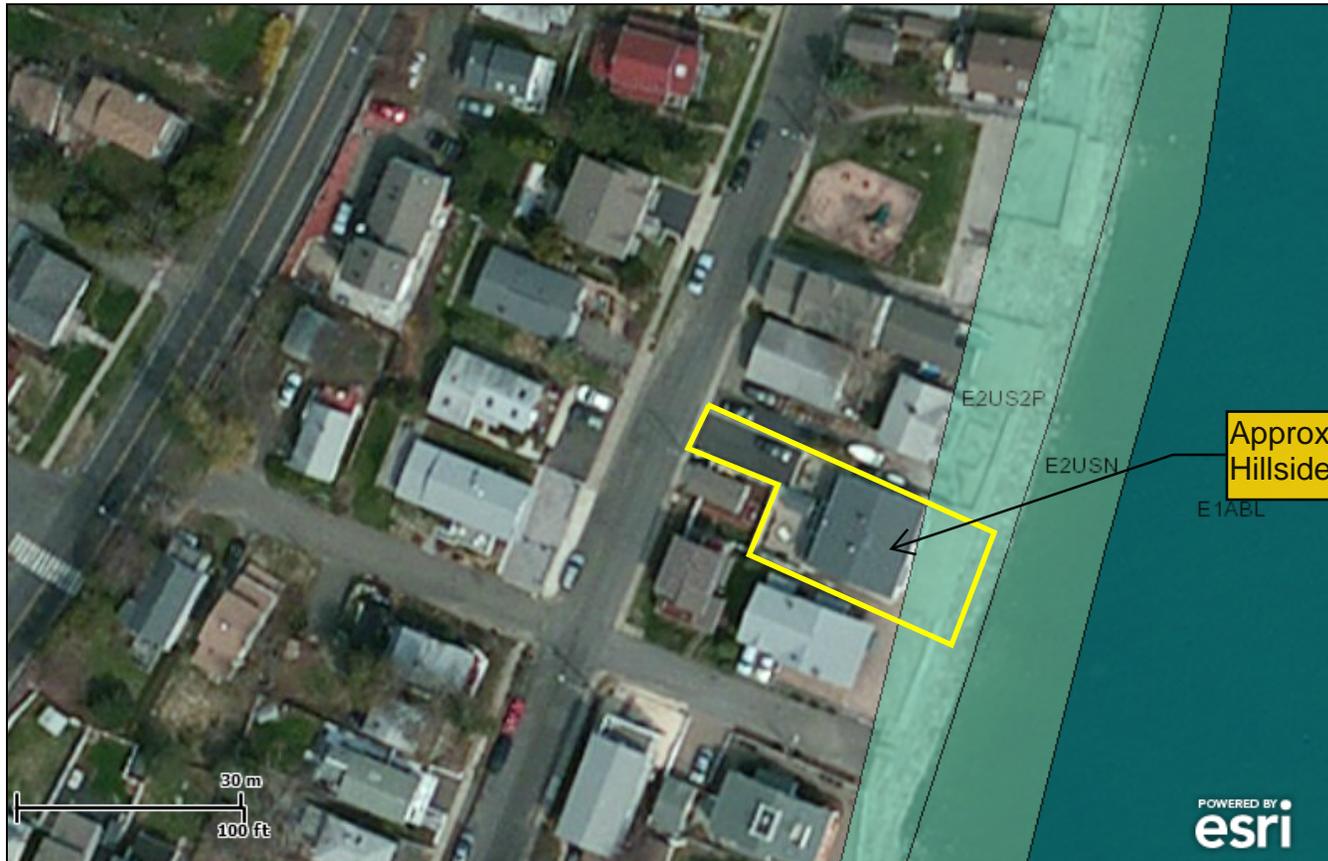
Wetlands

- Freshwater Emergent
- Freshwater Forested/Shrub
- Estuarine and Marine Deepwater
- Estuarine and Marine
- Freshwater Pond
- Lake
- Riverine
- Other

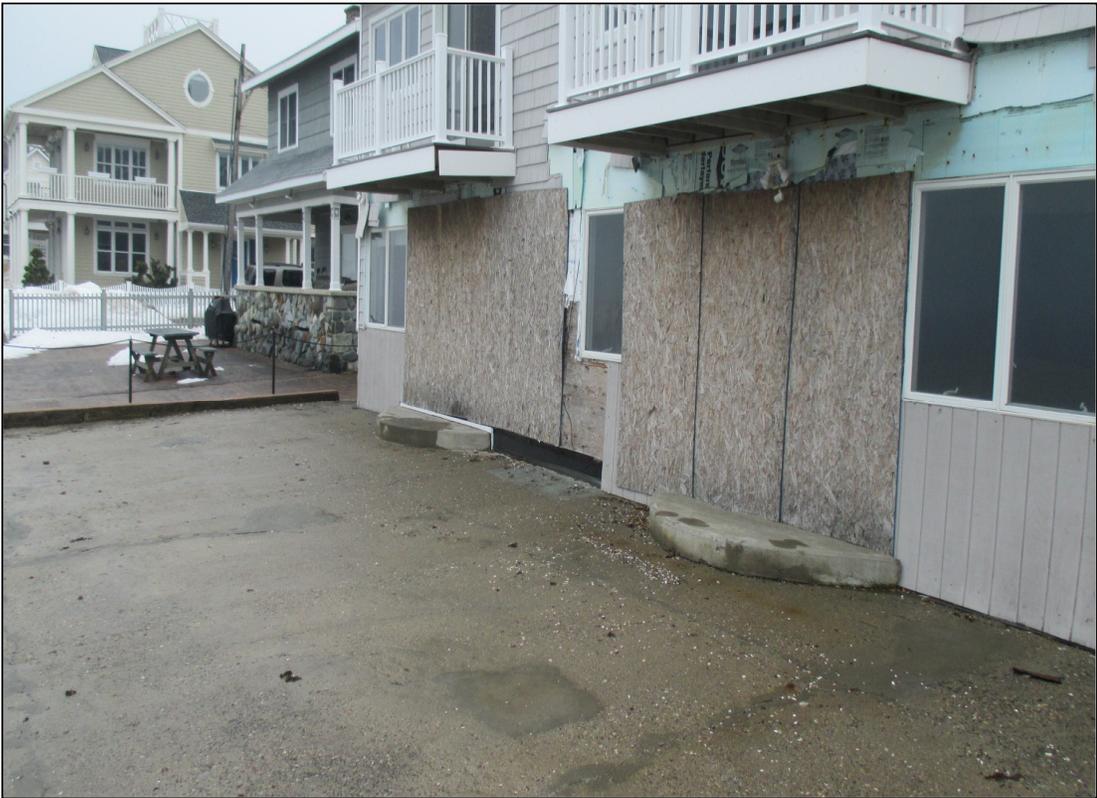
Photo 1: View of concrete deck and residence along eastern part of site (JMM photo taken 3/17/15); facing southwesterly

As per your request, Mr. James McManus a soil and wetland scientist with **JMM Wetland Consulting Services, LLC** (JMM) conducted a site visit at the above-referenced site on March 17th, 2015. The purpose of the investigation was to verify the absence or the presence of regulated wetland areas in accordance with the State of Connecticut Statutes (i.e. tidal and inland). The subject site is located south/southeast of Hillside Avenue in Milford, CT. The site is currently a developed lot with two attached single-family residences, paved driveway, concrete sidewalks and deck, concrete seawall, stone seawall, and coastal features located east of the concrete seawall (see photos 1-2, attached).

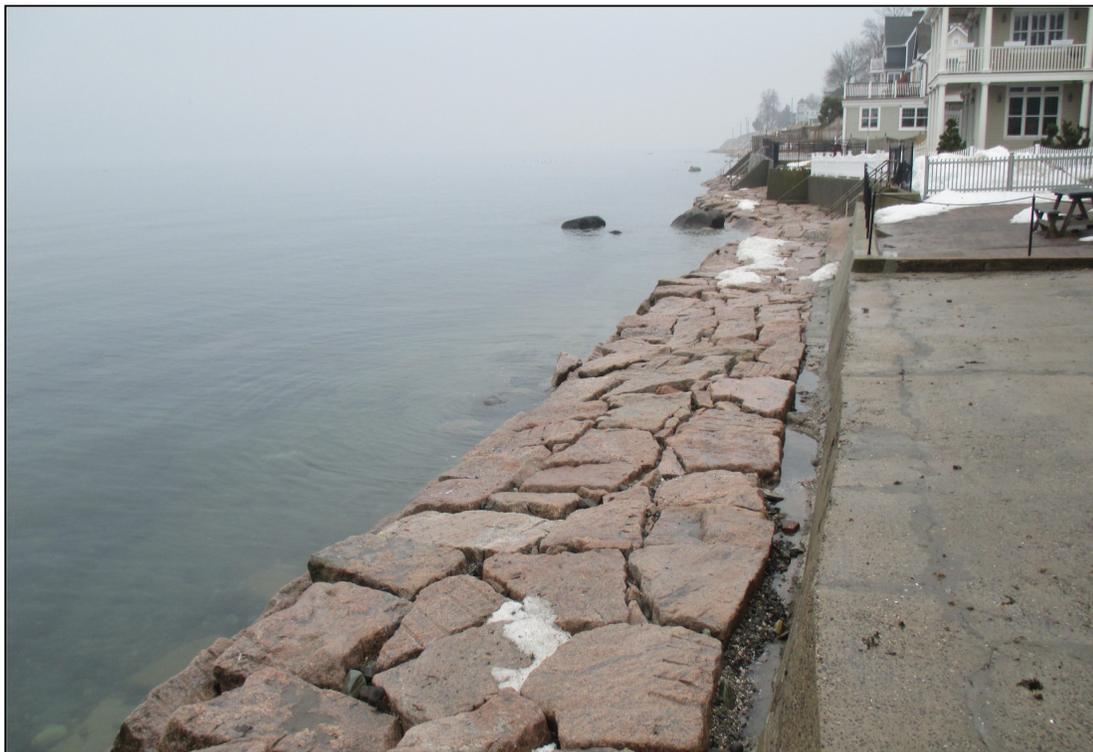
Photo 2: View of concrete/stone seawalls along eastern part of site (JMM photo taken 3/17/15); facing southeasterly

No poorly or very poorly drained soils (i.e. inland wetland regulated areas) or watercourses were identified on the overall property. However, coastal features were observed east of the existing concrete seawall (see photo 2).

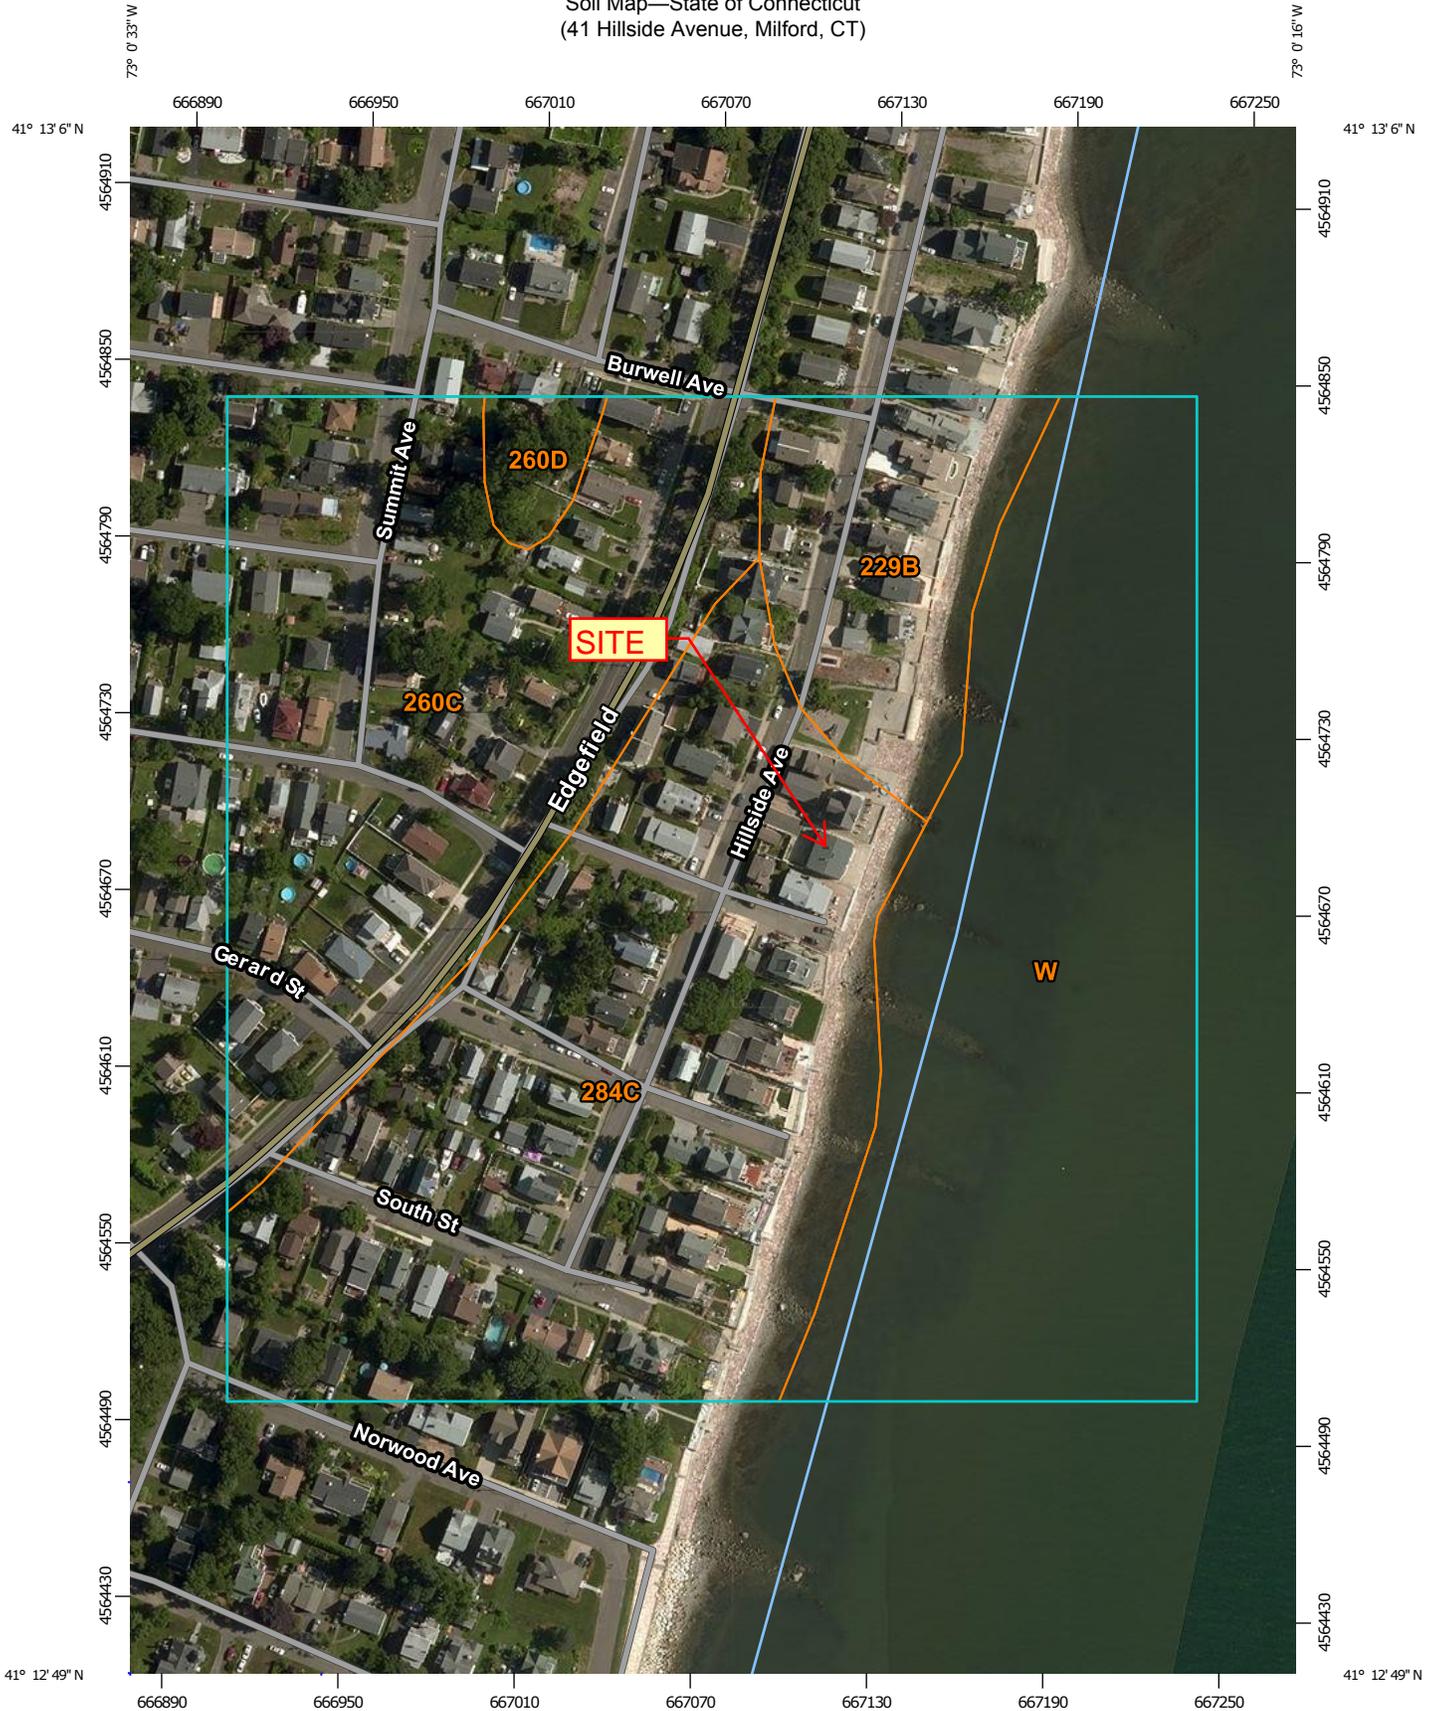
Soil Map—State of Connecticut
(41 Hillside Avenue, Milford, CT)

Map Scale: 1:2,560 if printed on A portrait (8.5" x 11") sheet.

The upland soils on the site were observed to be disturbed throughout. The disturbed “upland type” soils are mapped as the Udorthents (308) mapping unit.

Udorthents (308). This soil mapping unit consists of well drained to moderately well drained soils that have been altered by cutting, filling, or grading. The areas either have had two feet or more of the upper part of the original soil removed or have more than two feet of fill material on top of the original soil. *Udorthents* or Made Land soils can be found on any soil parent material but are typically fluvial on glacial till plains and outwash plains and stream terraces.
