RE: 39 Richard Street, Milford, CT

Project name: DOH 1252

RE: Hazardous Building Materials Survey for Proposed Renovations
Location: 39 Richard St, Milford, CT
LEA Comm. No. 01MH4.07

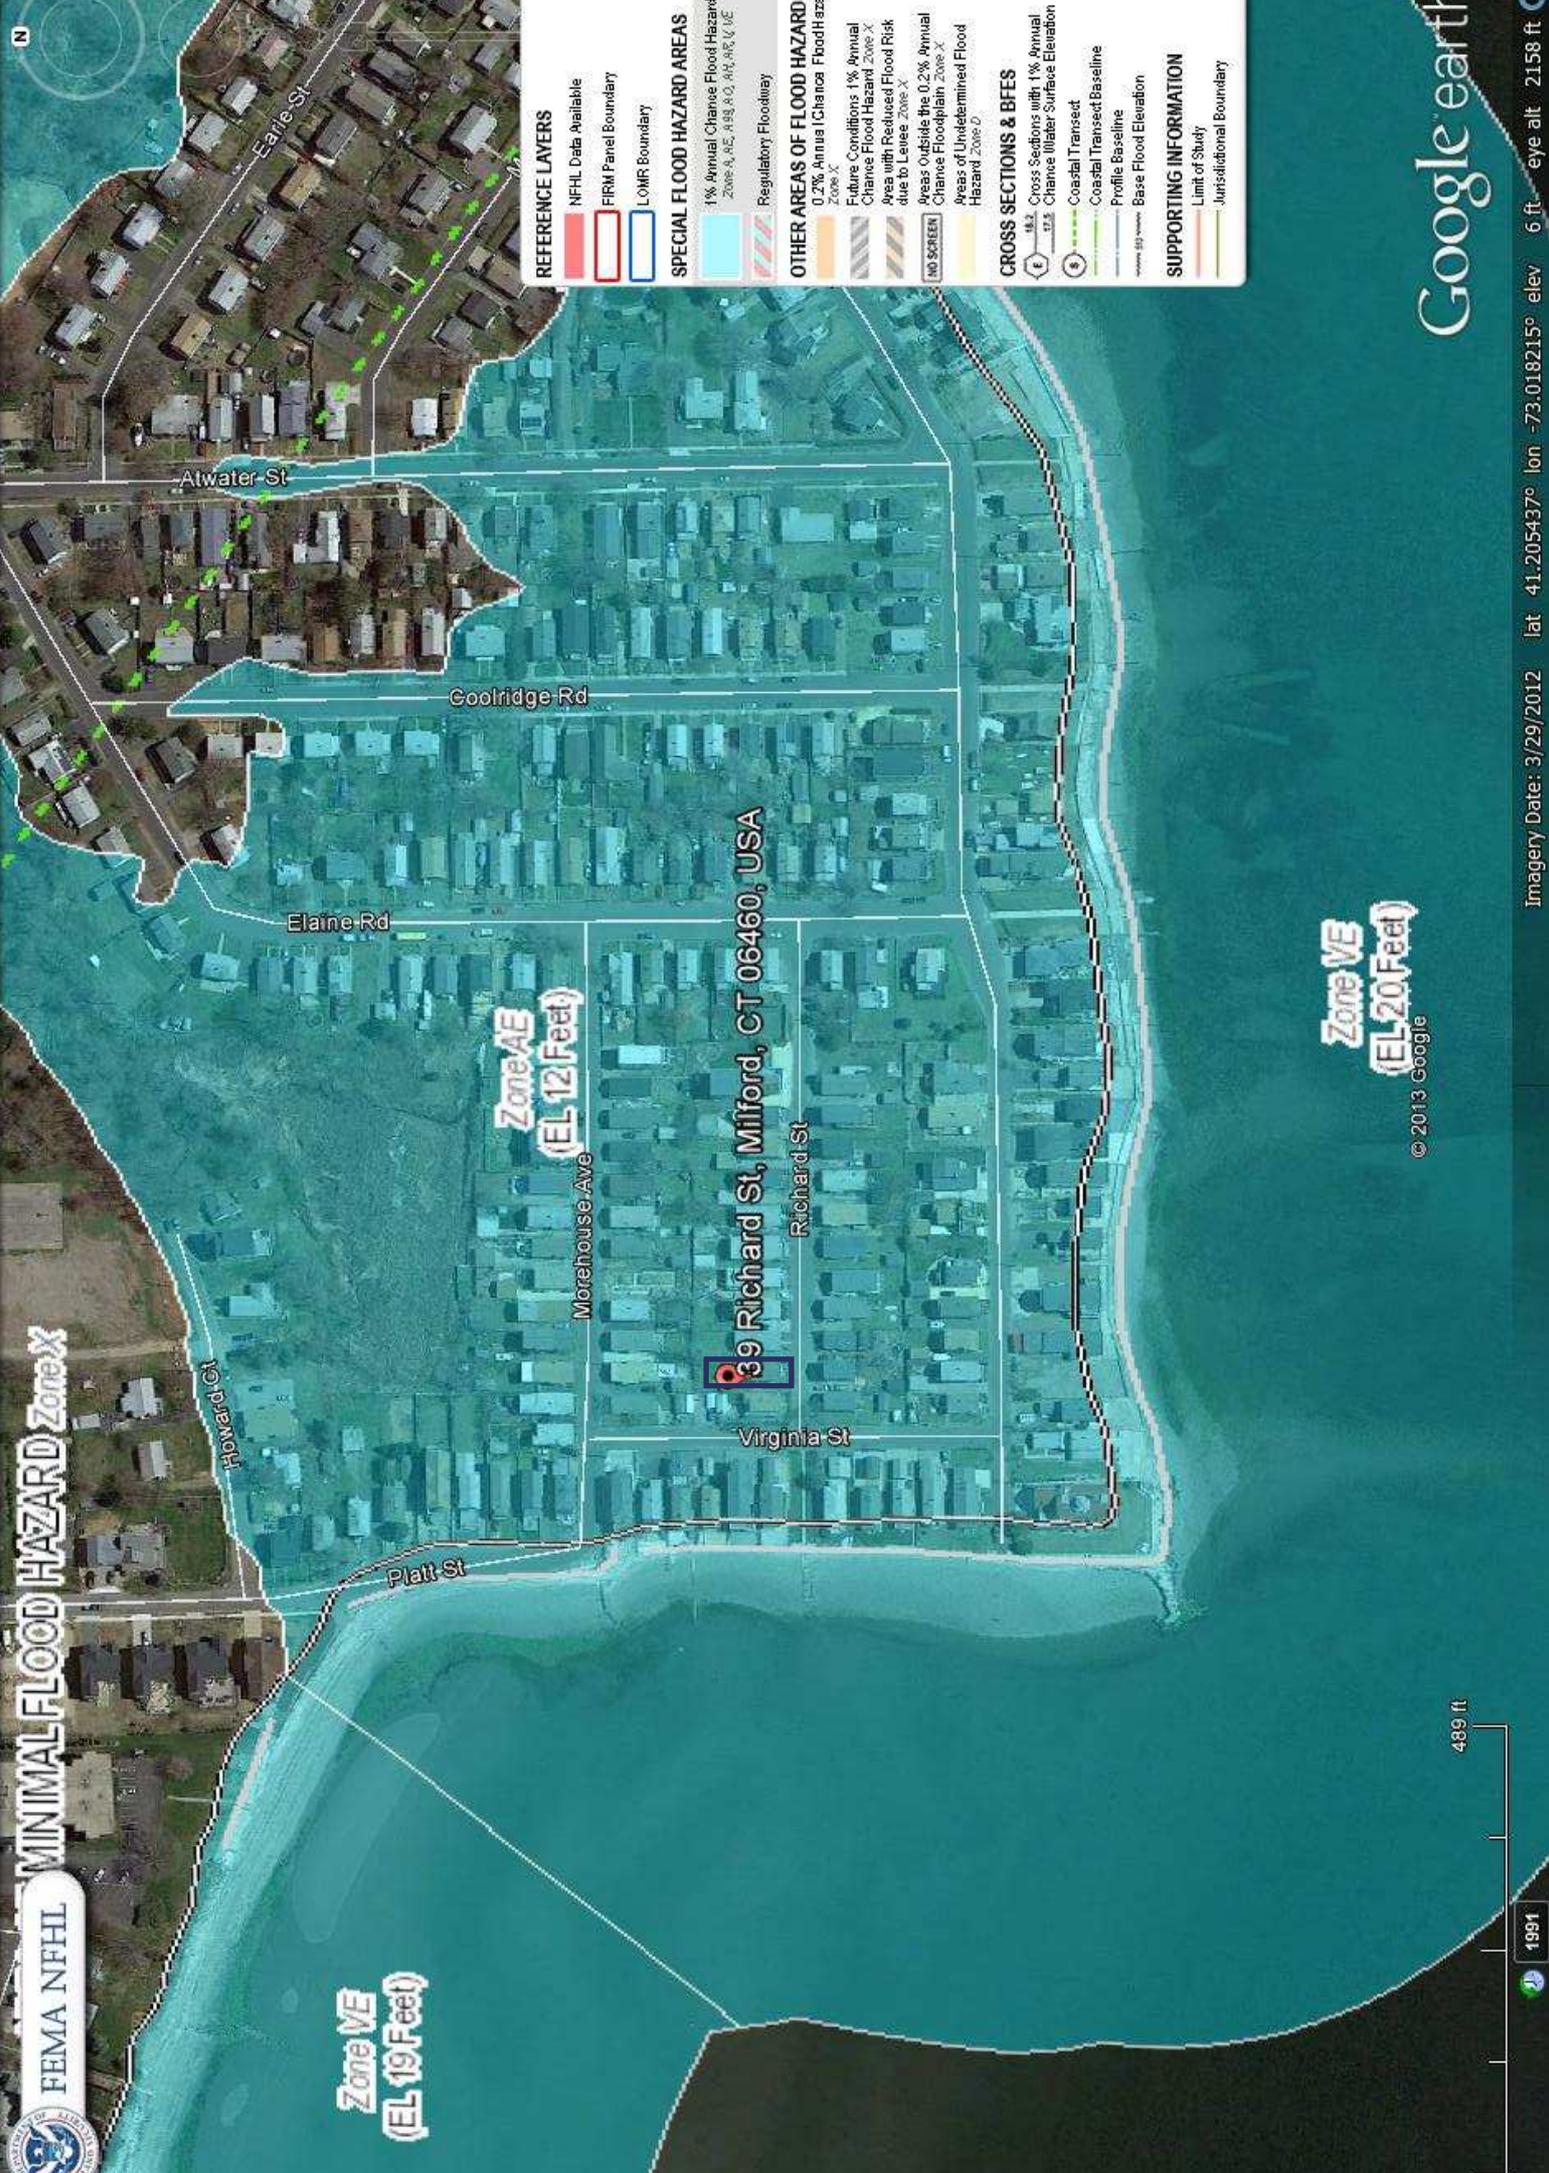
39 Richard Street,
Milford, CT

**Zone VE
(EL. 19 Feet)**

**Zone AE
(EL. 12 Feet)**

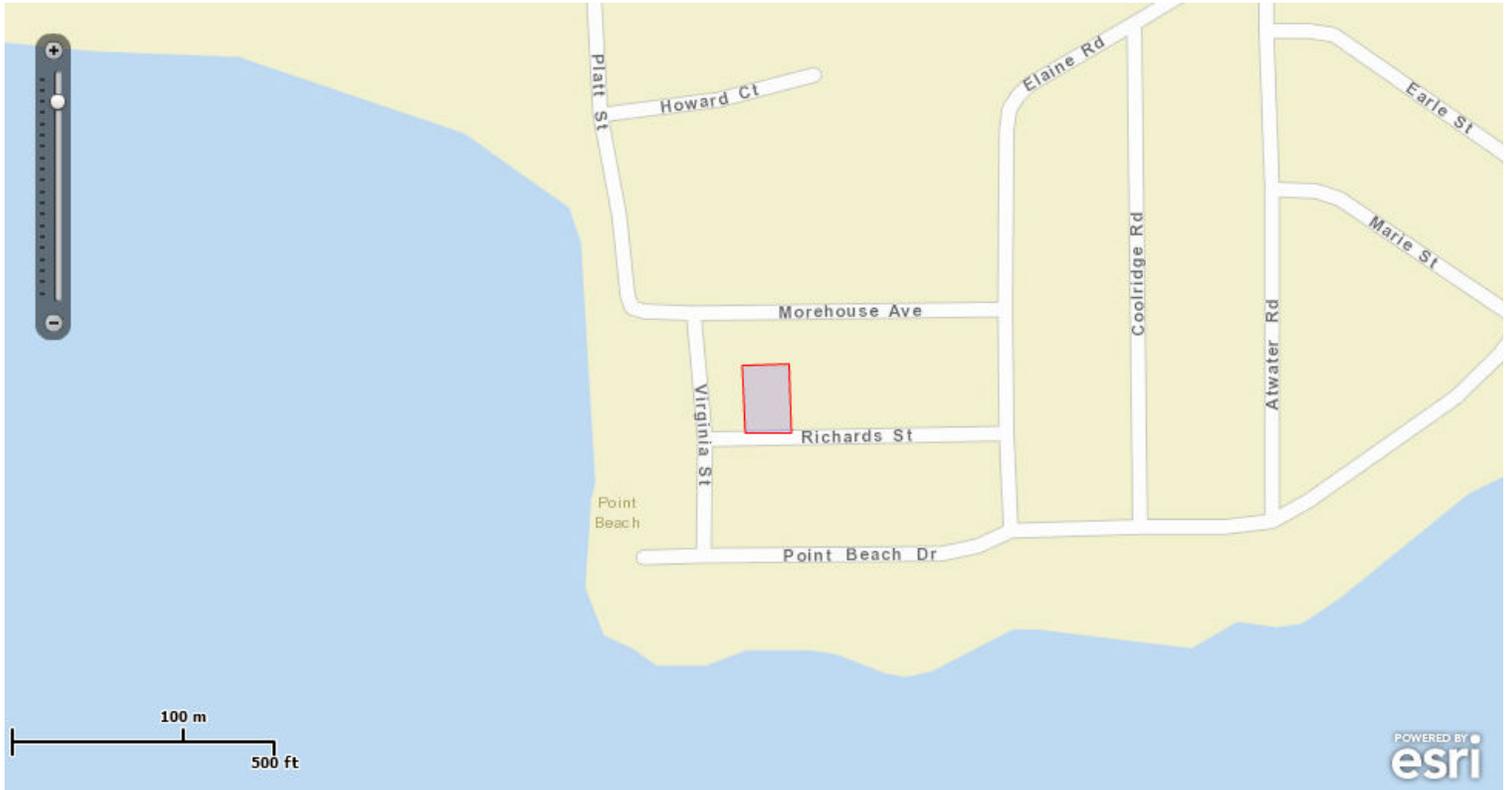
Project Location Map:

Project Coordinates: MULTIPOLYGON (((-73.0193097 41.2053774, -73.0193314 41.2057328, -73.0190042 41.2057408, -73.0189881 41.2053776, -73.0193097 41.2053774)))
