**RE: Environmental Assessment Report**  
**Department of Housing**  
**CDBG-DR – Sandy Disaster Recovery Program**  
**64 Hackley Street**  
**Bridgeport, Connecticut 06605**  
**Application #1326**  
**Eagle Project No. 14-028.12T11**

This assessment and report is intended to satisfy the review process of the National Environmental Policy Act (NEPA) Statutory Checklist Sections 13C (Lead-Based Paint), 13D (Asbestos), 13E (Radon) and 13F (Mold).

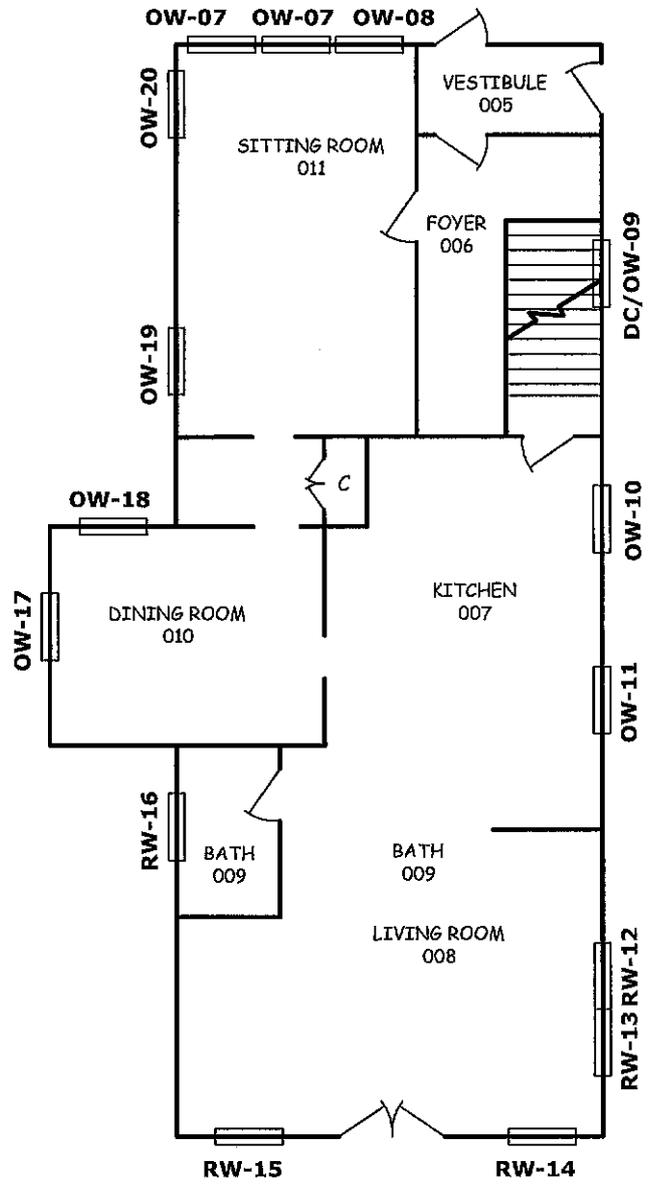
**WINDOW KEY:**

- DC** = DECORATIVE
- OW** = OLDER OR ORIGINAL WOOD SASH (TESTED POSITIVE FOR LEAD-BASED PAINT)
- RW** = REPLACEMENT WOOD SASH (TESTED NEGATIVE FOR LEAD-BASED PAINT)

SIDE-B

SIDE-D

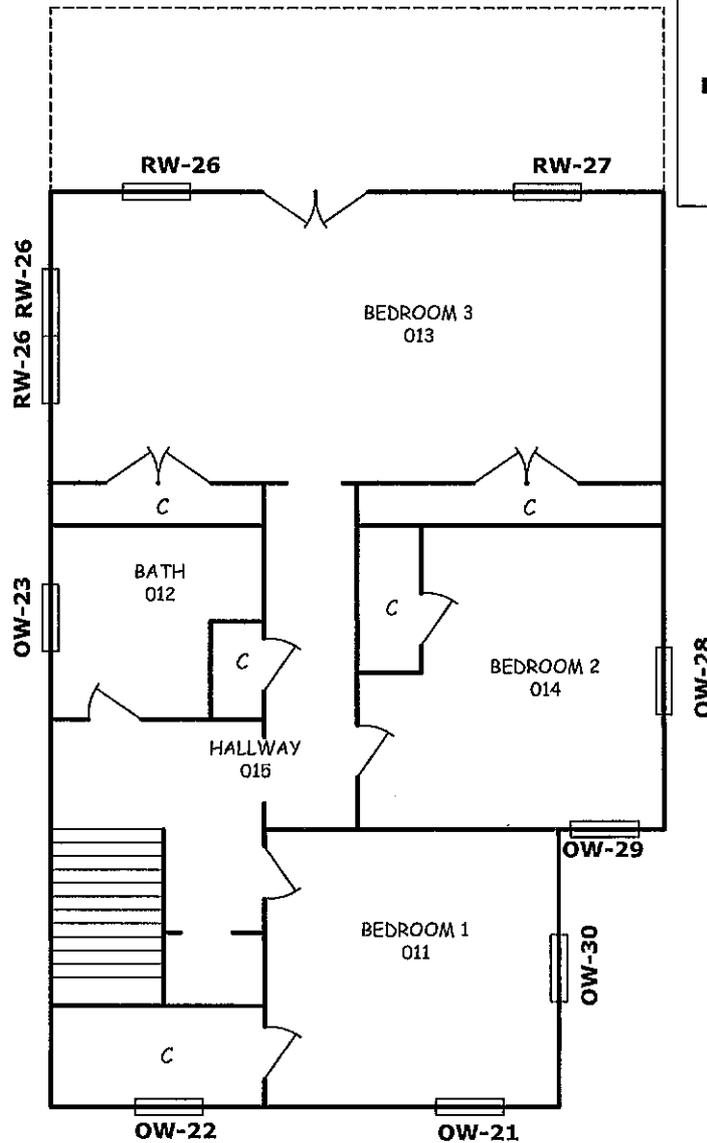
**WINDOW KEY:**

- DC** = DECORATIVE
- OW** = OLDER OR ORIGINAL WOOD SASH (TESTED POSITIVE FOR LEAD-BASED PAINT)
- RW** = REPLACEMENT WOOD SASH (TESTED NEGATIVE FOR LEAD-BASED PAINT)

NOT TO SCALE

C = CLOSET EVALUATED WITH ADJACENT ROOM

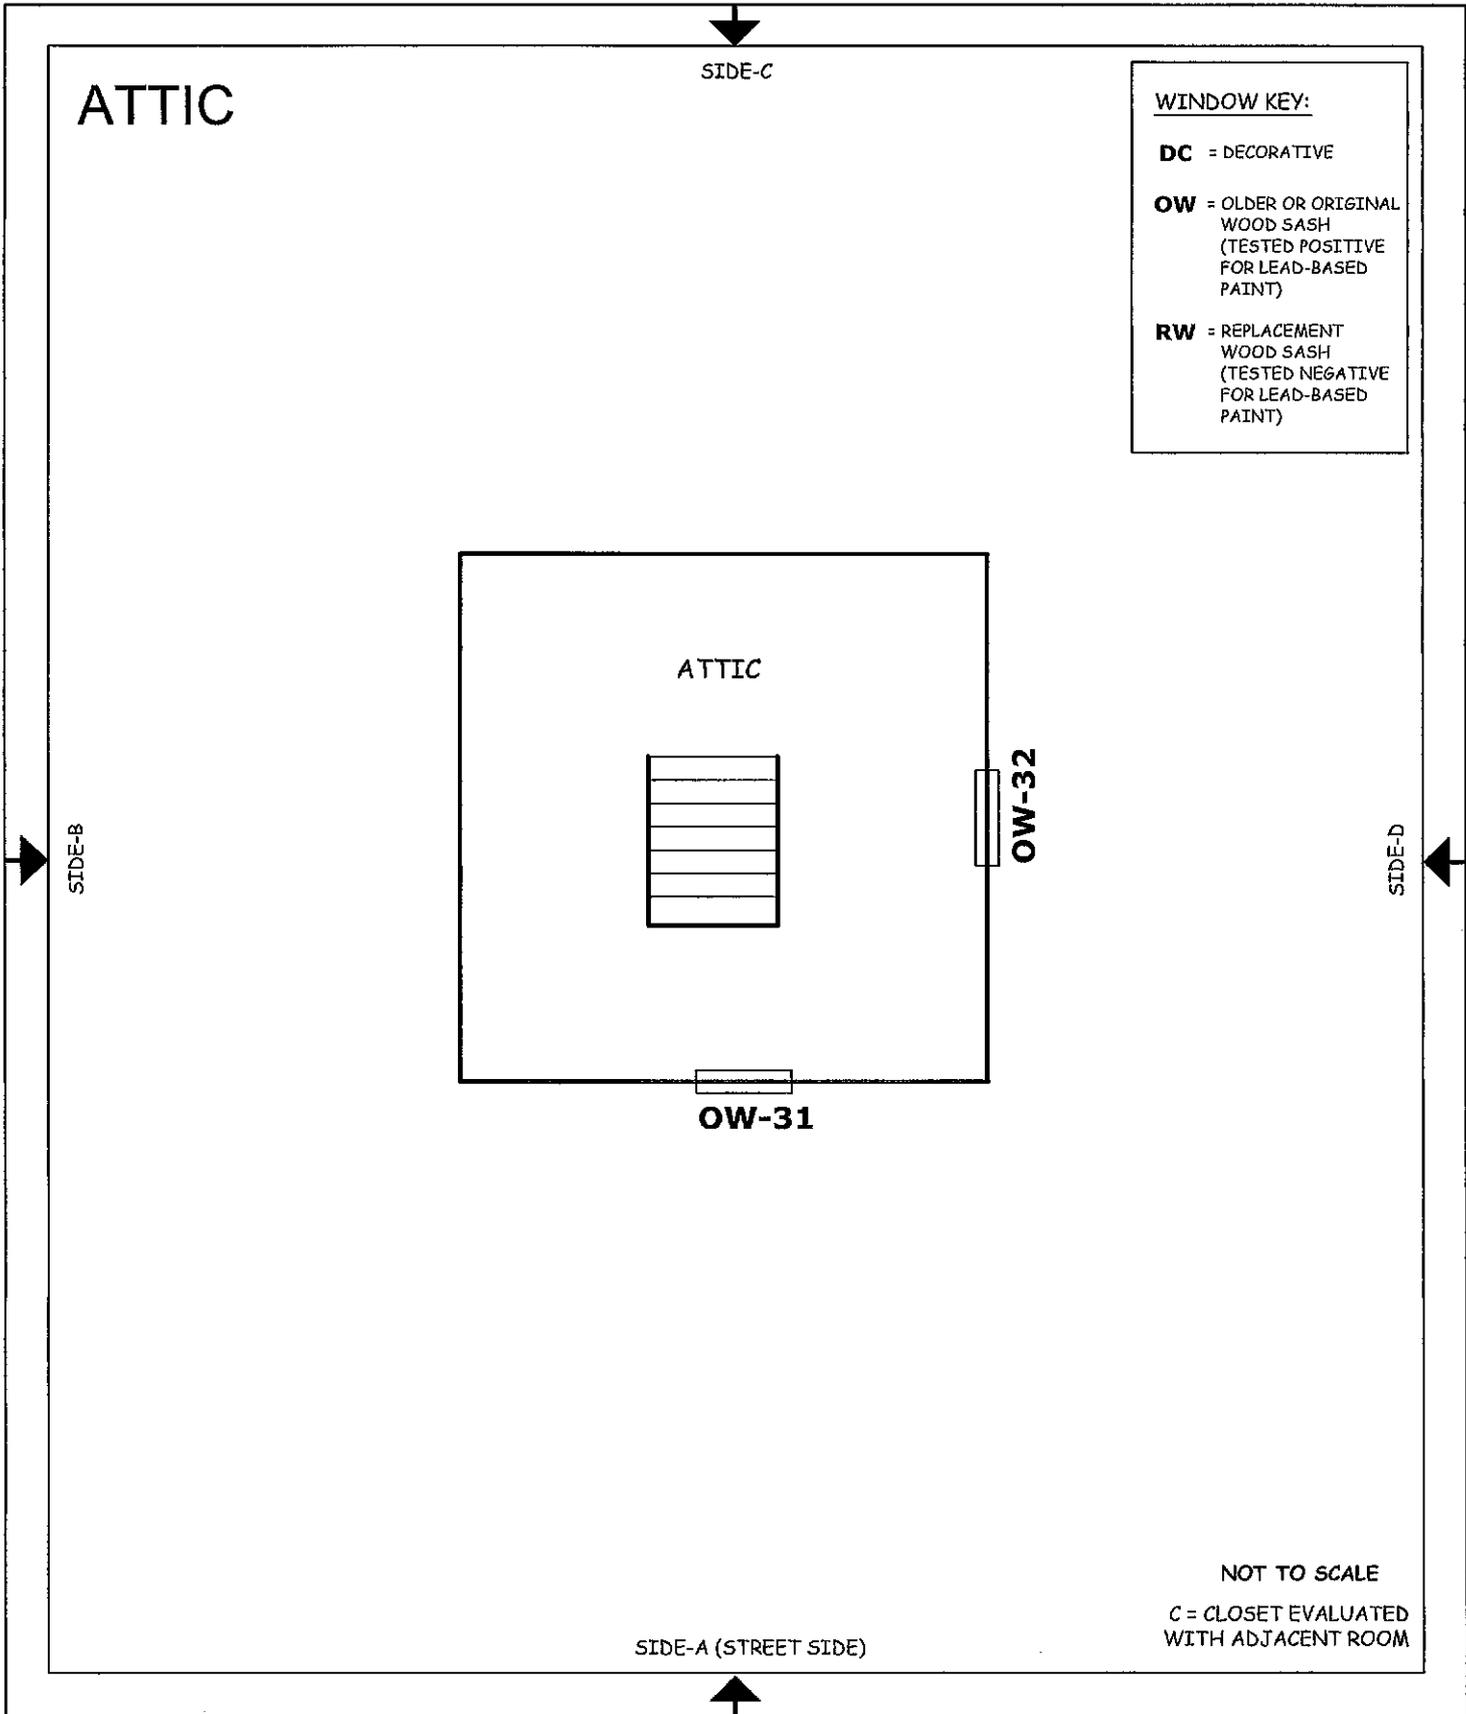
**FP-3**

**WINDOW KEY:**

**DC** = DECORATIVE
