RE: Environmental Assessment Report
Department of Housing
CDBG-DR – Sandy Disaster Recovery Program
155 Shore Road
Clinton, Connecticut
Application #2068
Eagle Project No. 14-028.12T4

Please find the attached Environmental Assessment Report conducted at 155 Shore Road located in Clinton, Connecticut (Site). The environmental assessment was performed in support of the planned renovations/repairs to the Site building under the State of Connecticut Department of Housing Community Development Block Grant – Disaster Recovery Program (Program). The assessment focused only on those areas of the building that are scheduled for renovation/repair work with the exception of the lead hazard screen, which included the interior and exterior of the entire building. The proposed scope of renovation/repair work was provided to Eagle Environmental, Inc. (Eagle) by Capital Studio Architects (CSA).

This assessment and report is intended to satisfy the review process of the National Environmental Policy Act (NEPA) Statutory Checklist Sections 13C (Lead-Based Paint), 13D (Asbestos), 13E (Radon) and 13F (Mold).

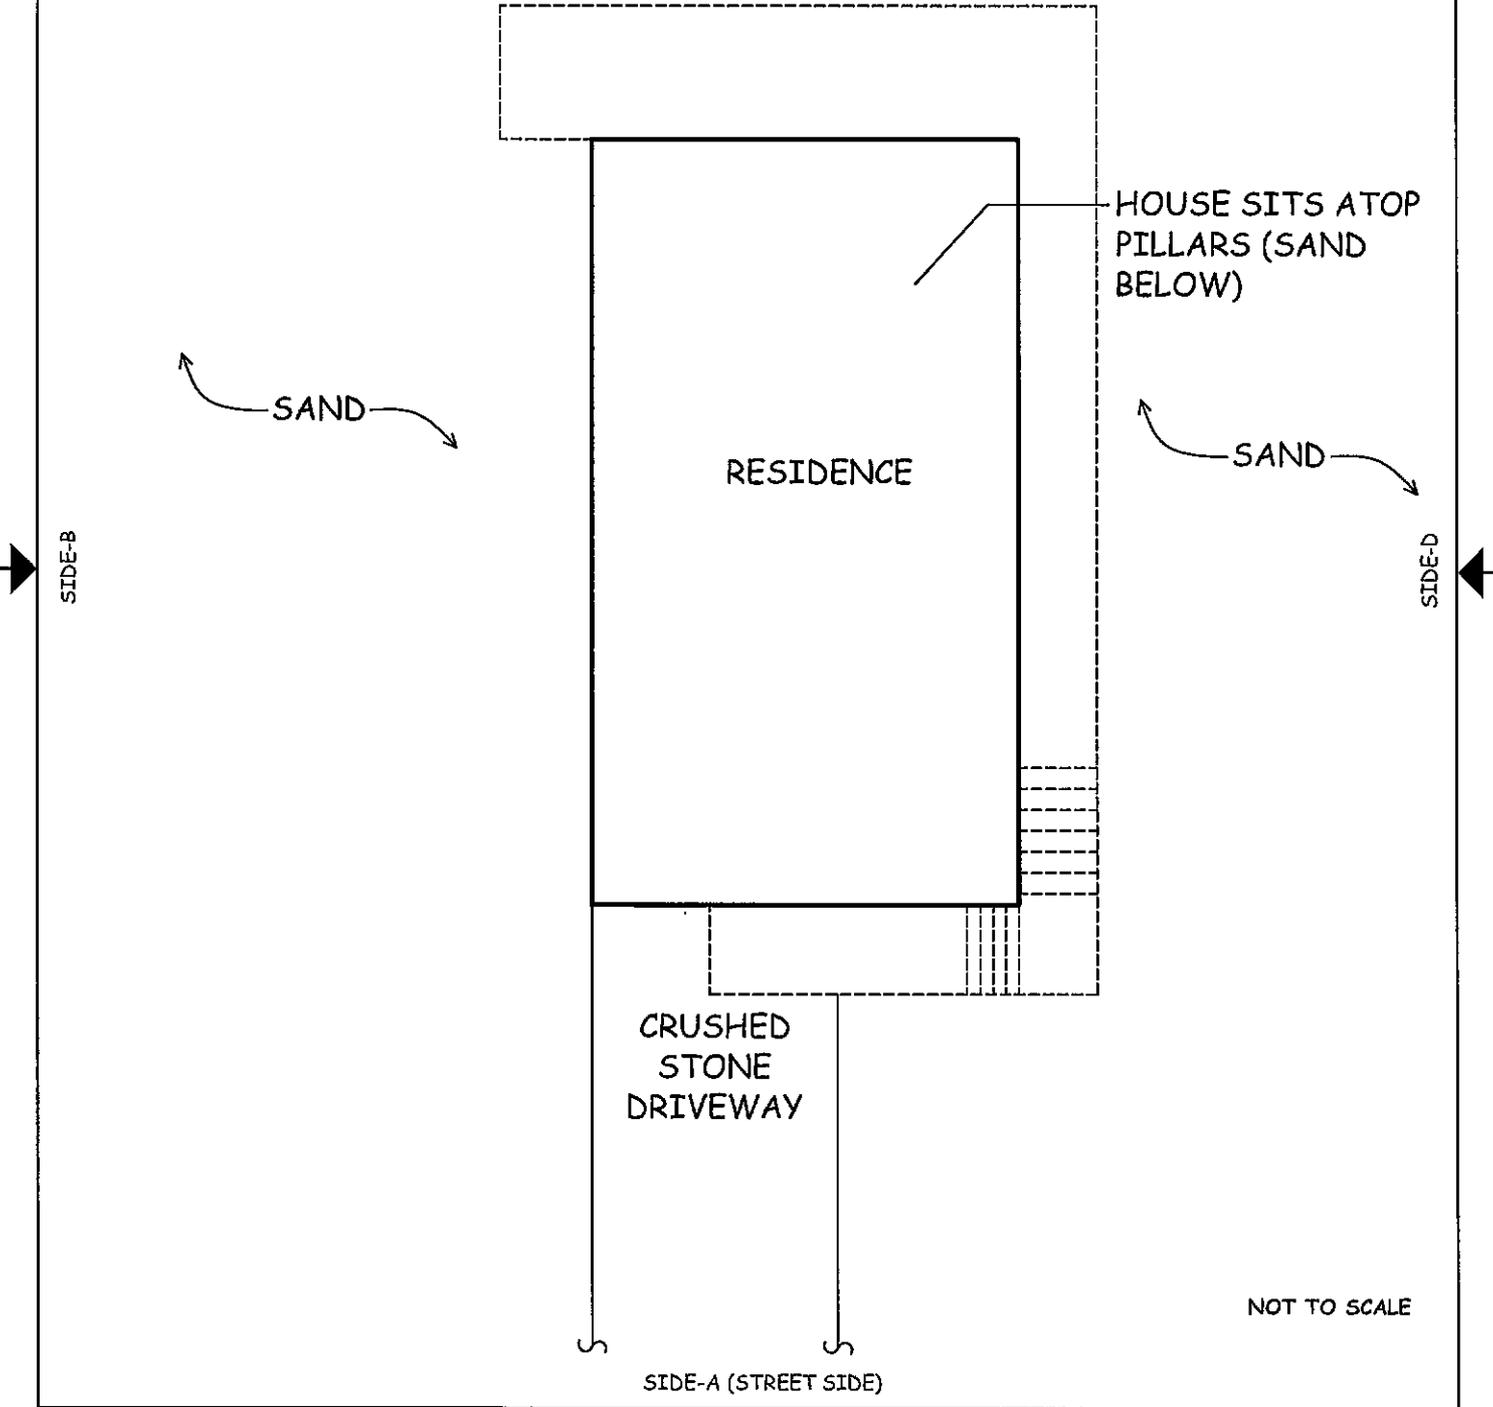
SIDE-C

NOT TO SCALE

SP-1 SITE PLAN
FP-1 FIRST FLOOR PLAN
FP-2 SECOND FLOOR PLAN
FP-3 THIRD FLOOR PLAN

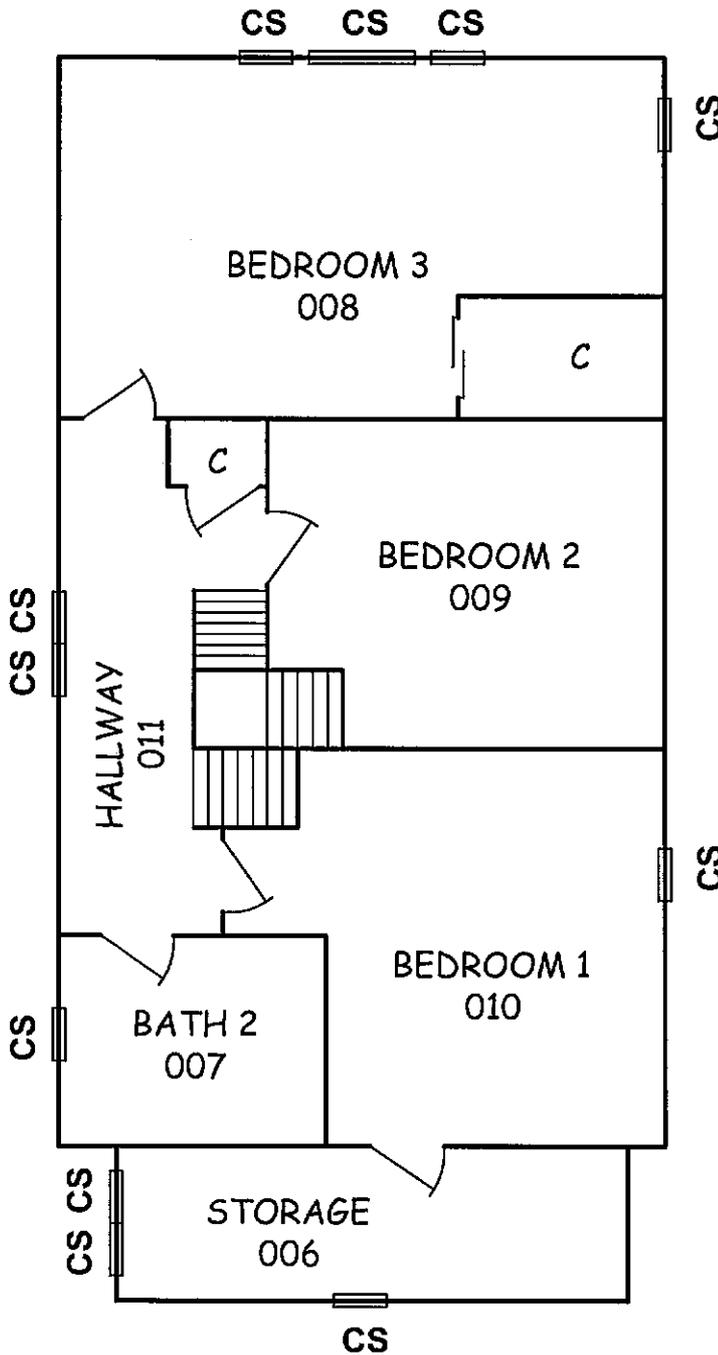
FX = FIXED

RW = REPLACEMENT
WOOD SASH
(TESTED NEGATIVE
FOR LEAD-BASED
PAINT)

NOT TO SCALE

SIDE-A (STREET SIDE)

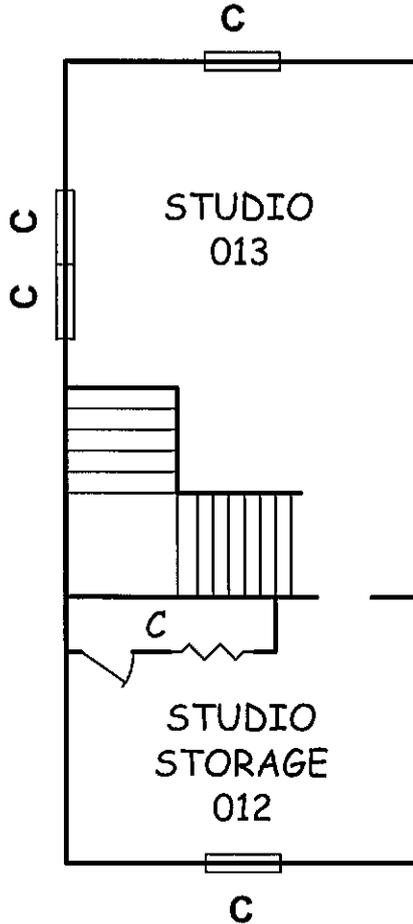
FX = FIXED

RW = REPLACEMENT
WOOD SASH
(TESTED NEGATIVE
FOR LEAD-BASED
PAINT)

NOT TO SCALE

SIDE-A (STREET SIDE)

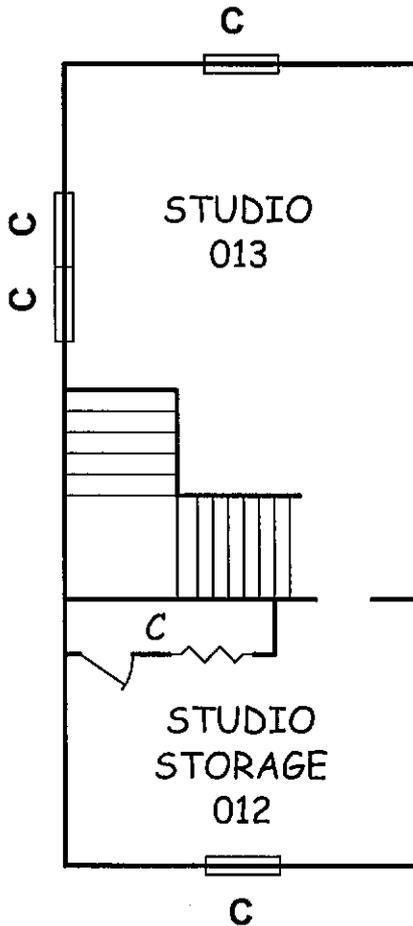
FX = FIXED

RW = REPLACEMENT
WOOD SASH
(TESTED NEGATIVE
FOR LEAD-BASED
PAINT)

NOT TO SCALE

SIDE-A (STREET SIDE)
