RE: Applicant 1529, 106 Beachland Avenue, Milford, CT

This letter is to provide a summary description of the Statutory Checklist for CDBG-DR Applicant – 1529, Sharon Zaubi.

Attachment 2 – Checklist Item #2, #12A and #14A Documentation – FEMA FIRM Flood Mapping

**Hazardous Materials
Inspection Report**

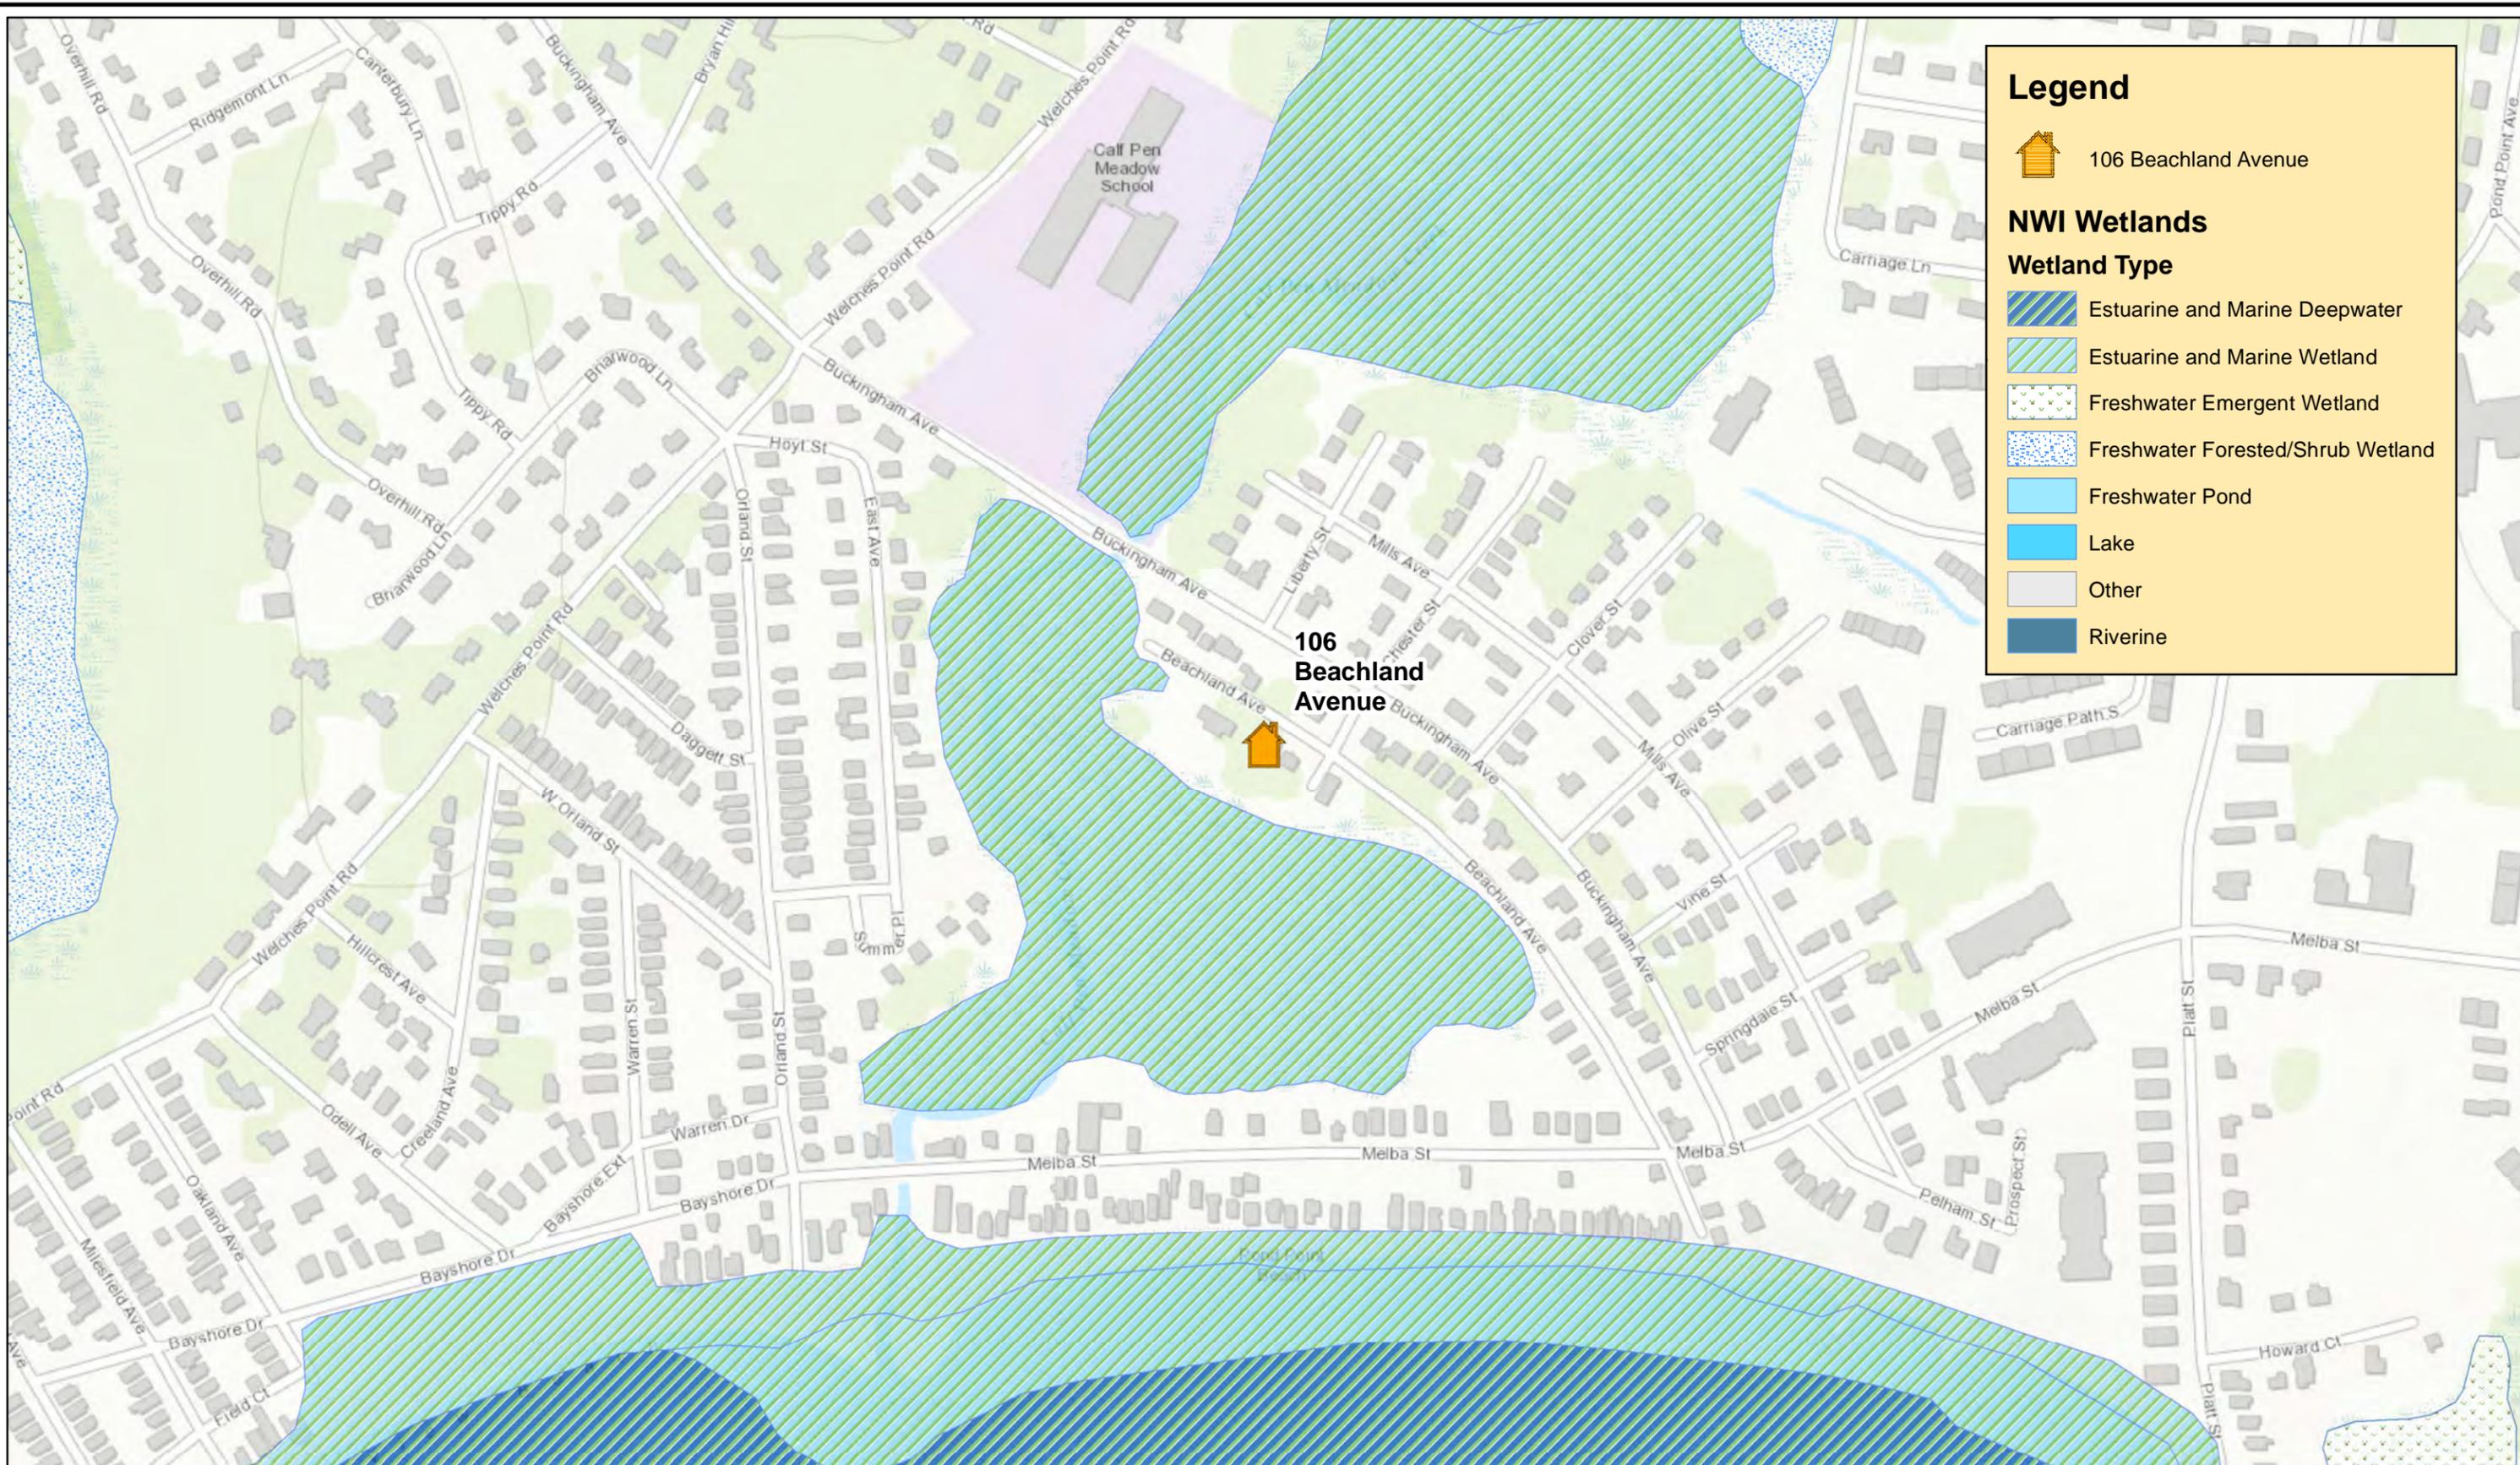
Attachment 3 – Checklist Item 3 Documentation – Wetlands Protection

Wetlands or other mapped features may have changed since the date of the imagery or field work. There may be occasional differences in polygon boundaries or classifications between the information depicted on the map and the actual conditions on site.

Certain wetland habitats are excluded from the National mapping program because of the limitations of aerial imagery as the primary data source used to detect wetlands. These habitats include seagrasses or submerged aquatic vegetation that are found in the intertidal and subtidal zones of estuaries and nearshore coastal waters. Some deepwater reef communities (coral or tubercid worm reefs) have also been excluded from the inventory. These habitats, because of their depth, go undetected by aerial imagery.

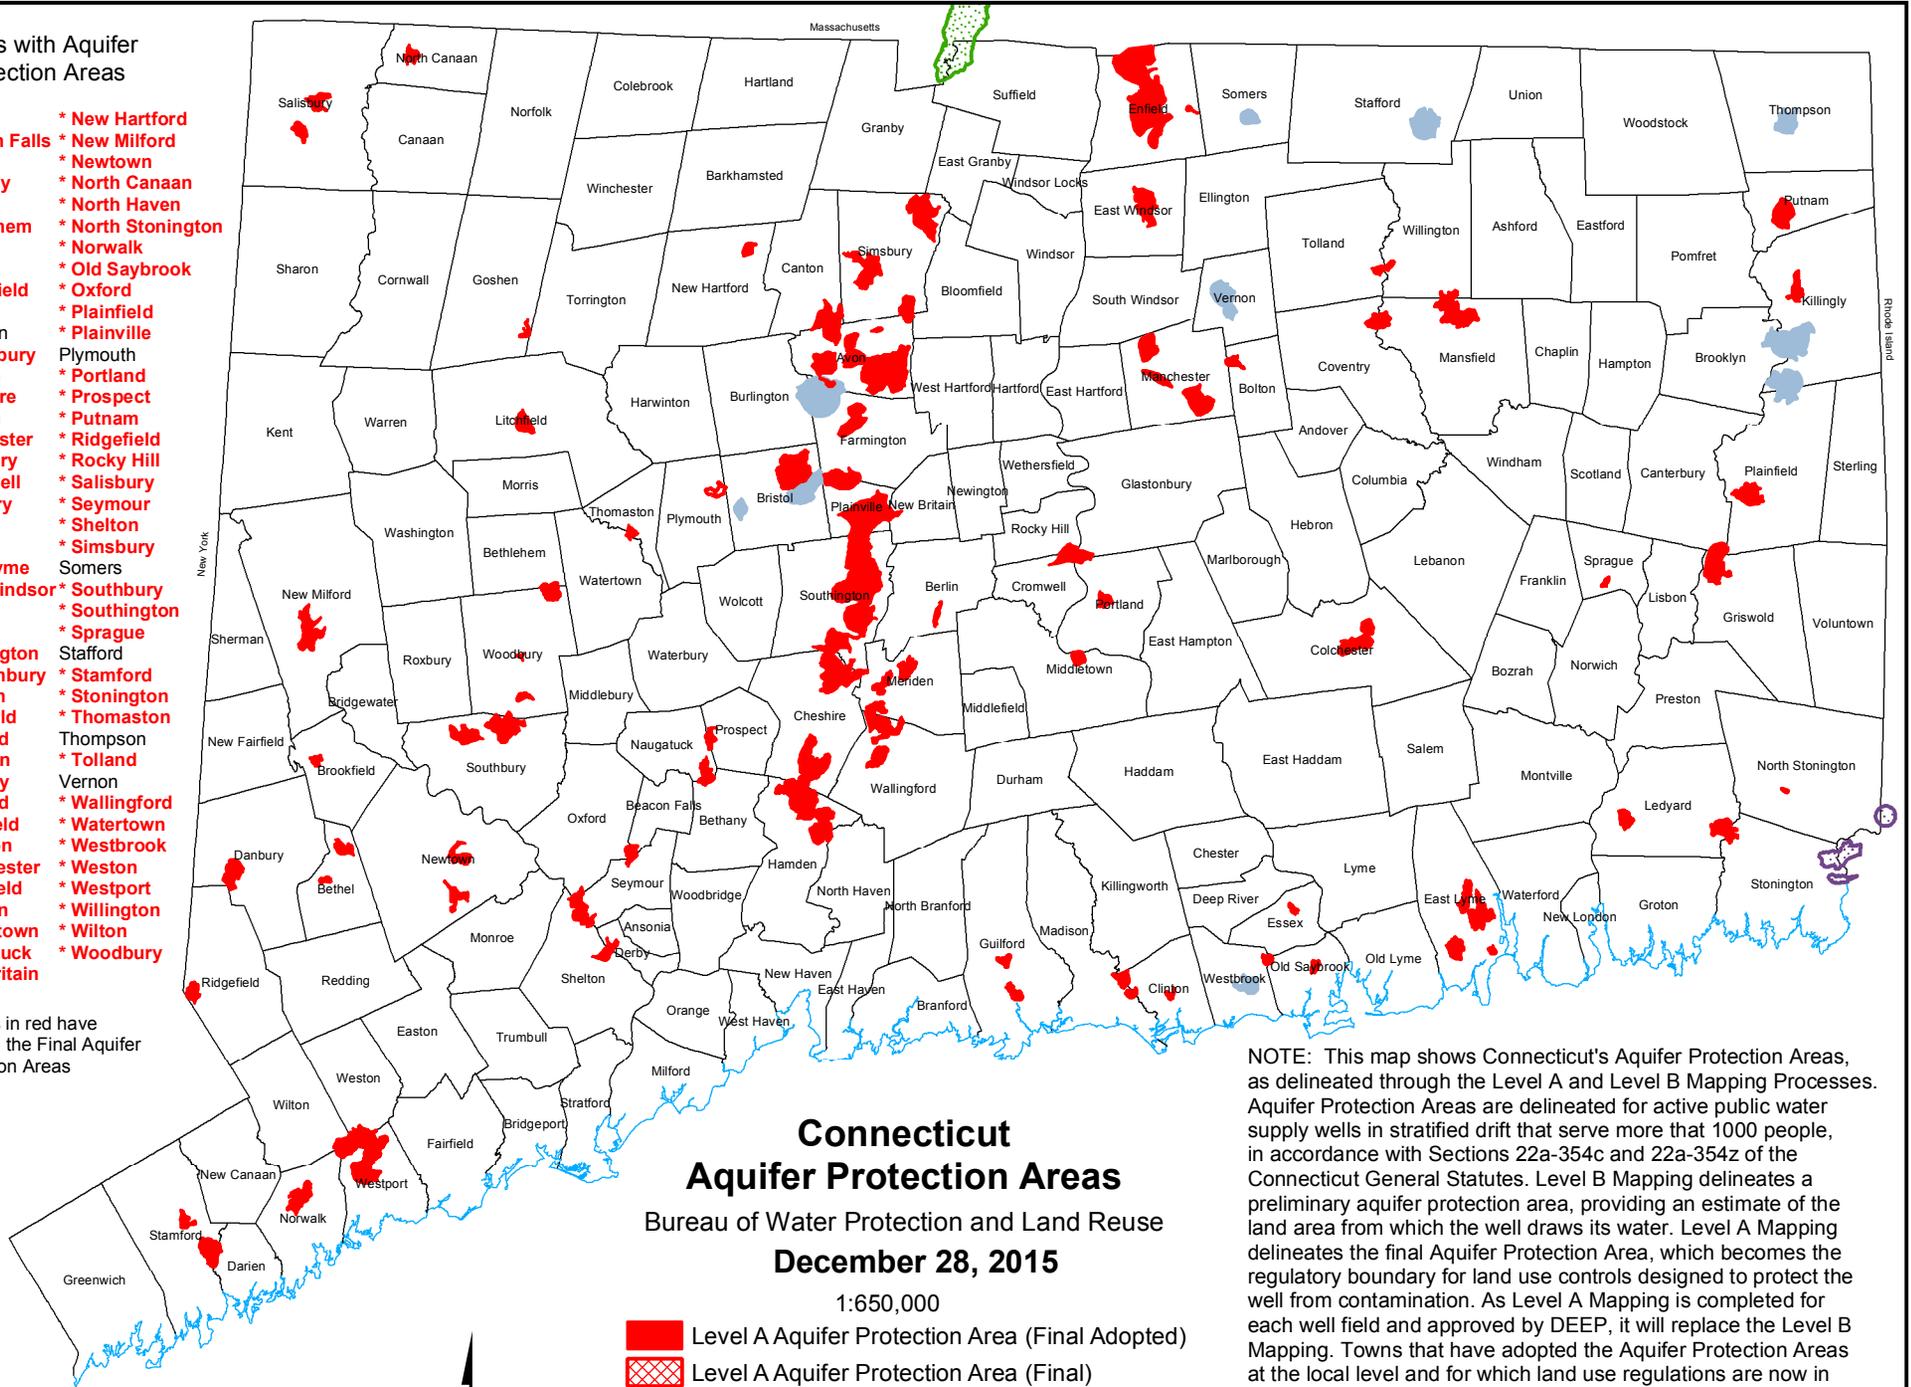
**Connecticut
Aquifer Protection Areas**

Bureau of Water Protection and Land Reuse
