**RE: Environmental Assessment Report  
Department of Housing  
CDBG-DR – Sandy Disaster Recovery Program  
28 West End Drive  
Old Lyme, Connecticut  
Application 1648  
Eagle Project No. 14-028.12T31**

Please find the Environmental Assessment Report conducted at 28 West End Drive located in Old Lyme, Connecticut (Site). The environmental assessment was performed in support of the planned renovations/repairs to the Site building under the State of Connecticut Department of Housing Community Development Block Grant – Disaster Recovery Program (Program). The assessment focused only on those areas of the building that are scheduled for renovation/repair work with the exception of the lead-based paint hazard screen, which included the interior and exterior of the entire building. The proposed scope of renovation/repair work was provided to Eagle Environmental, Inc. (Eagle) by Capital Studio Architects (CSA).

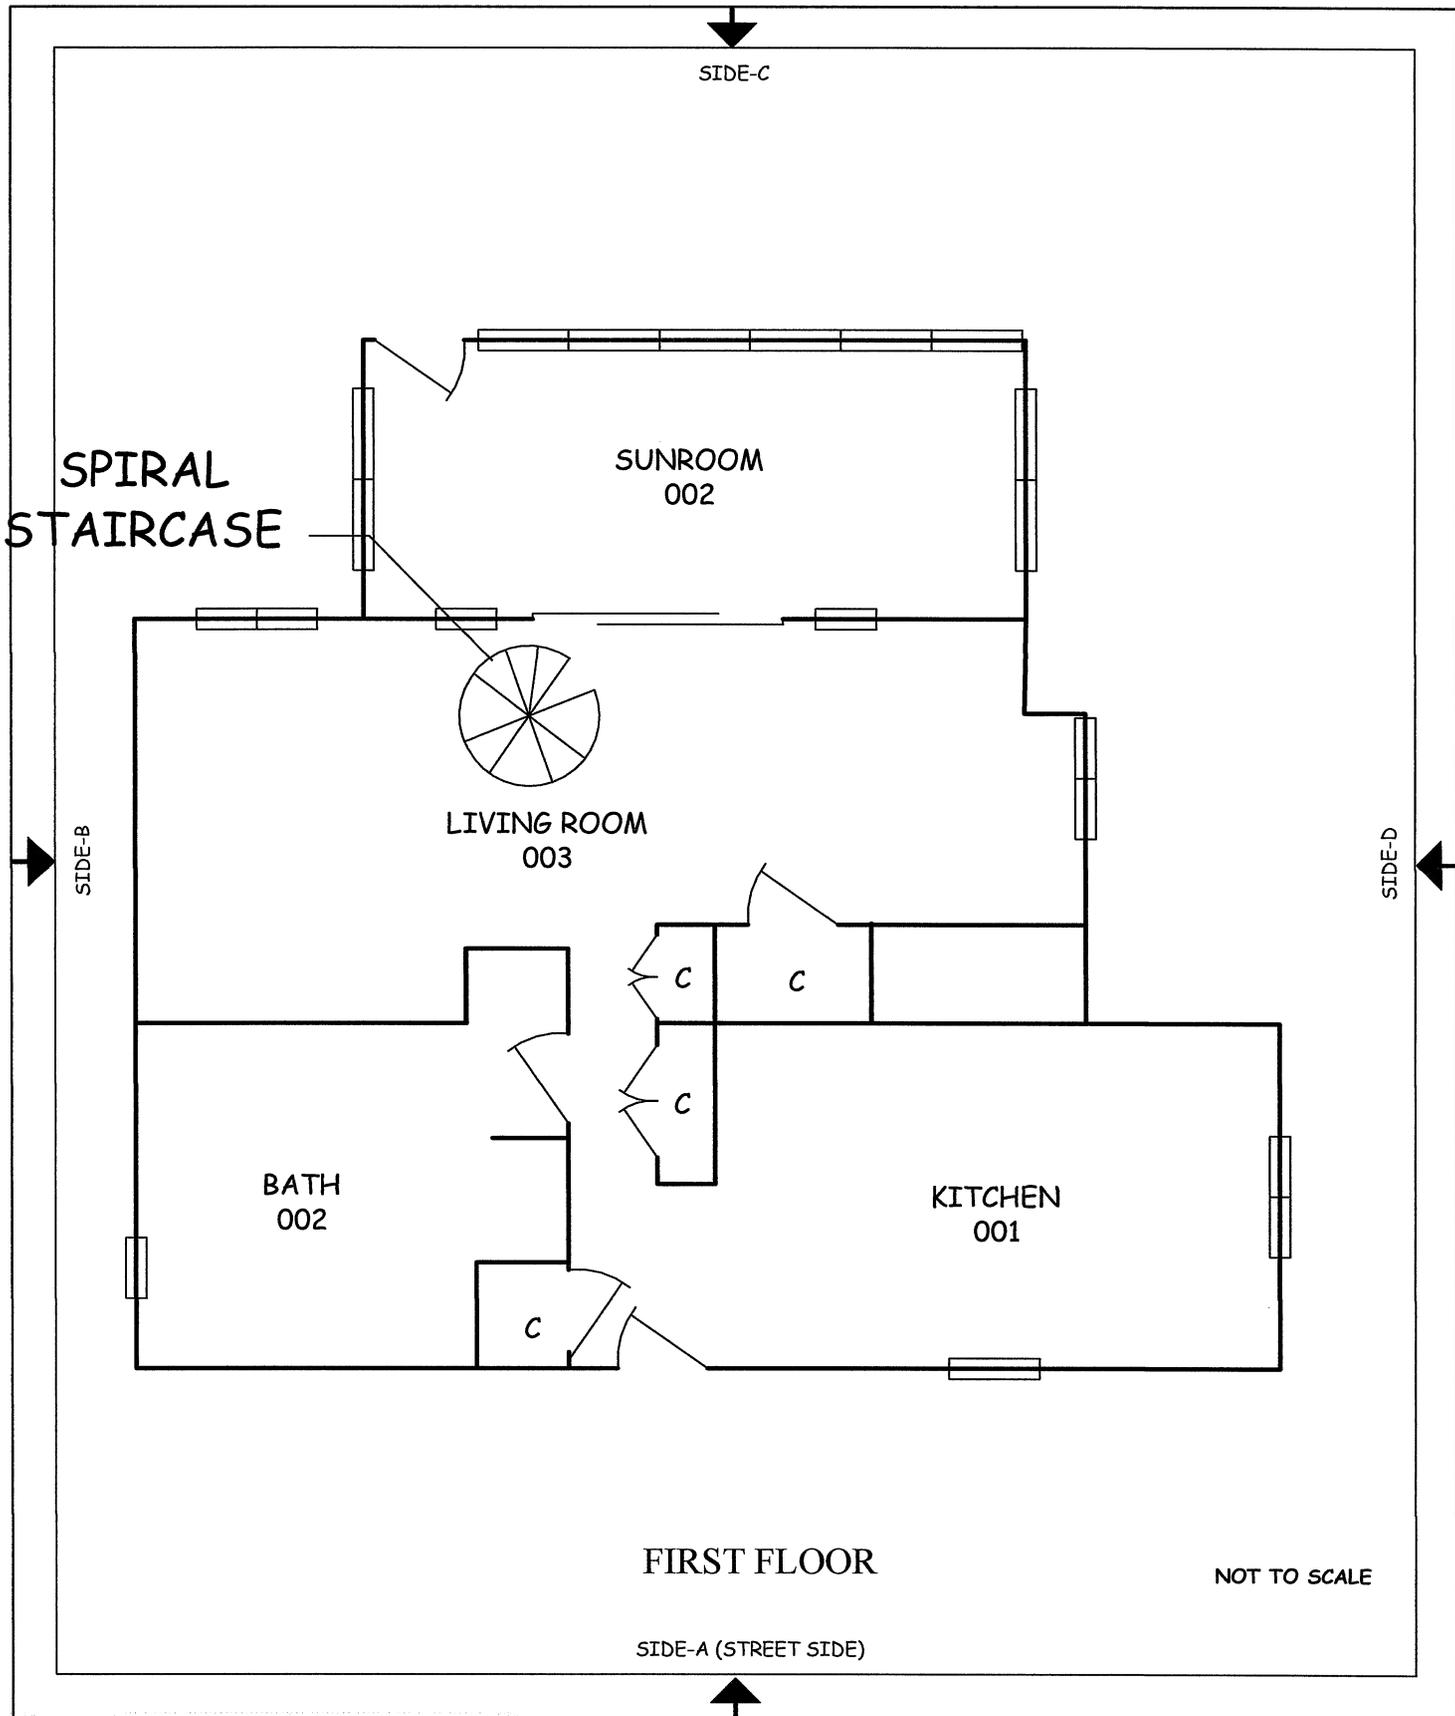
**SHEET NO.**  
**FP-1**  
SHEET 1 OF 2

FP-1 FIRST FLOOR PLAN  
FP-2 SECOND FLOOR PLAN
