STATE AND FEDERAL BRIDGE PROGRAM
PRELIMINARY APPLICATION

**WEST MAIN STREET OVER
HOCKANUM RIVER**

VERNON, CONNECTICUT

Connecticut Department of Transportation Bridge No. 04573

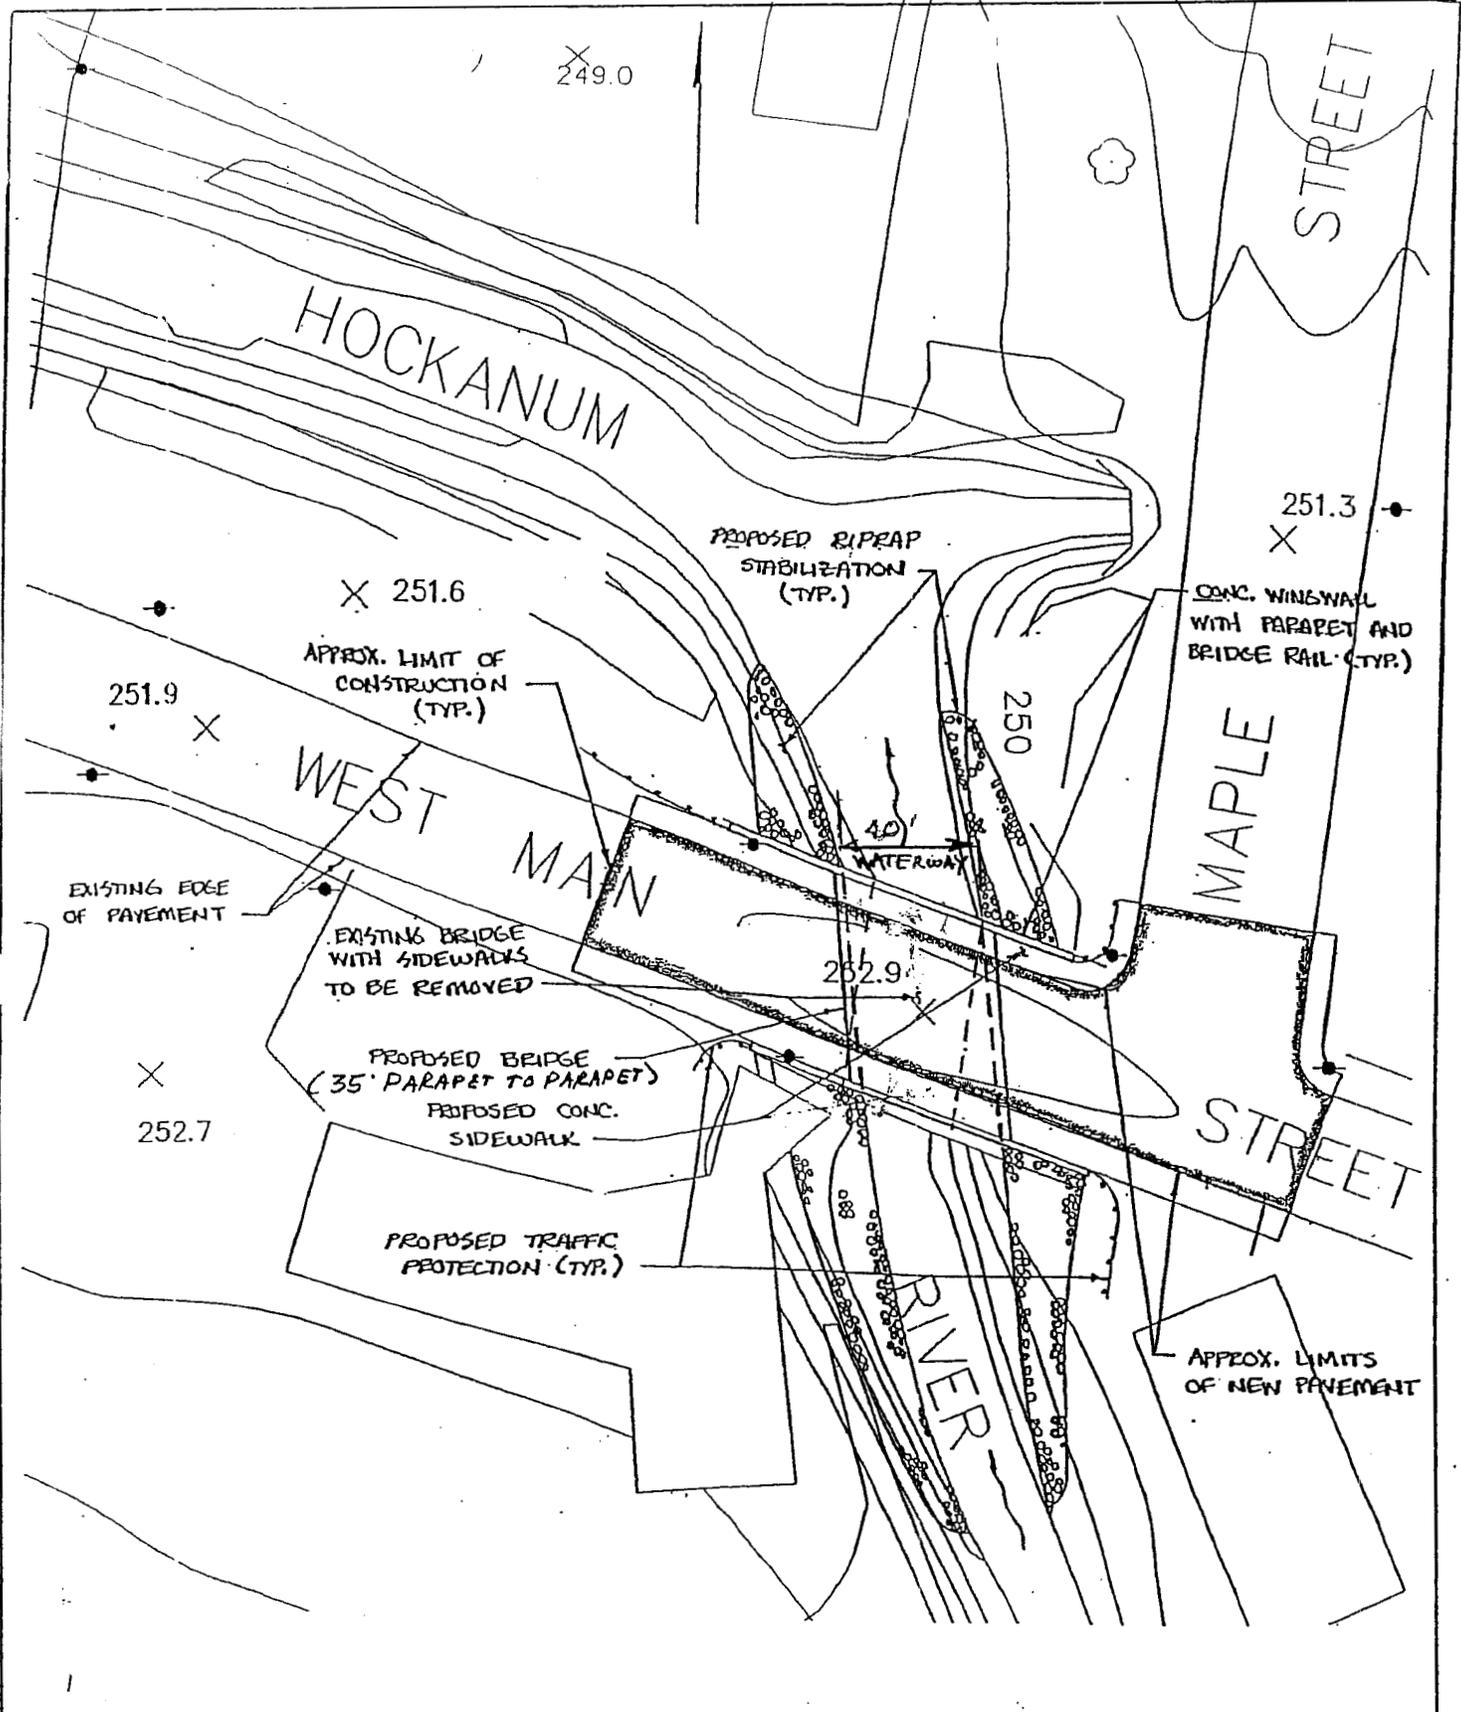
TOWN OF VERNON
SITE PLAN
 WEST MAIN STREET OVER HOCKANUM RIVER
 WEST MAIN STREET VERNON

The proposed improvements for the West Main Street Bridge consist of removing and replacing the existing structure. The Flood Insurance study shows that the bridge is in flood hazard area AE (base flood elevations determined) and there is a designated floodway in this area. Preliminary hydraulic computations indicate that, in order to comply with the Flood Management Certification requirements, the new structure should have a hydraulic opening of 40 feet. Some of the ConnDOT design criteria for a Large Structure cannot be met within the constraints of the location, street geometry and existing right-of-way. The proposed bridge will be designed to pass the 100-year flow for unencroached conditions, but the freeboard will be less than one foot and the required 2-foot underclearance will not be available. West Main Street is a local street with low traffic volumes and alternate routes are available, therefore according to the Local Bridge Program Manual for Fiscal Year 2008 and the 2000 ConnDOT Drainage Manual, Chapter 9 - Bridges, lower design criteria can be approved by the Department.

proposed to be founded on piles. A 5-foot wide sidewalk is proposed to be constructed along the north side of the bridge.

The roadway approaches would be modified for the minor profile adjustments and metal beam railings provided on both sides. The abutments would be protected with riprap and the channel banks stabilized in the vicinity of the new bridge. Relocation of a 12" water main on the south side of the bridge and a buried 6" gas main on the north side of the bridge are anticipated.
