**Asbestos Inspection Report
for
Eastern Connecticut State University
Nathan Hale Hall
833 Main Street
Willimantic, Connecticut**

**Project # BI-2B-753 (RW-02-3)
DPW # 68416**

EnviroMed Project # IH-02-121

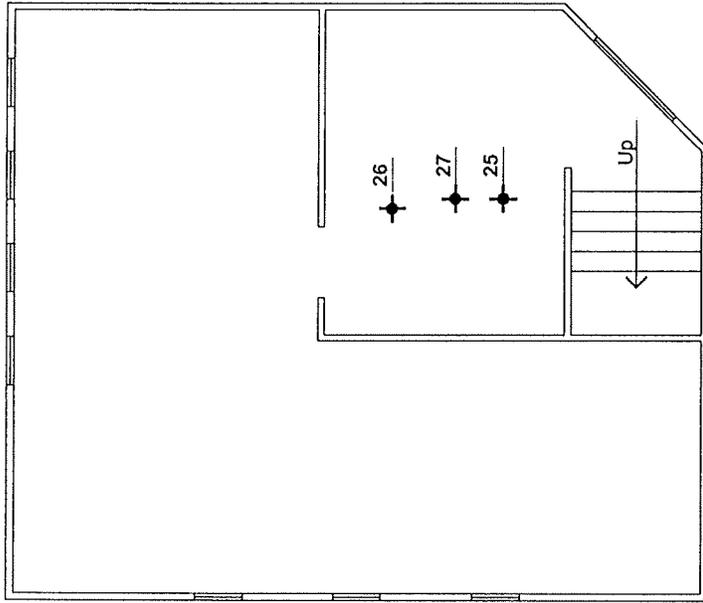
Drawing Title: Asbestos Bulk Sample Location Diagram		Date: 3/04/2002
Prepared by: EnviroMed Services, Inc. 25 Science Park, New Haven, CT 06511		Scale: N.T.S.
Project: ECSU - Nathan Hale Hall Garage Basement Floor Williamantic, Connecticut		Drawn By: E.H.
Prepared for: State of Connecticut Department of Public Works Hartford, Connecticut		Approved By: T.H.
EMS No. IH02-121 DPW No. 68416 Project No. BI-2B-828 (RW-02-3)		Drawing No. 2 of 10

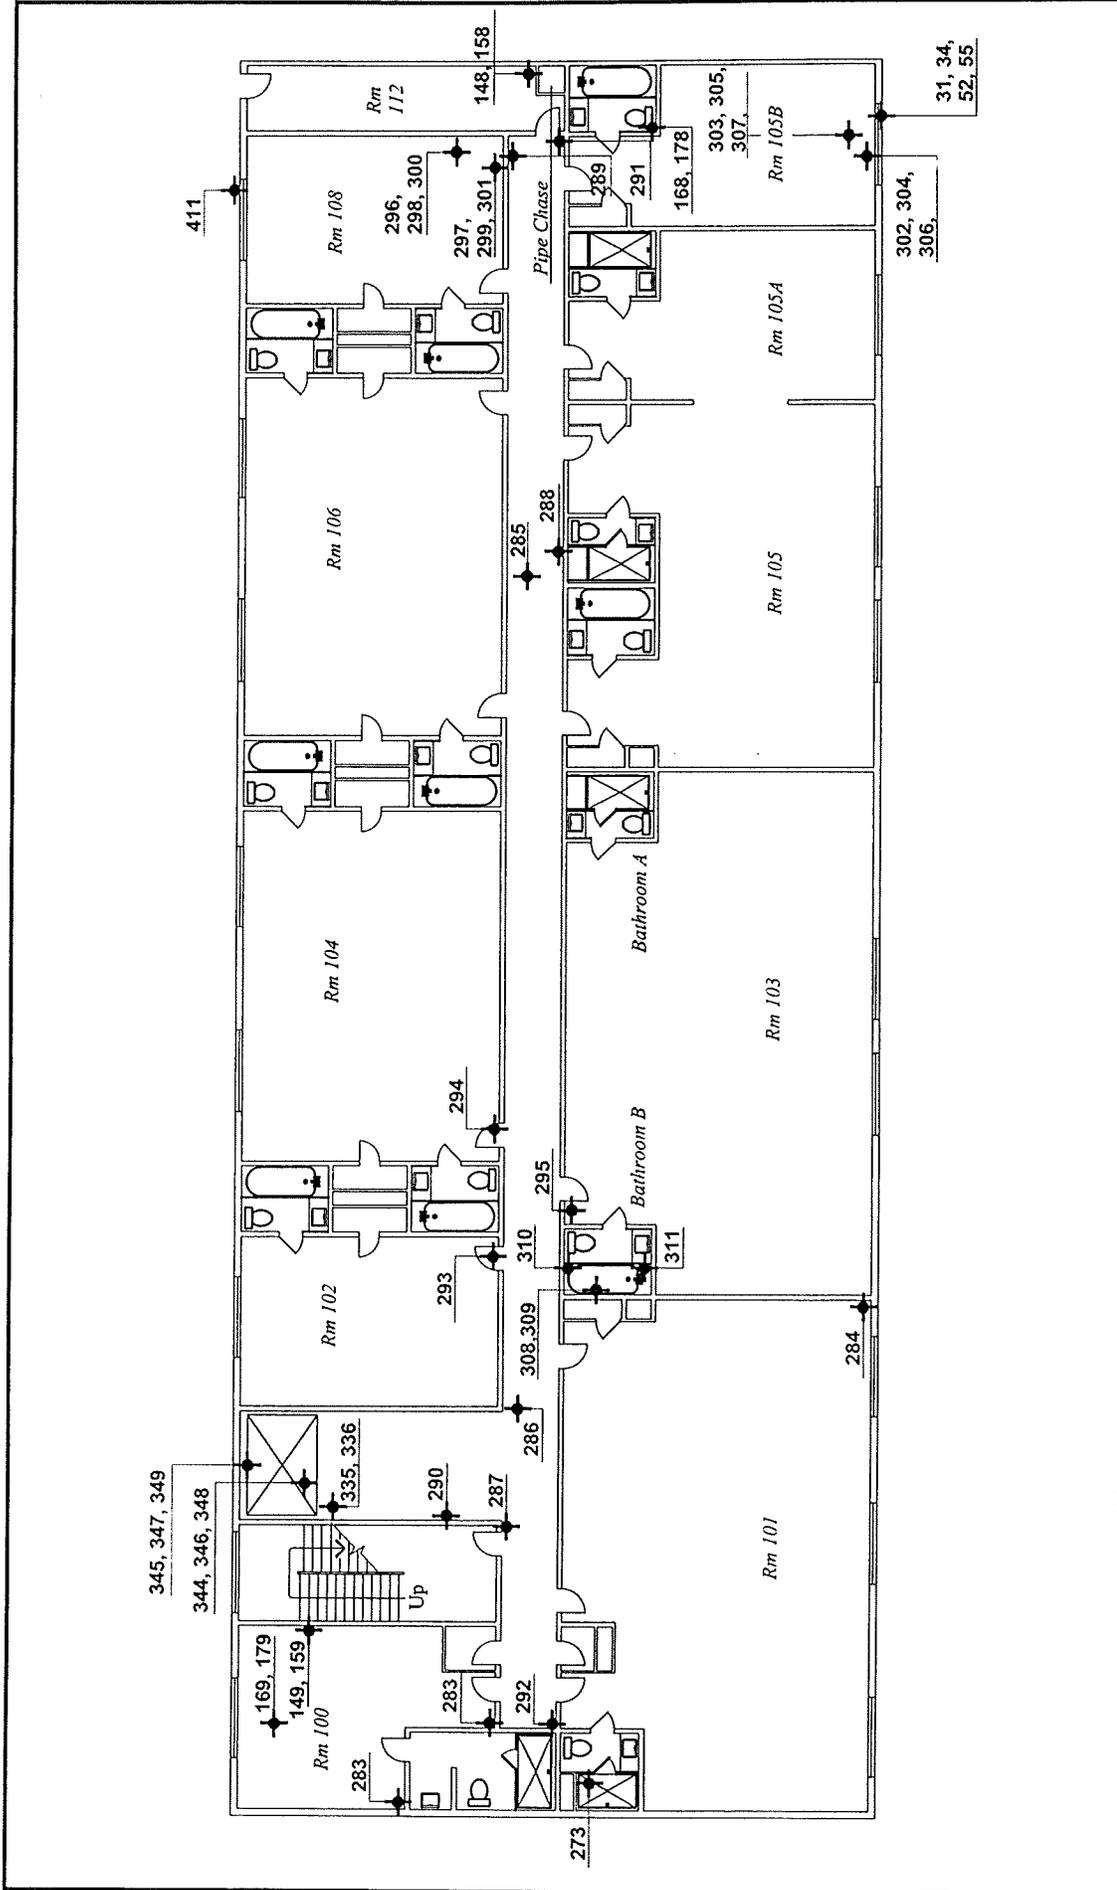
Drawing Title: Asbestos Bulk Sample Location Diagram		Date: 3/04/2002
Prepared by: EnviroMed Services, Inc. 25 Science Park, New Haven, CT 06511		Scale: N.T.S.
Project: ECSU - Nathan Hale Hall Main Building First Floor Willimantic, Connecticut		Drawn By: E.H.
Prepared for: State of Connecticut Department of Public Works Hartford, Connecticut		Approved By: T.H.
EMS No. IH02-121 DPW No. 68416 Project No. BI-2B-S2K (RW-02-3)		Drawing No. 5 of 10

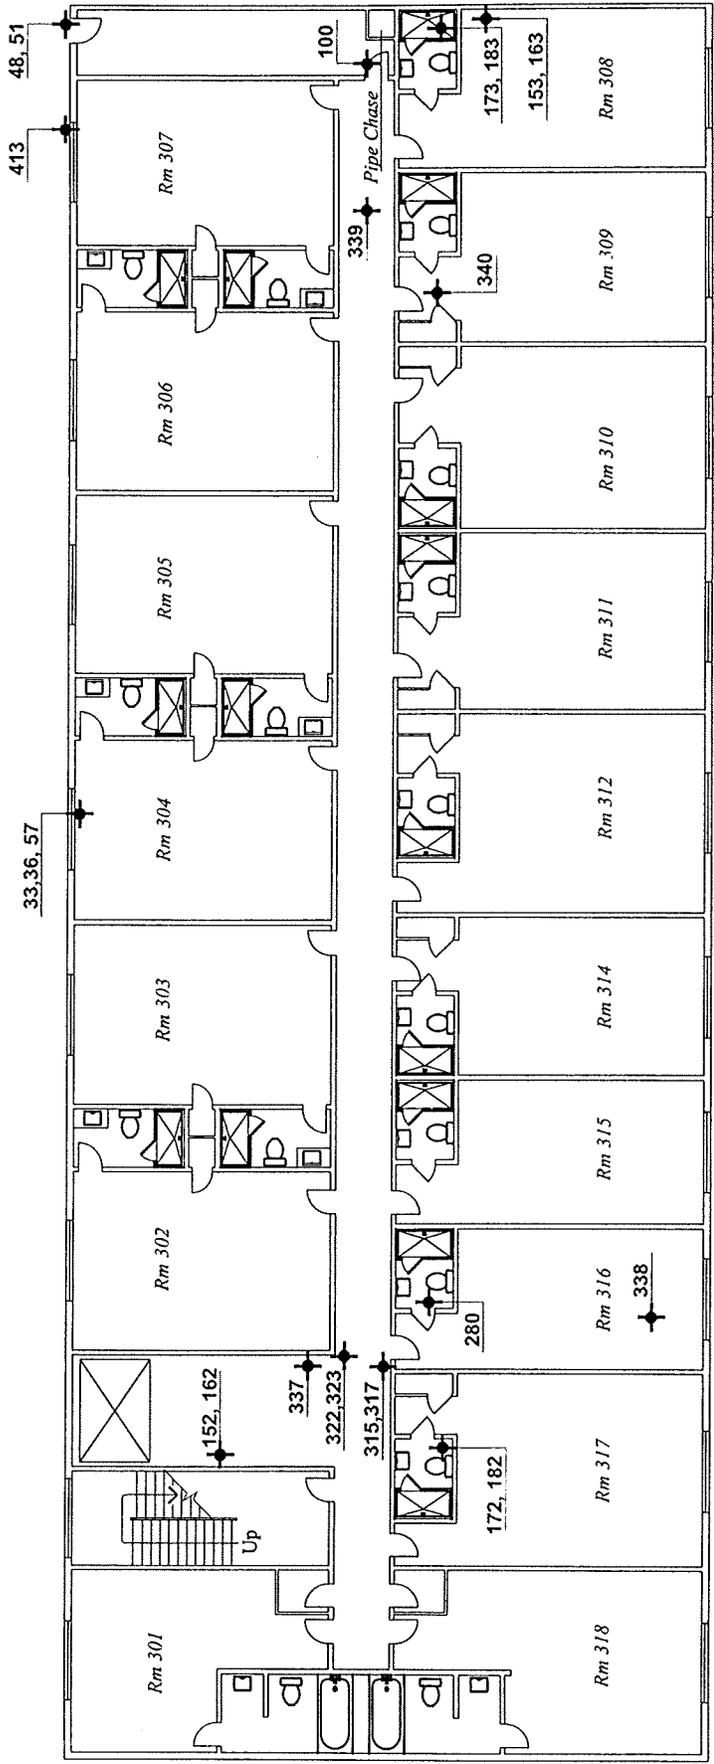
Drawing Title: Asbestos Bulk Sample Location Diagram		Date: 3/04/2002
Prepared by: EnviroMed Services, Inc. 25 Science Park, New Haven, CT 06511		Scale: N.T.S.
Project: FCSU - Nathan Hale Hall Main Building Third Floor Willimantic, Connecticut		Drawn By: E.H.
Prepared for: State of Connecticut Department of Public Works Hartford, Connecticut		Approved By: T.H.
REVISIONS		Drawing No. 7 of 10
DATE	MARK	DESCRIPTION

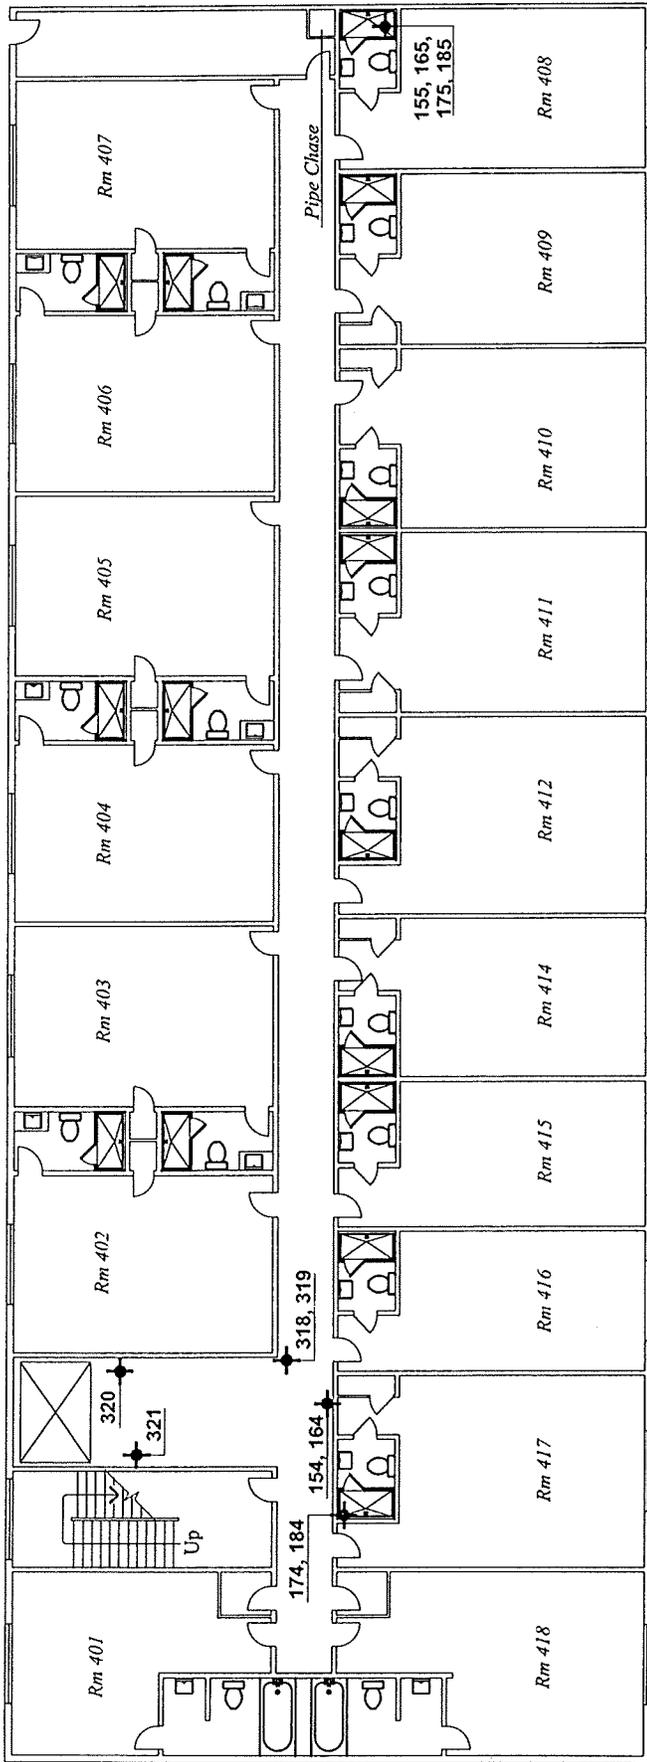
Drawing Title: Asbestos Bulk Sample Location Diagram		Date: 3/04/2002
Prepared by: EnviroMed Services, Inc. 25 Science Park, New Haven, CT 06511		Scale: N.T.S.
Project: FCSU - Nathan Hale Hall Main Building Fourth Floor Willimantic, Connecticut		Drawn By: E.H.
Prepared for: State of Connecticut Department of Public Works Hartford, Connecticut		Approved By: T.H.
EMS No. JH02-121 DPW No. 68416 Project No. BI-2B-828 (R.W-02-3)		Drawing No. 8 of 10
REVISIONS		
DATE	MARK	DESCRIPTION

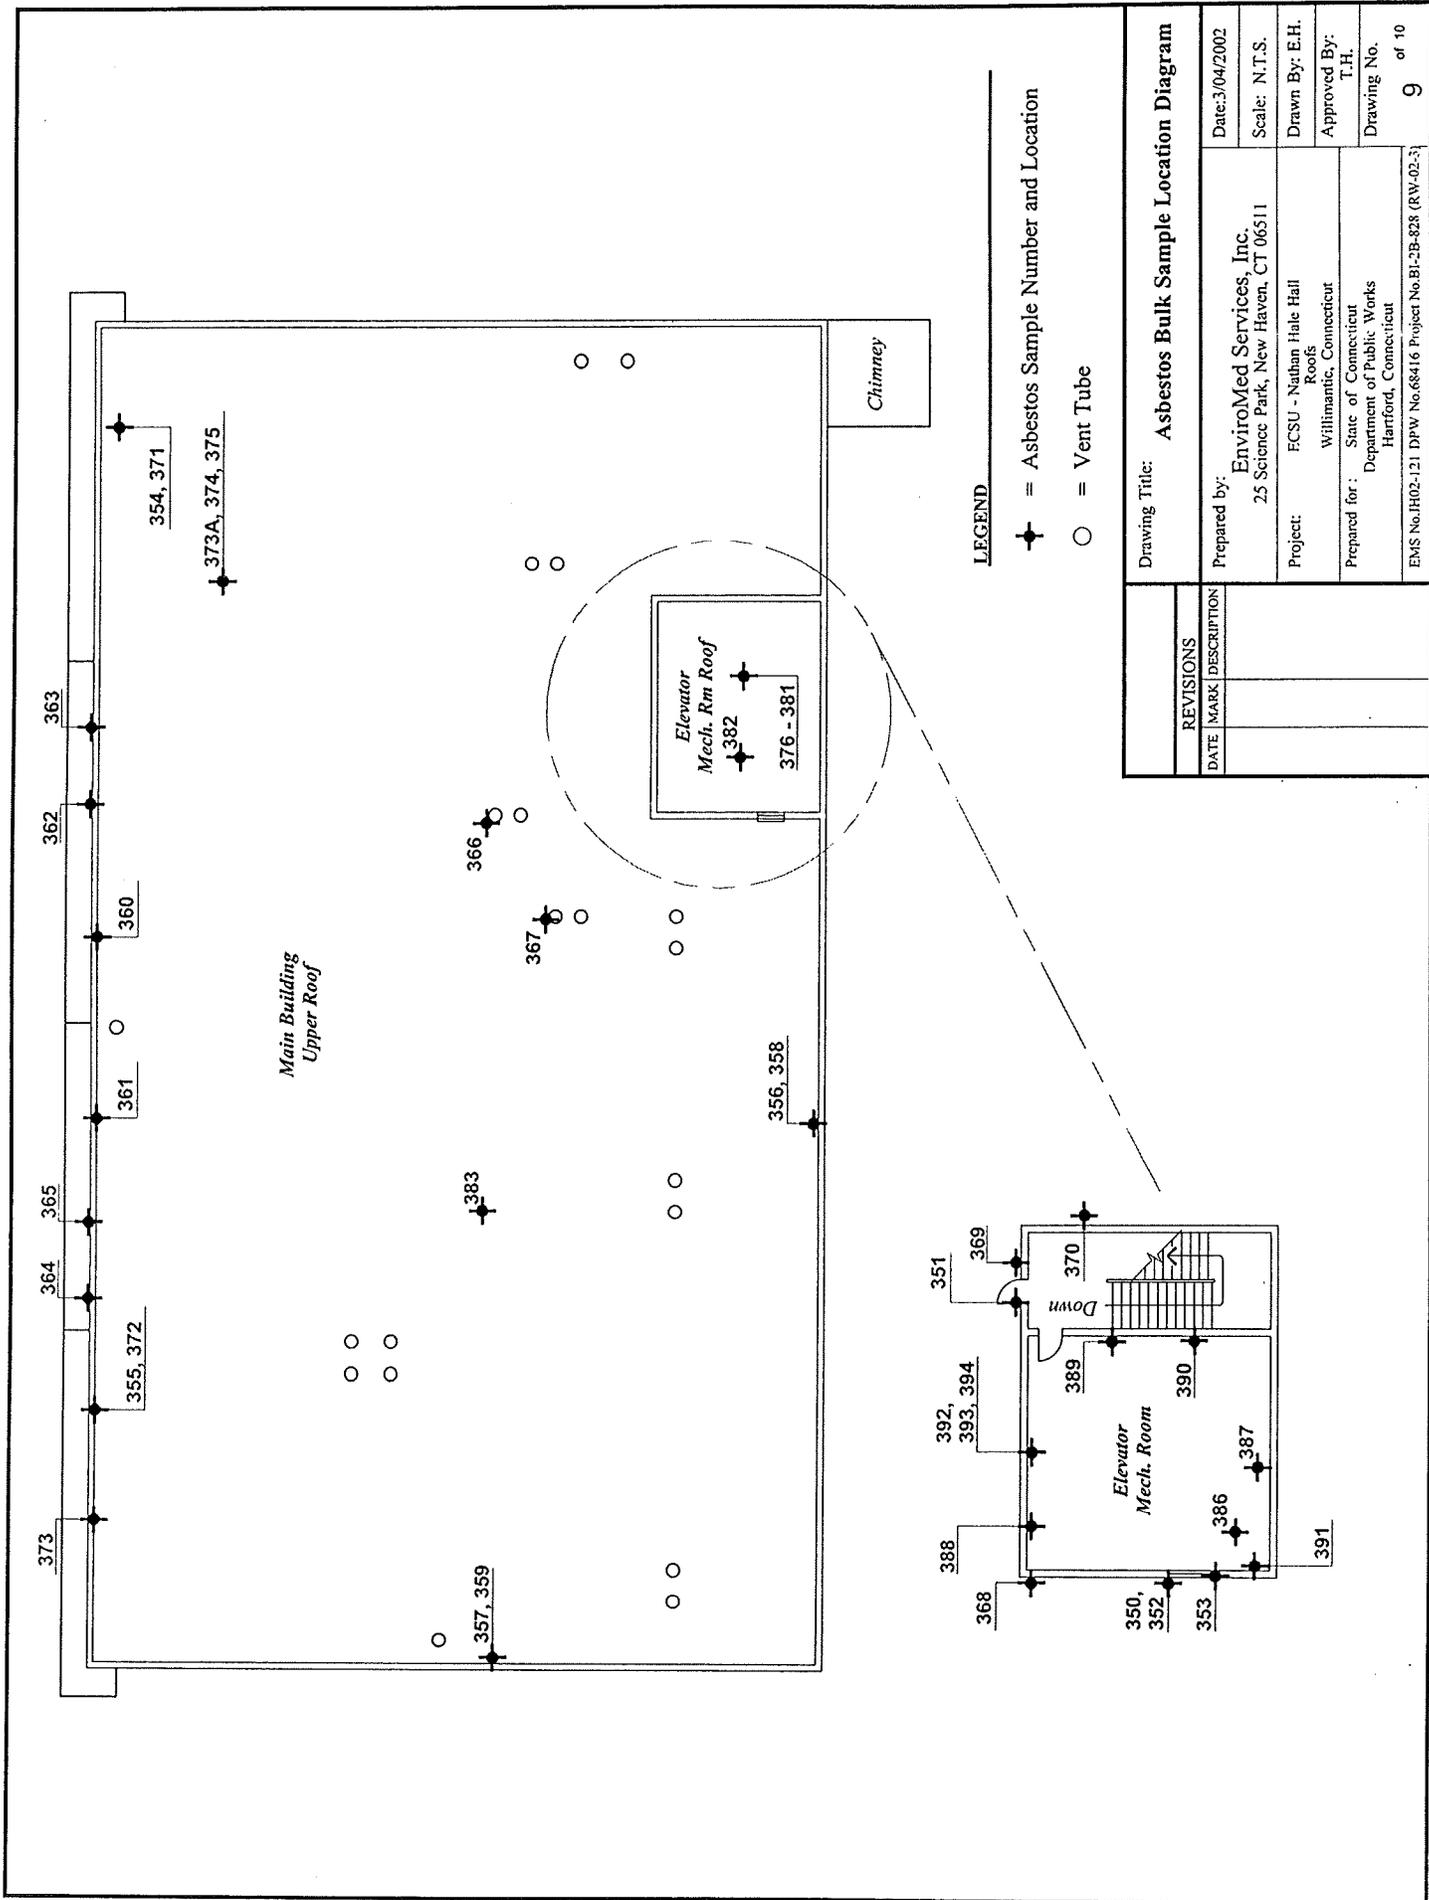
Drawing Title: Asbestos Bulk Sample Location Diagram		Date: 3/04/2002
Prepared by: EnviroMed Services, Inc. 25 Science Park, New Haven, CT 06511		Scale: N.T.S.
Project: FCSU - Nathan Hale Hall Roofs Willimantic, Connecticut		Drawn By: E.H.
Prepared for: State of Connecticut Department of Public Works Hartford, Connecticut		Approved By: T.H.
EMS No. JH02-121 DPW No. 68416 Project No. BI-2B-828 (RVV-02-3)		Drawing No. 9 of 10

There is approximately 6,080 square feet of black roll-on roofing material located on the garage roof. The second layer of roofing was found to contain 4 percent asbestos. The third layer of roofing was found to contain 5 percent asbestos. The first, fourth, fifth, sixth and seventh layers were found to contain no asbestos. The black cement joint sealant and flashing paper were found to contain no asbestos.

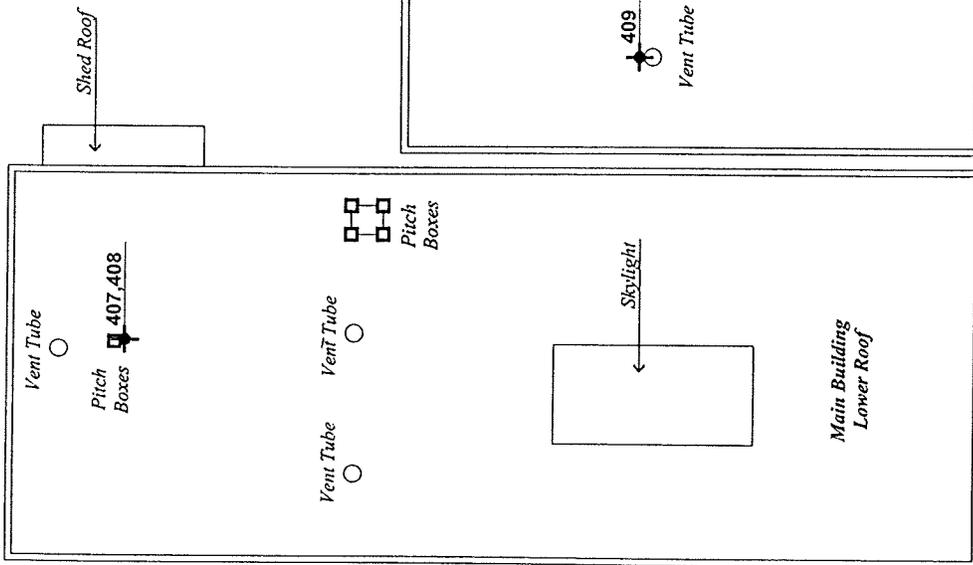
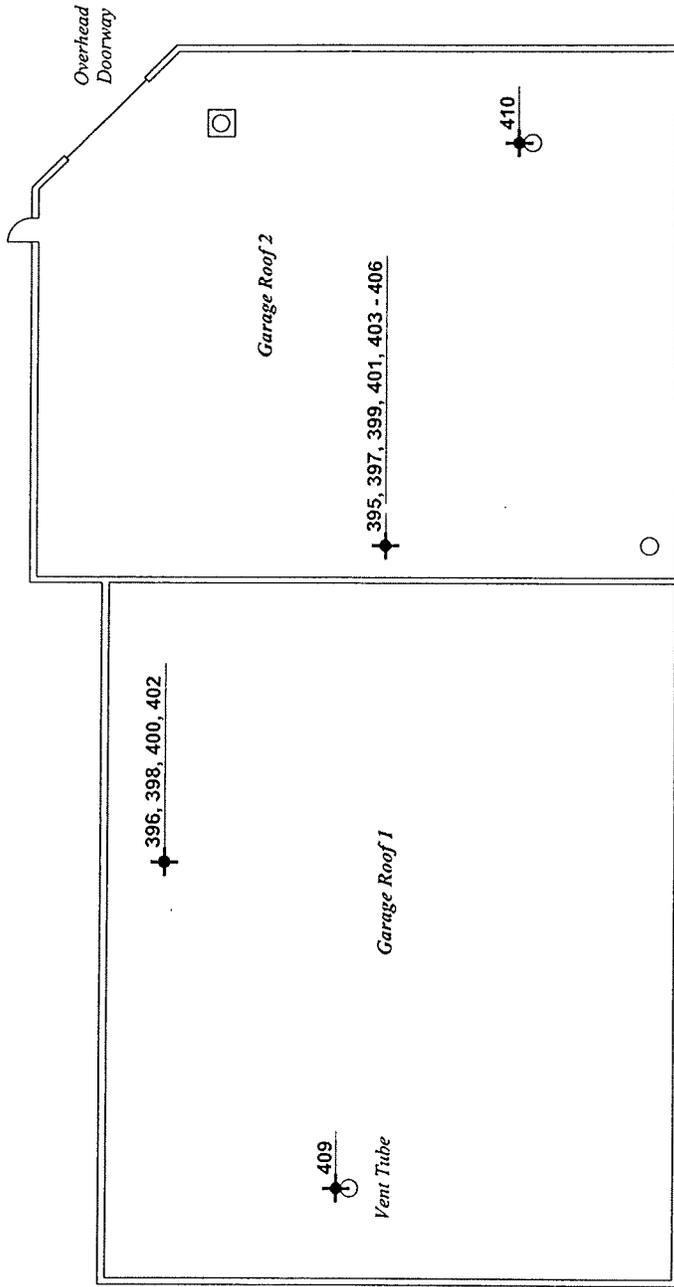
Drawing Title:	Asbestos Bulk Sample Location Diagram	
Prepared by:	EnviroMed Services, Inc. 25 Science Park, New Haven, CT 06511	
Project:	ECSU - Nathan Hale Hall Roofs Willimantic, Connecticut	
Prepared for:	State of Connecticut Department of Public Works Hartford, Connecticut	
Date:	3/04/2002	Scale: N.T.S.
Drawn By:	E.H.	Approved By: T.H.
Drawing No.	EM5 No.1102-121 DPV No.68416 Project No.B1-2B-828 (RW-02-3)	
	10	of 10
