Docket No. 217 – Development and Management Plan Inspection

Northeast Utilities Service Company Certificate of Environmental Compatibility and Public Need for the construction of a 345-kV electric transmission line and reconstruction of an existing 115-kV electric transmission line between Connecticut Light and Power Company’s Plumtree Substation in Bethel, through the towns of Redding, Weston, and Wilton, and to the Norwalk Substation in Norwalk, Connecticut.

Date: September 29, 2005

Location: Transition Stations (Hoyts Hill, Archers Lane)

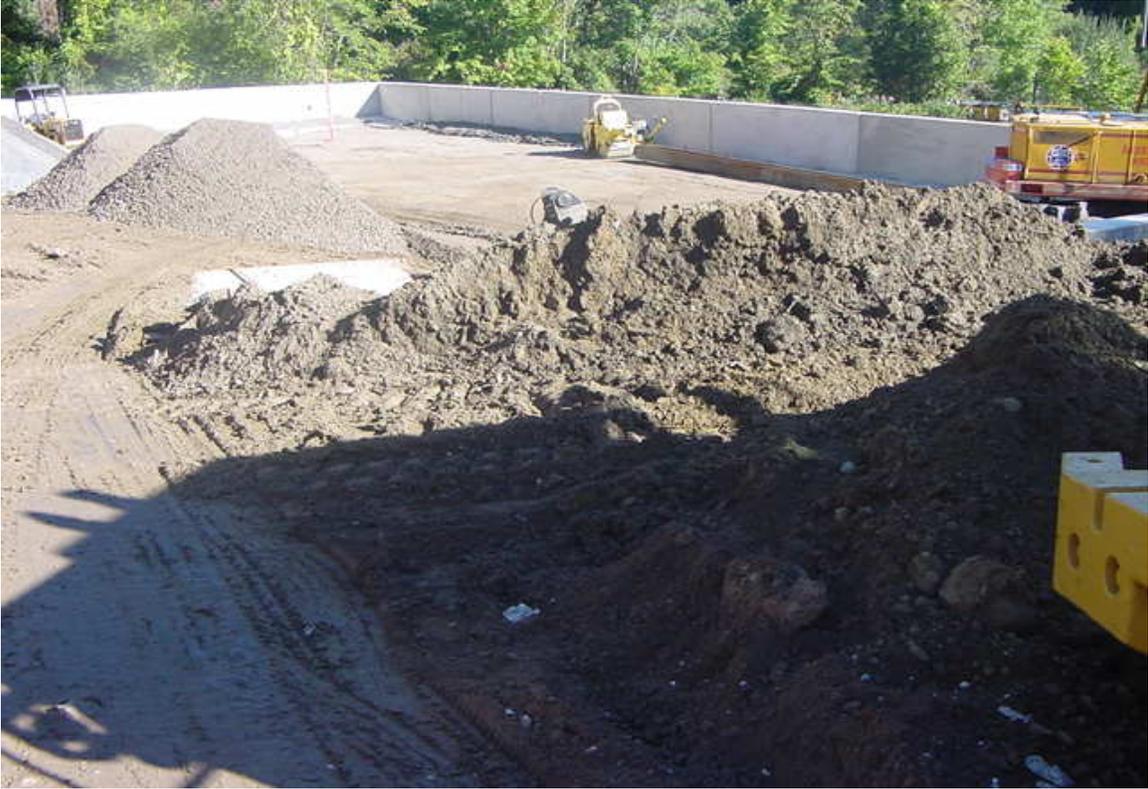
Hoyts Hill Transition Station: View of the ongoing construction of the infrastructure of the station including backfilling to grade. (9/29/05)

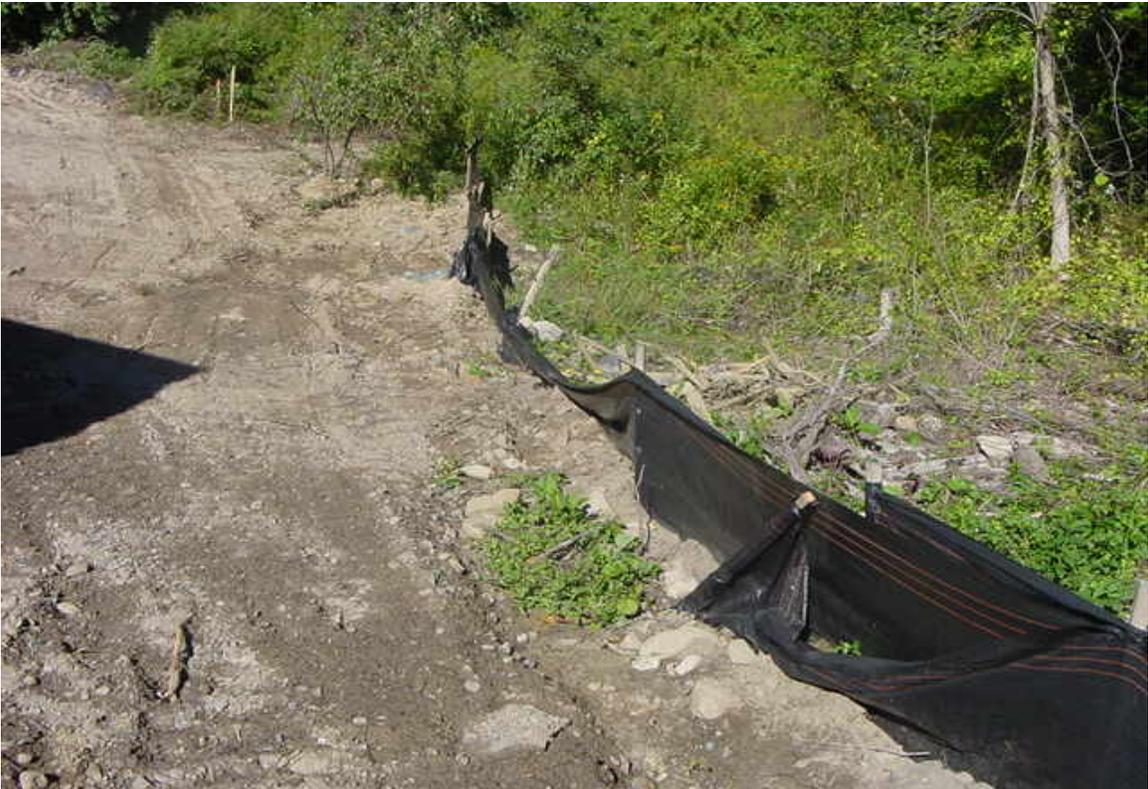
The end of the northern edge of silt fence needs some minor maintenance when feasible. (9/29/05)

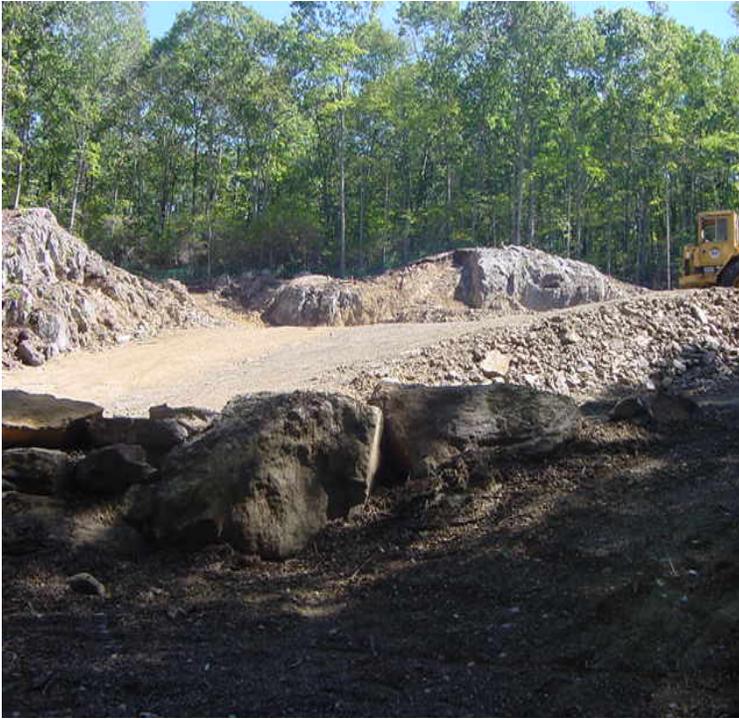
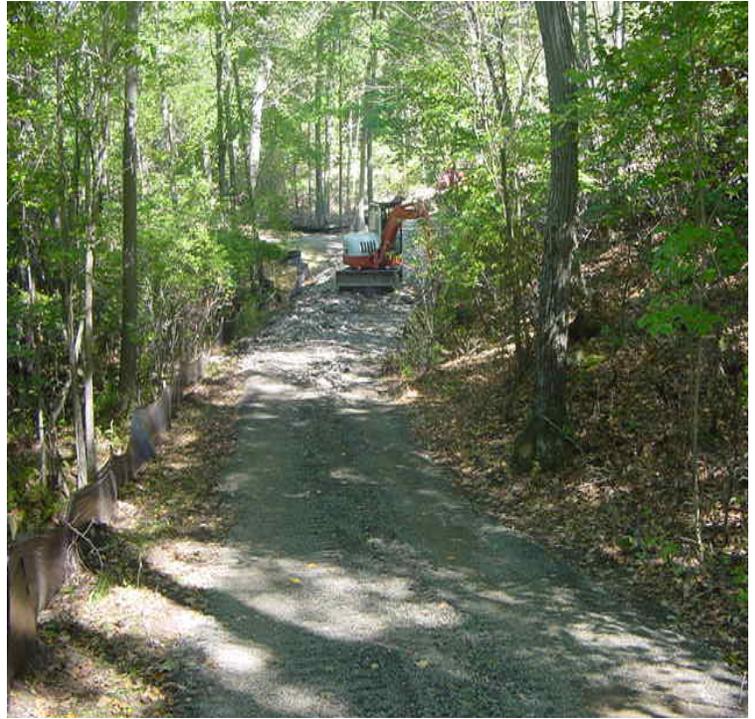
Archers Lane Transition Station: The photo on the left shows the area into the site where blasting and grading have continued. Photo on the right shows the access road leading past the station to the ROW. Erosion controls were extended along the path here. (9/29/05)

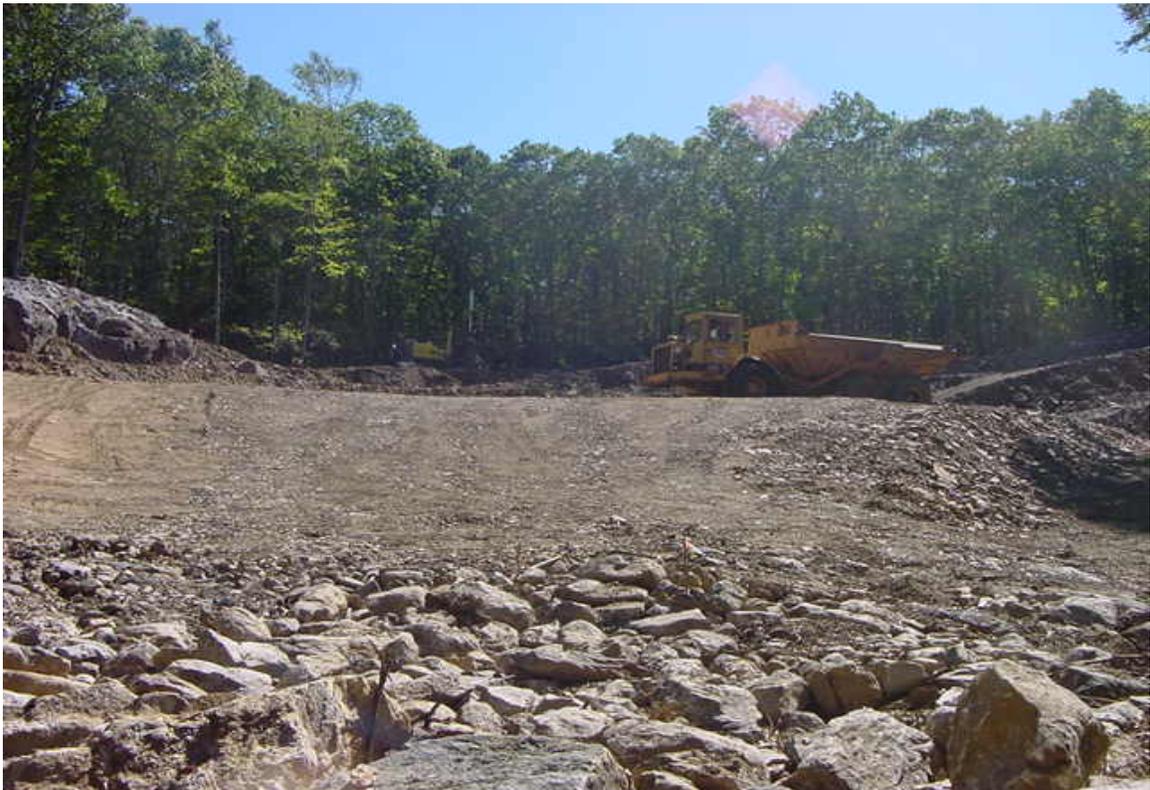
Overall view of the station site following continuing blasting and earthwork. (9/29/05)
