Docket No. 272 – Development and Management Plan Inspection

Segment 2a Inspection

Date: July 22, 2008

Location: Segment 2a – Beseck Switching Station to Cheshire/Hamden Town Line

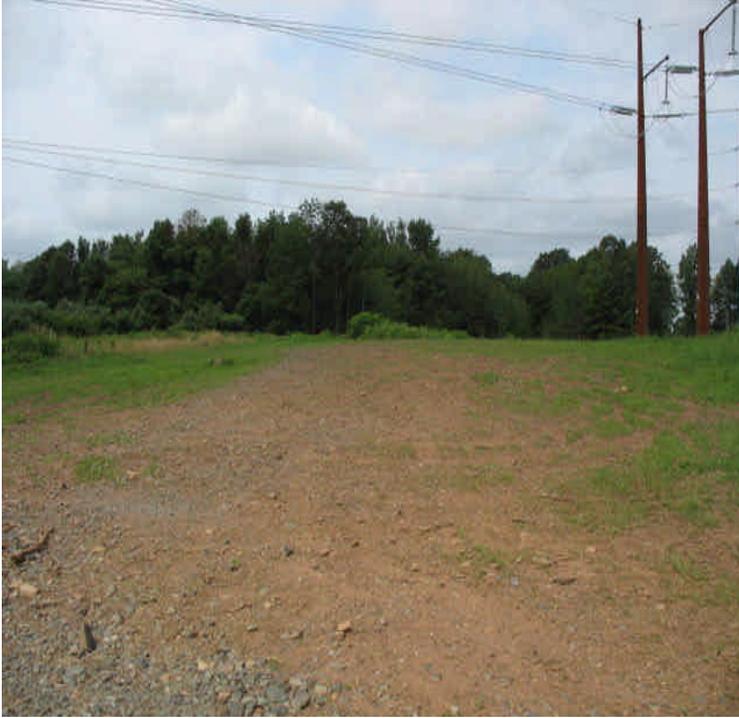
Carpenter Ln: The disturbed area remains graded and seeded but vegetative growth is still fairly sparse. Additional seed may be needed during more favorable conditions.

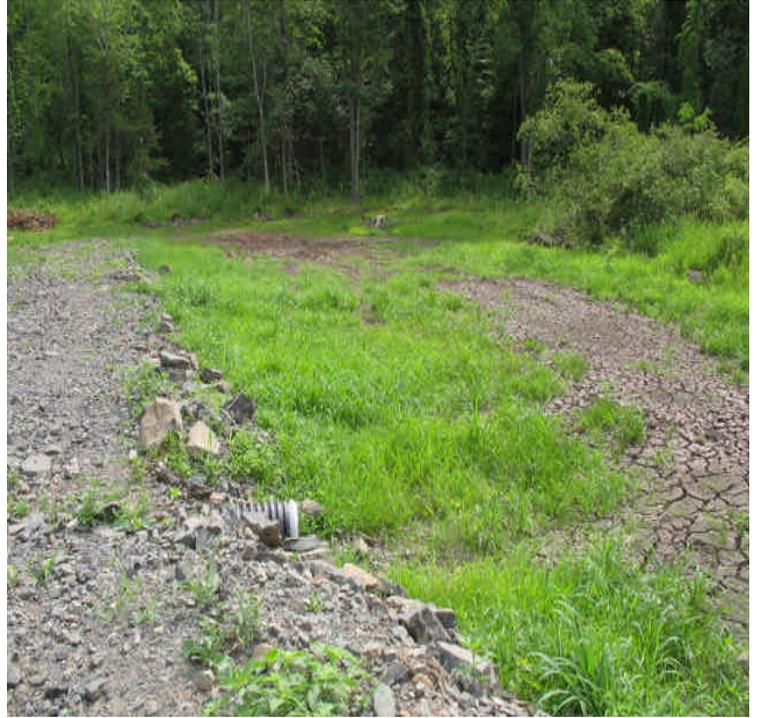
Carpenter Ln: Restoration work is complete within the wetlands. Minor seeding will be done when water subsides. Impacts were reduced from original permitted numbers and narrowed to a spur road.

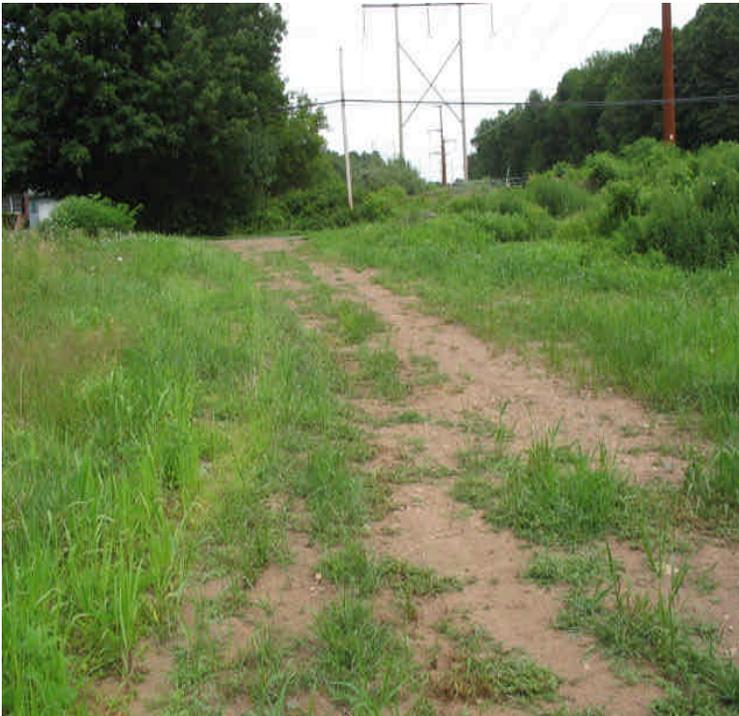
Durham Rd (South): Exposed access road sloping toward the wetlands. Needs minor controls to prevent run-off from entering the wetlands. The noted increase in vegetation will also help filter run-off.

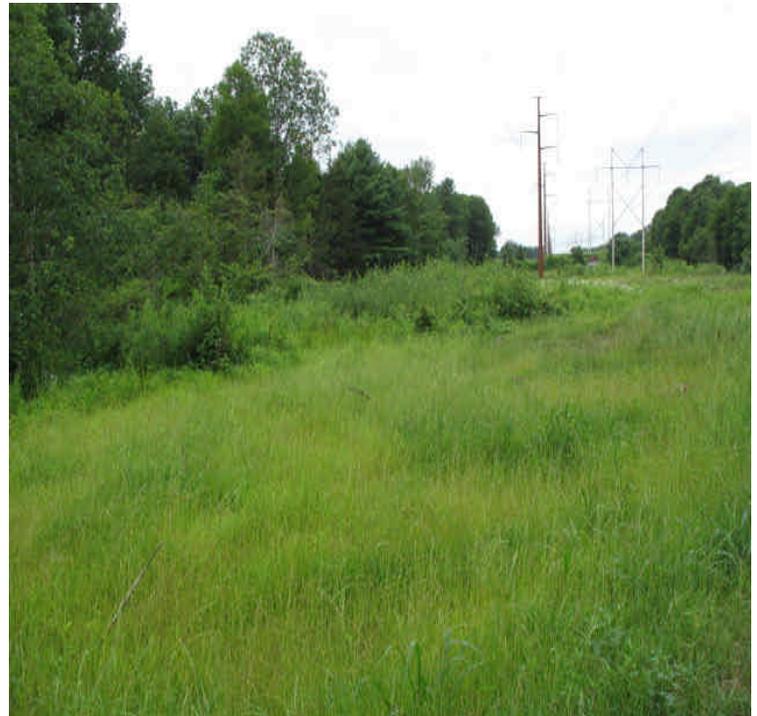
Liney Hall Ln: Final stabilization within the wetland is almost complete. Remaining stone was removed by hand. No further action needed,

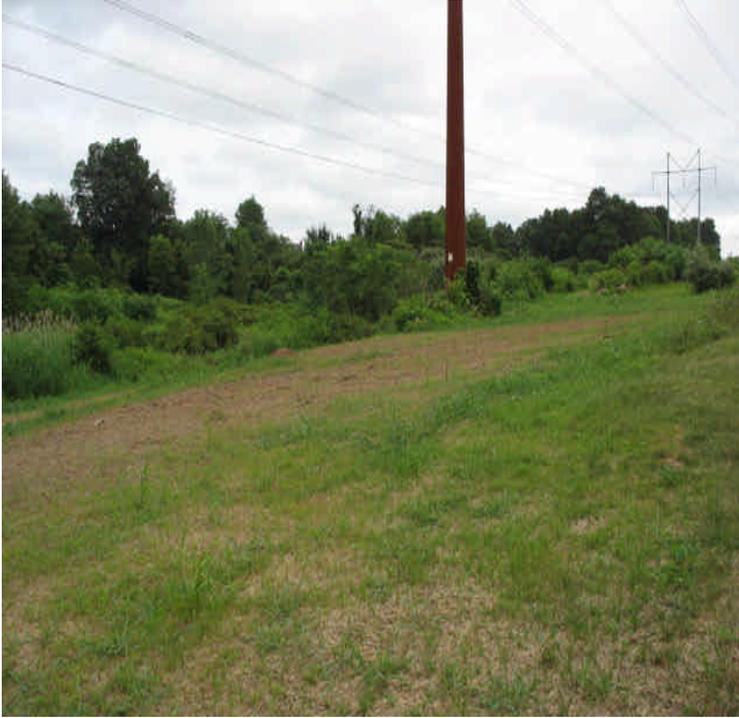
Stony Brook Rd: Old pad and access road may need additional seed during more favorable conditions as vegetation is sparse in this area.

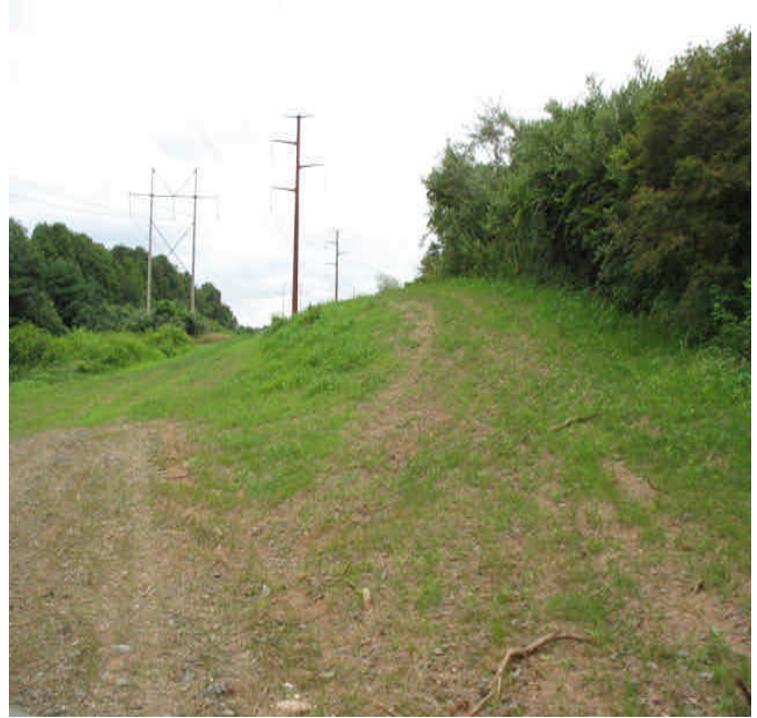
Powers Rd: Final restoration complete. Some grass growth noted. Additional seed may be needed along the slopes during more favorable conditions.

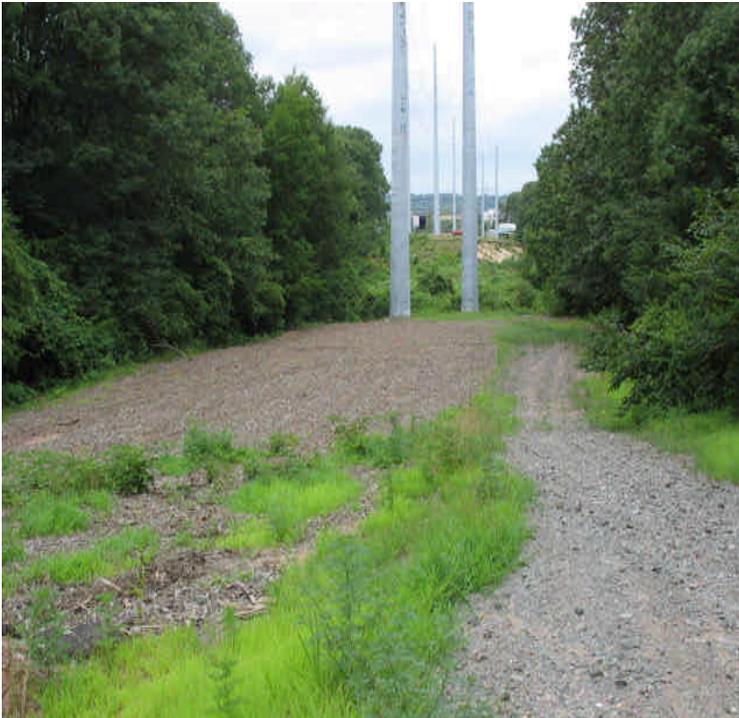
Docker Dr: Area remains stabilized with heavy bark mulch and some adjacent vegetation.

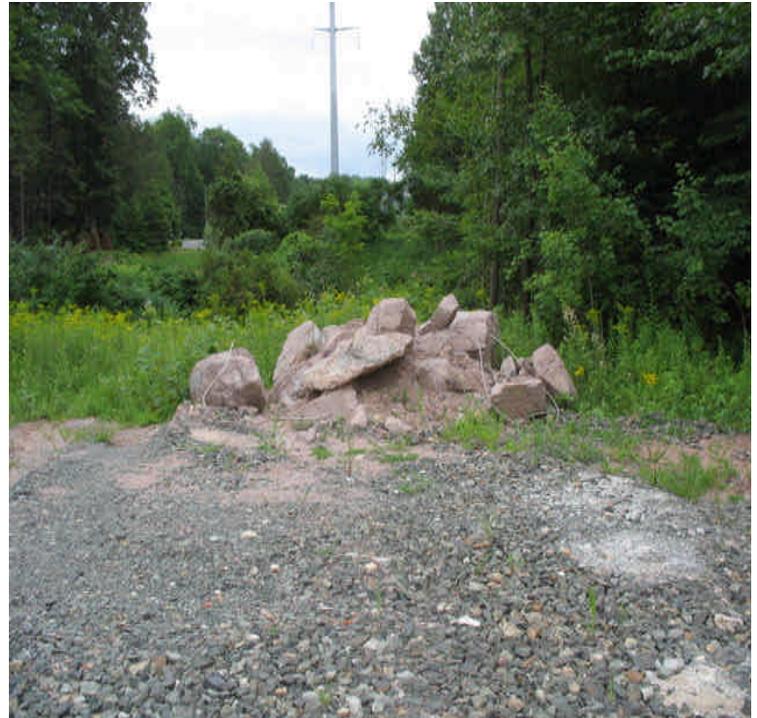
Cook Hill Jct: Small core stockpile left at the edge of the ROW. Remove material during reclamation. This area will be one of the last restored.
