ENVIRONMENTAL INSPECTION REPORT

MIDDLETOWN – NORWALK 345-KV PROJECT: UI Portion – Town of Stratford, City of Bridgeport

Connecticut Siting Council Docket No. 272

Date: October 13 and 19, 2006 **Weather Conditions:** Sunny (October 13)
Inspector: Louise Mango Scattered clouds (October 19, after rain Oct. 18)
(0.33" rain reported in Bridgeport on 10/18/06)

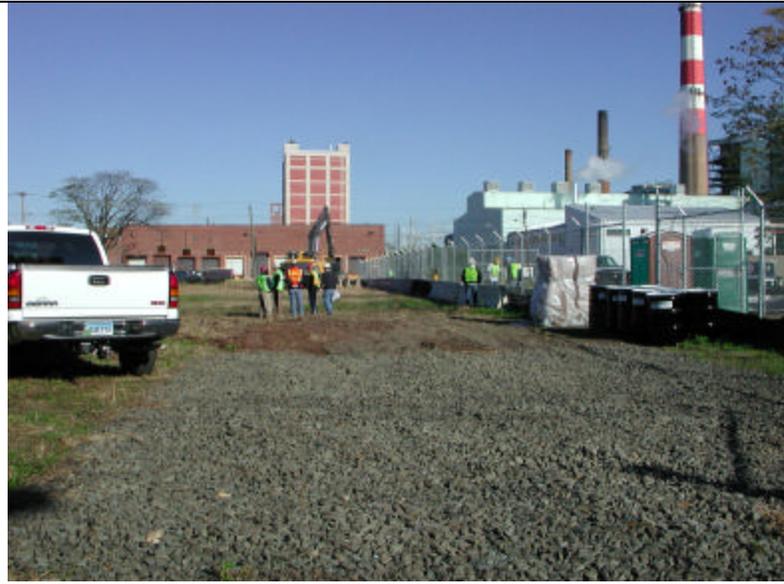
Photo 10-13-1: Singer Substation, view to north, anti-tracking pad, jersey barriers, and drums in preparation for commencement of site work.

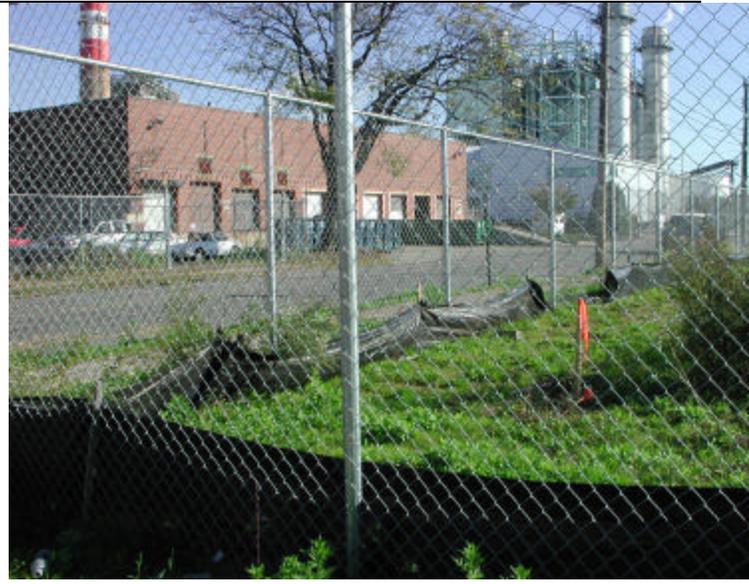
Photo 10-13-2: Singer Substation, view of silt fence in need of repair, northwest corner of site

CONSTRUCTION ACTIVITY / LOCATION	FIELD OBSERVATIONS (PHOTO REF. NO.)	RECOMMENDATIONS	CORRECTIVE ACTIONS
Singer Substation – October 13	Contractor mobilizing equipment to the site and preparing temporary soil stockpile areas. No earth-moving activities performed. Gravel anti-tracking pads installed at site entrances off Henry and Atlantic streets. Contractor and UI trailers / parking areas established. (Photo 10-13-1)	N/A	N/A
	Silt fence was installed around entire substation site, inside the existing chain link fence. This fence was installed prior to contractor mobilization, in conjunction with the erection of the chain link fence. In some areas, silt fence had fallen down or had holes. (Photos 10-13-2 through 4)	Replace or supplement silt fence as needed to maintain an effective erosion / sedimentation barrier	Informed UI (R. Pinto, C. Maresca) of need to replace silt fence. UI advised that the fence would be repaired or replaced as soon as possible.

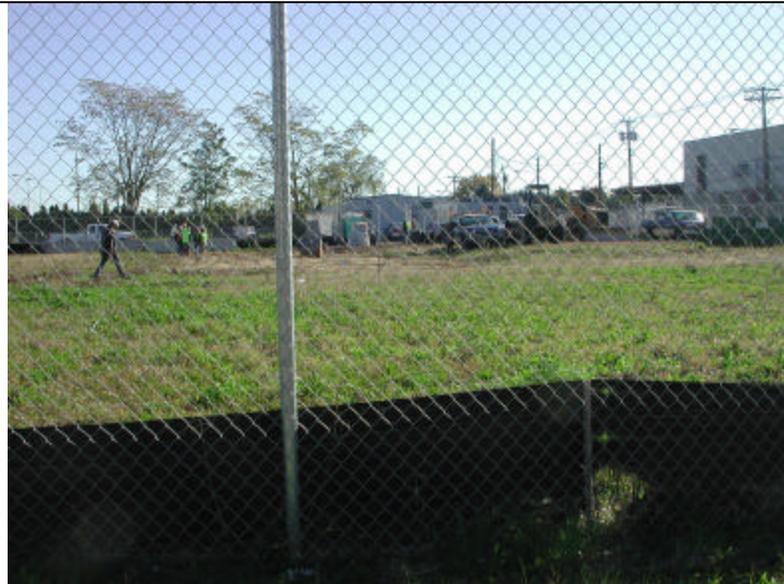
Photo 10-13-3: Singer Substation, view to east from Main Street. Silt fence in need of repair.

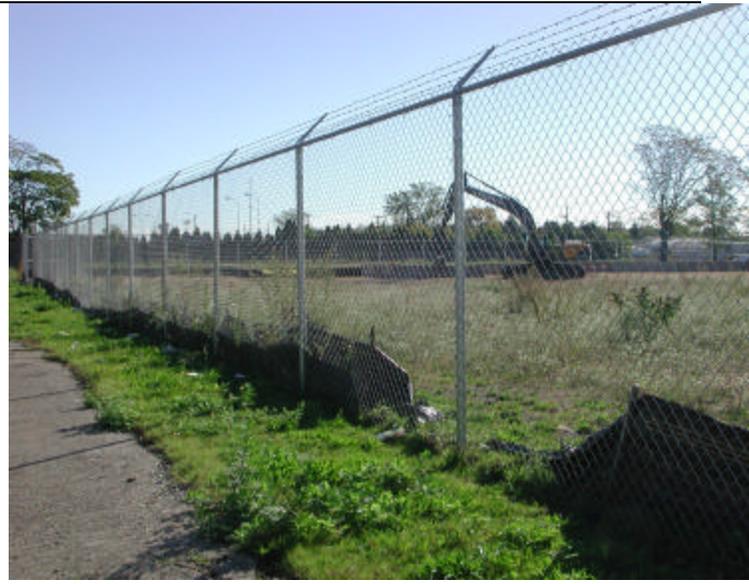
Photo 10-13-4: Singer Substation, view of site from northwest corner, silt fence in need of repair.

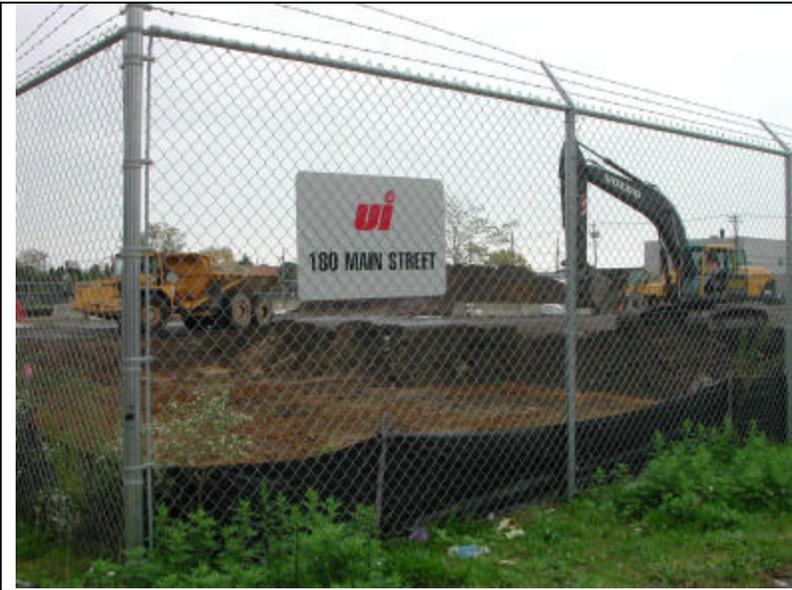
Singer Substation – October 19	Silt fence around site repaired or supplemented with a second row of silt fence in certain areas. No areas of erosion / sedimentation observed, although there was standing water evident on-site from the previous days' rain.	None	N/A
	Site cleared of vegetation during soil stripping.	None	N/A
	Excavation at substation building area ongoing. Urban rubble in excavated soil will be disposed of off site.	None	N/A
	Temporary Soil Stockpile Areas (SSAs) contained within Jersey barriers ; includes top soil layers stripped from site, as well as soil from substation footprint excavation. Soil placed on plastic. Temporary soil stockpile areas not involved in ongoing excavation protected with plastic sheeting.	None	N/A
	10 55-gallon drums filled with soil excavated from small area of site where lead contamination was detected during sampling. Drums placed within Jersey barrier containment area until manifested/transported off site for ultimate disposal.

Photo 10-19-1: Singer Substation, building excavation. Silt fence on northwest corner of site repaired.

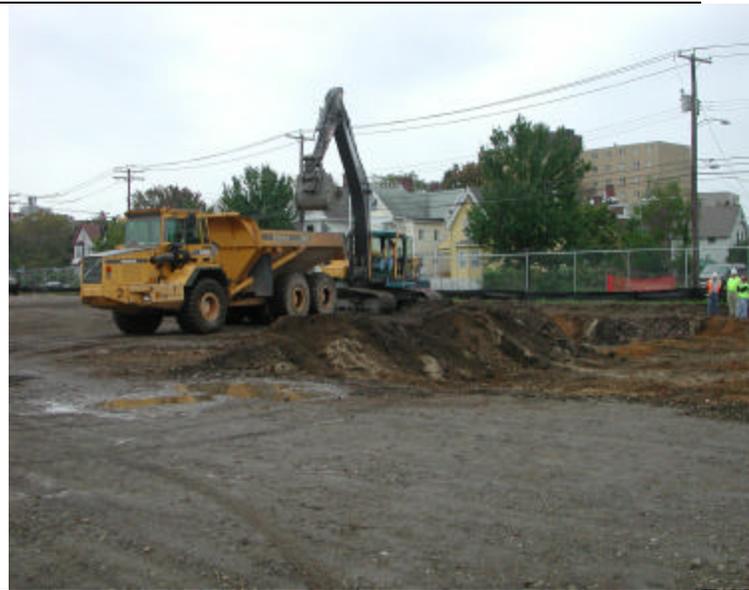
Photo 10-19-2: Singer Substation, excavation for substation building.

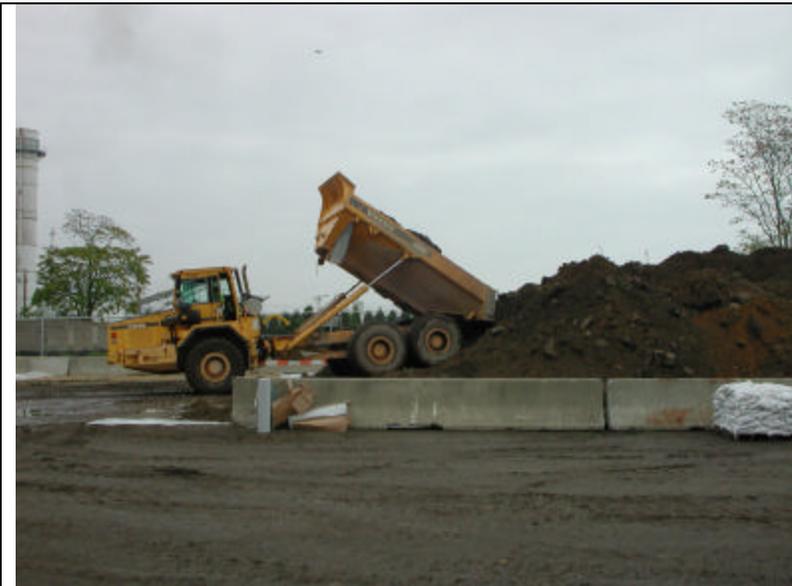
Photo 10-19-3: Singer Substation, excavated soil placed in temporary on-site Spoil Storage Area.

Removal of stockpiled soil. The week of October 23, spoil temporarily stockpiled on-site and unsuitable for use in the substation construction will be transported off-site for ultimate disposal. Current plans call for transport to Phoenix in Waterbury, CT. Soil disposal will proceed at a rate of an estimated 300 tons of soil per day (about 20 truck loads), all next week.

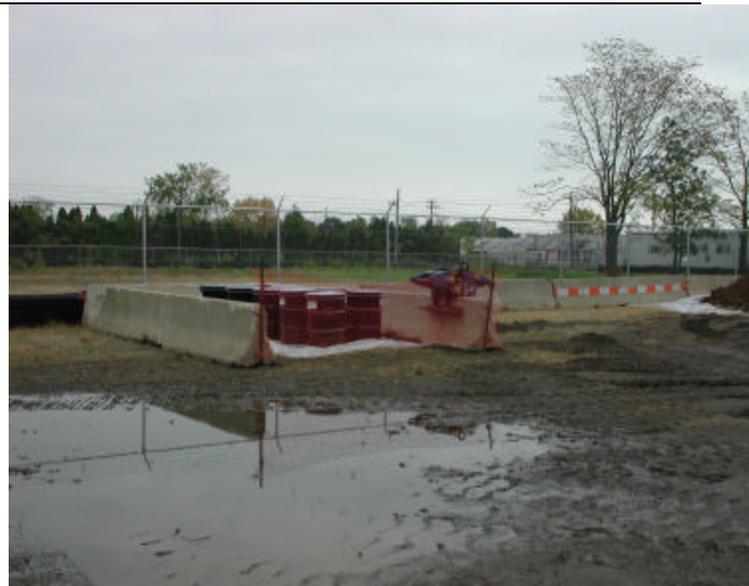
Photo 10-19-4: Singer Substation, containment area for temporary storage of excavated soils (10 55-gallon drums) containing lead.

The 10 55-gallon drums of soils contaminated with lead (and considered hazardous) will be manifested and transported off-site for appropriate disposal upon completion of analytical testing to confirm the soil contaminant levels.
